Rock-Koshkonong Lake District  
2009 Lake Study Report

On June 17, 2009, Stephen Hjort and Stanley Nichols of Eco-Resource Consulting (ERC) conducted the first lake study of 2009. The USGS water level gage data on that day was 777.34 msl.

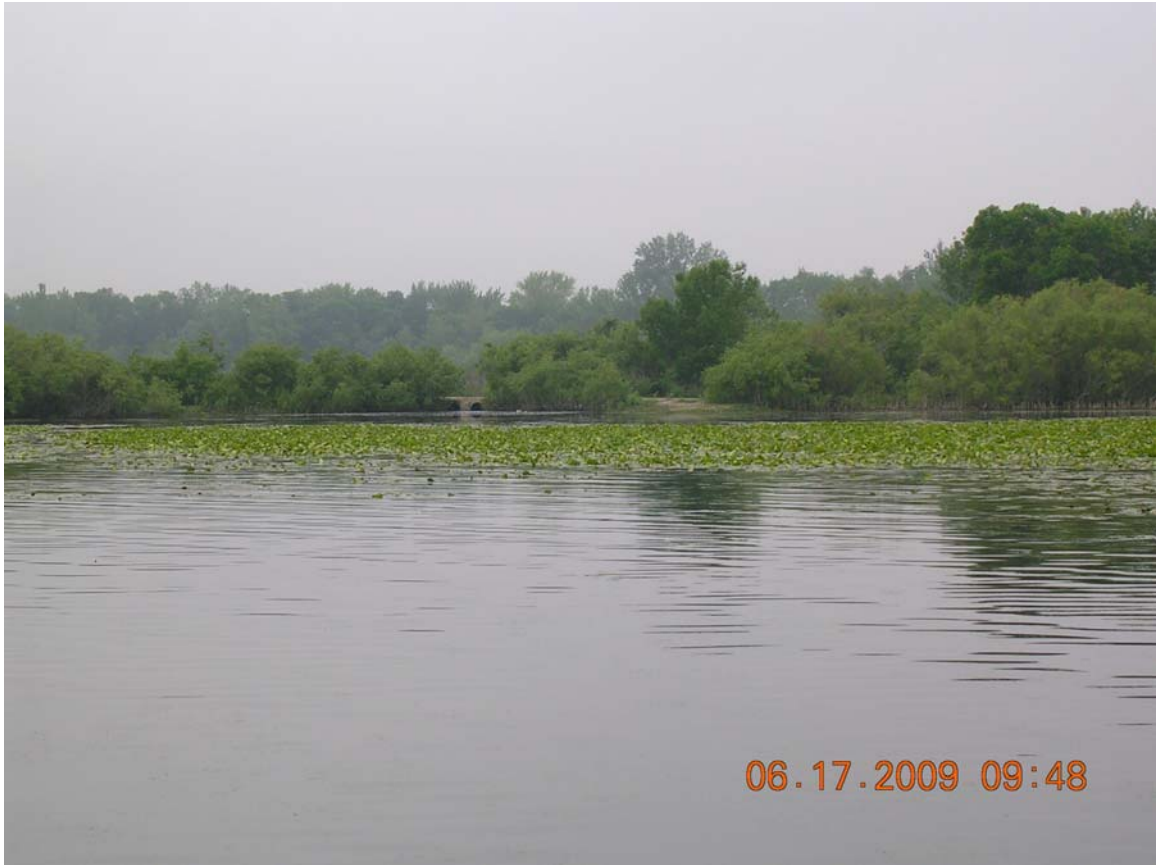
9:40 AM      Near outlet structure of dike was an expansive white water lily bed (*Nymphaea odorata*) that appeared similar in size and shape as previous observations. Water was very clear inside lily pad bed (could see bottom throughout) with other submergent aquatics noted, coontail (*Ceratophyllum demersum*), flatstem pondweed (*Potamogeton zosteriformus*), small duckweed (*Lemna minor*), water-meal (*Wolffia columbinia*), water smartweed (*Polygonum amphibium*), sago pondweed (*Stuckenia pectinatus*), curly leaved pondweed [CLP] (*Potamogeton crispus*) and river bulrush (*Scirpus fluviatilis*).

Photograph 1 below was taken north of the outlet structure looking south. Photographs 2 and 3 were taken from the same locations looking west and east respectively.

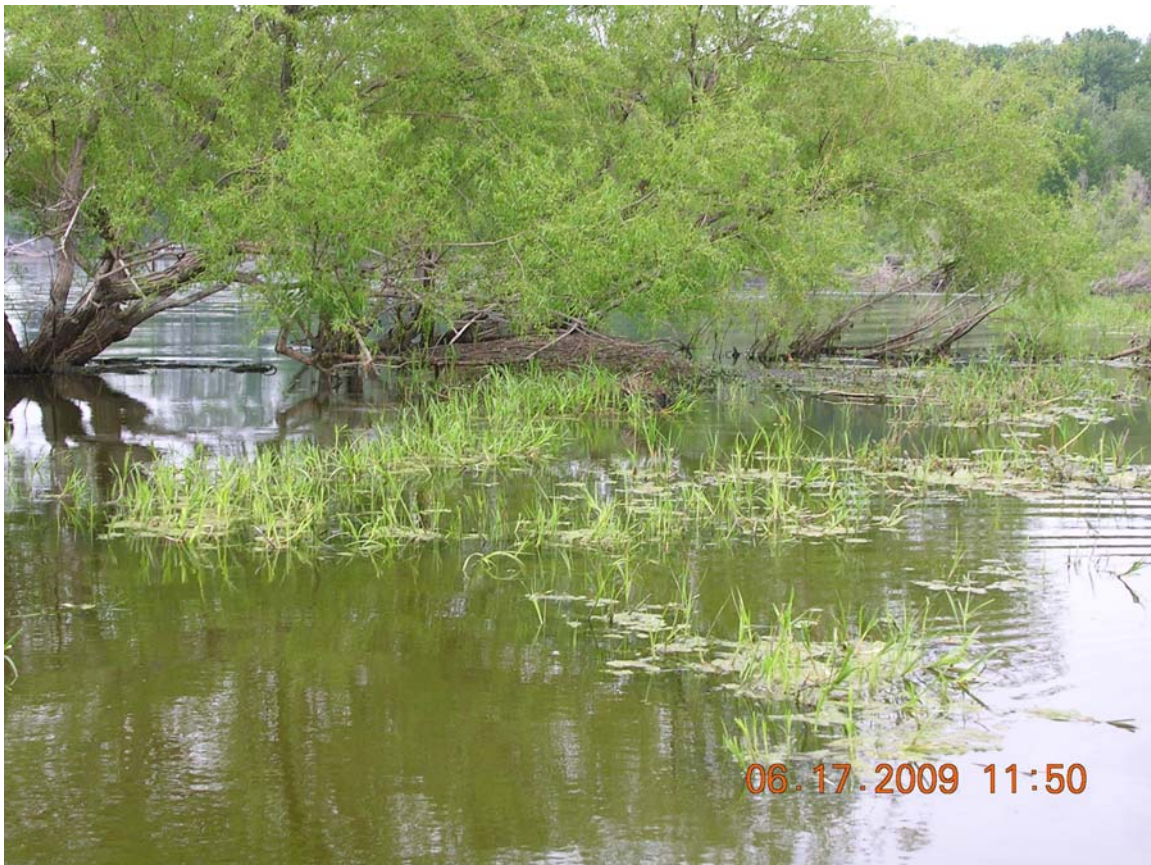
Photograph 4

11:30 AM Gilbert's Bay (WDNR-owned) GPS N 42.88982 W 88.90900  
Photographs below include shoreline photos of the remnant ice shove berm between black willow trees (Photograph 4) and shoreline north of (Photographs 5 & 6), and shoreline south (Photograph 7).

It appeared that significant erosion of this shoreline has occurred since ERC staff last visited this area in 2005. Shoreline plants observed included river bulrush, water smartweed, sandbar willow (*Salix exigua*) and black willow (*Salix nigra*).

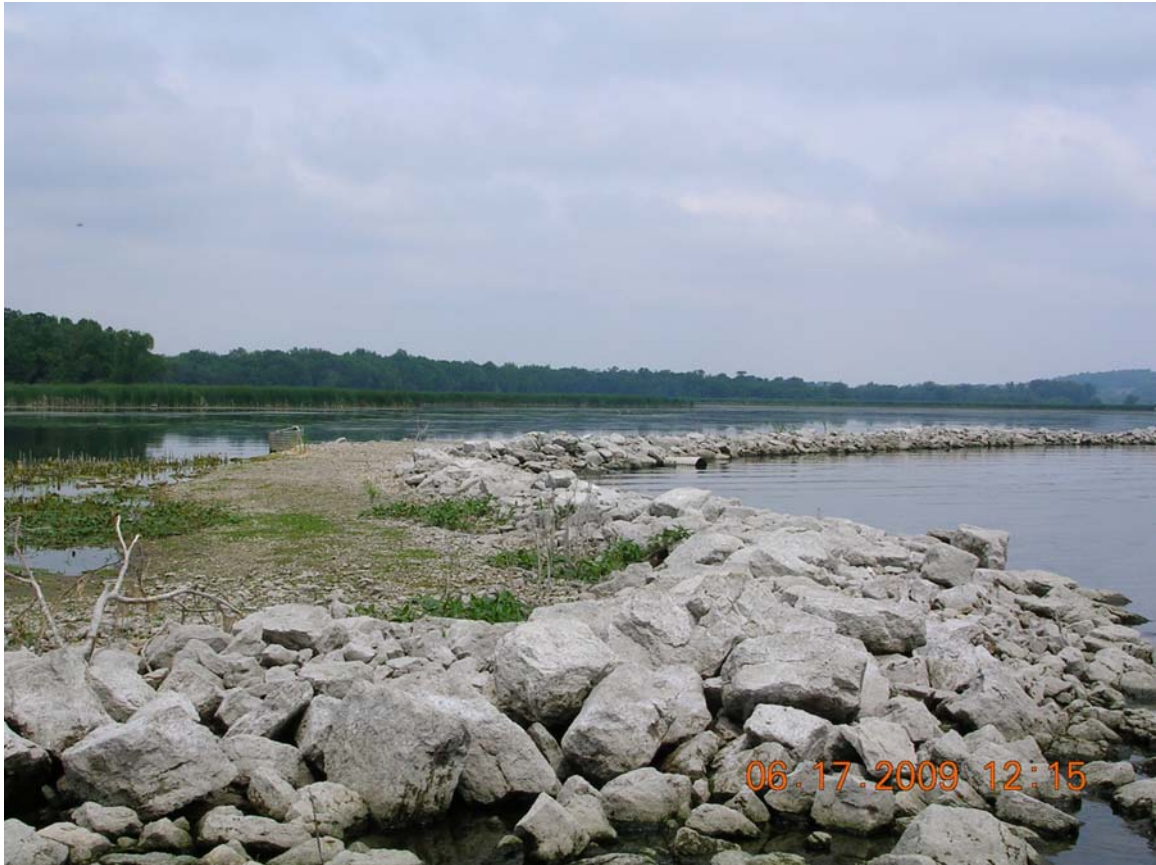
Photograph 8

12:00 PM	Mouth of Rock River Secchi Depth – 1.0'	GPS N 42.88940 W 88.91574 Total Depth 4.2' Green in color
12:15 PM	Stinker's Bay (central) Secchi Depth – 2.0' No SAV observed	GPS N 42.90637 W 88.94322 Total Depth 3.0' Greenish brown color
12:20 PM	HAI (riprap area)	The open water area north of the riprap has increased significantly since 2005. Water smartweed and river bulrush were observed on the backside of riprap and sago pondweed in backwater area. Photographs 8 and 9 below were taken south of the riprap looking northwest and northeast respectively.

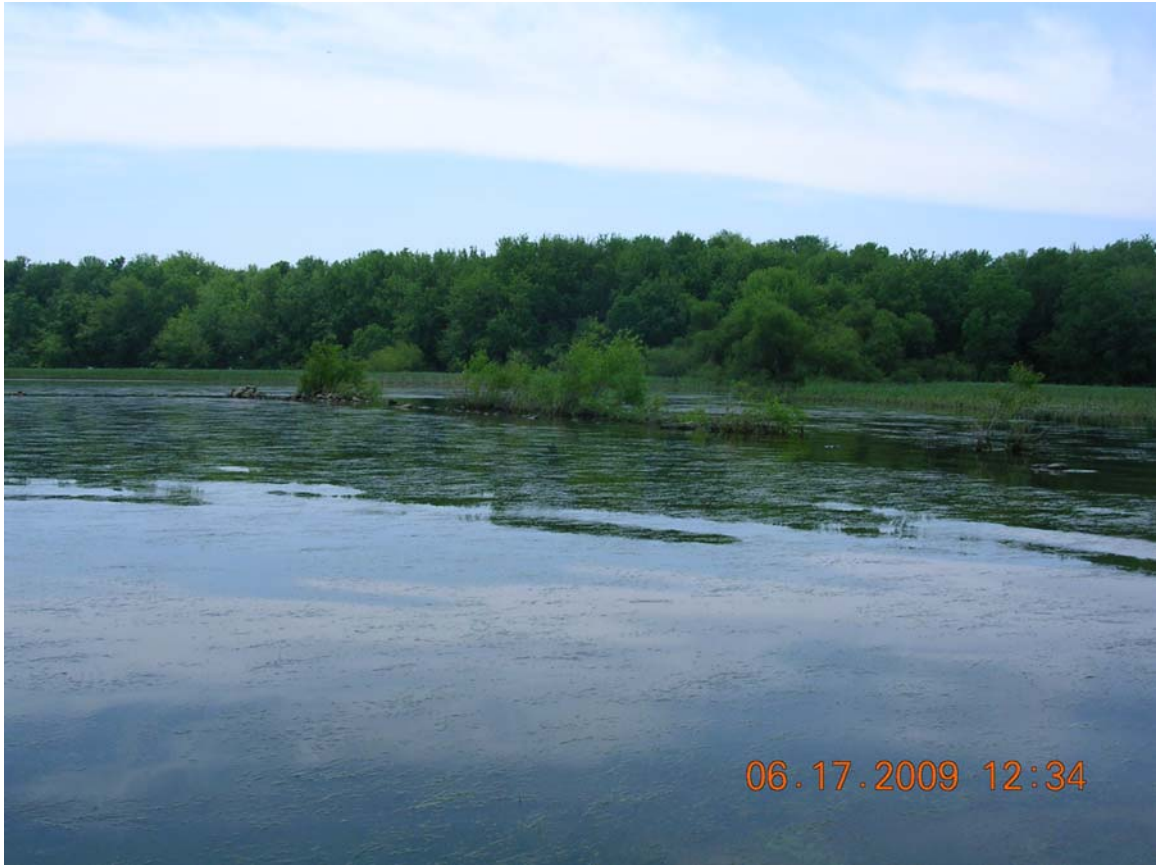
Photograph 10

Carcajou Shallow Marsh area behind riprap appears to be extending lakeward from former shoreline. Some sandbar willow present along riprap. Photographs 10 and 11 below were taken from south of the riprap looking west and east respectively.

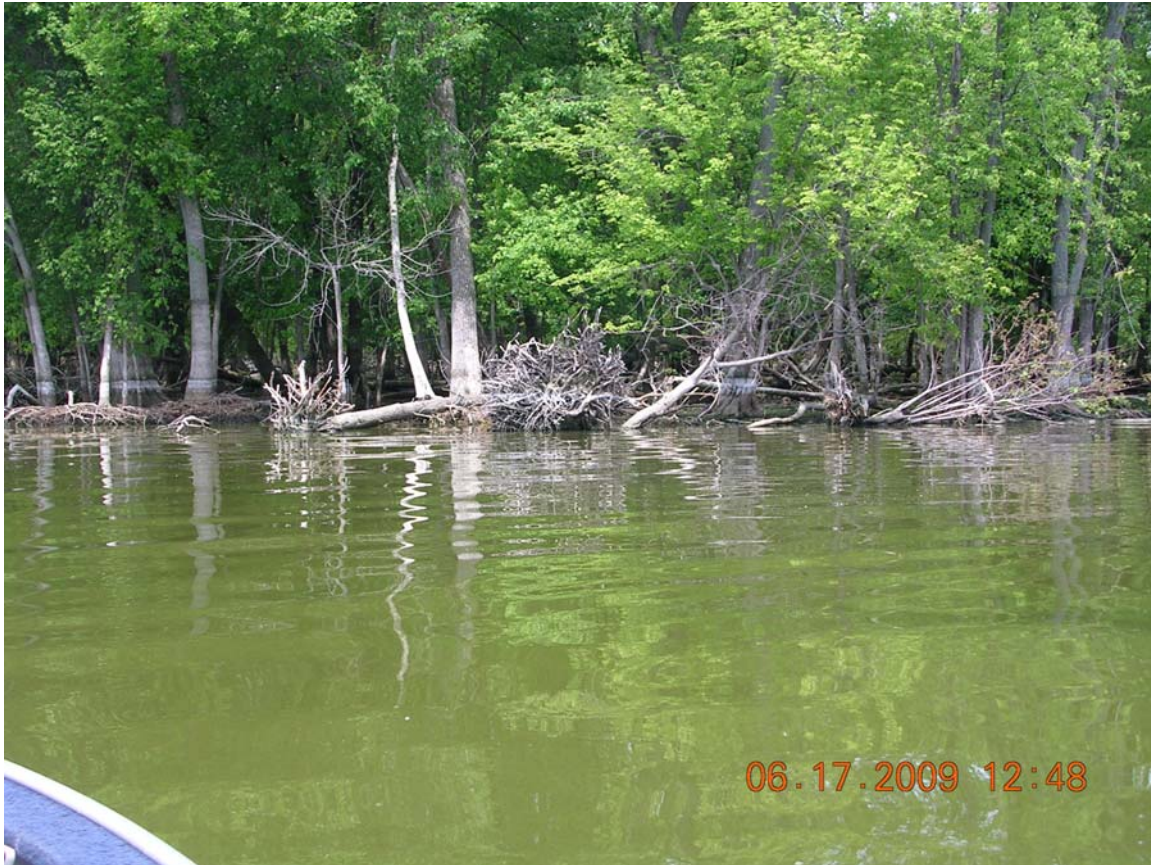
12:45 PM Carcajou Floodplain Forest. Photograph 12 below is the location of the former Lake Study Plot. Continued tree tip-overs evident at this location.

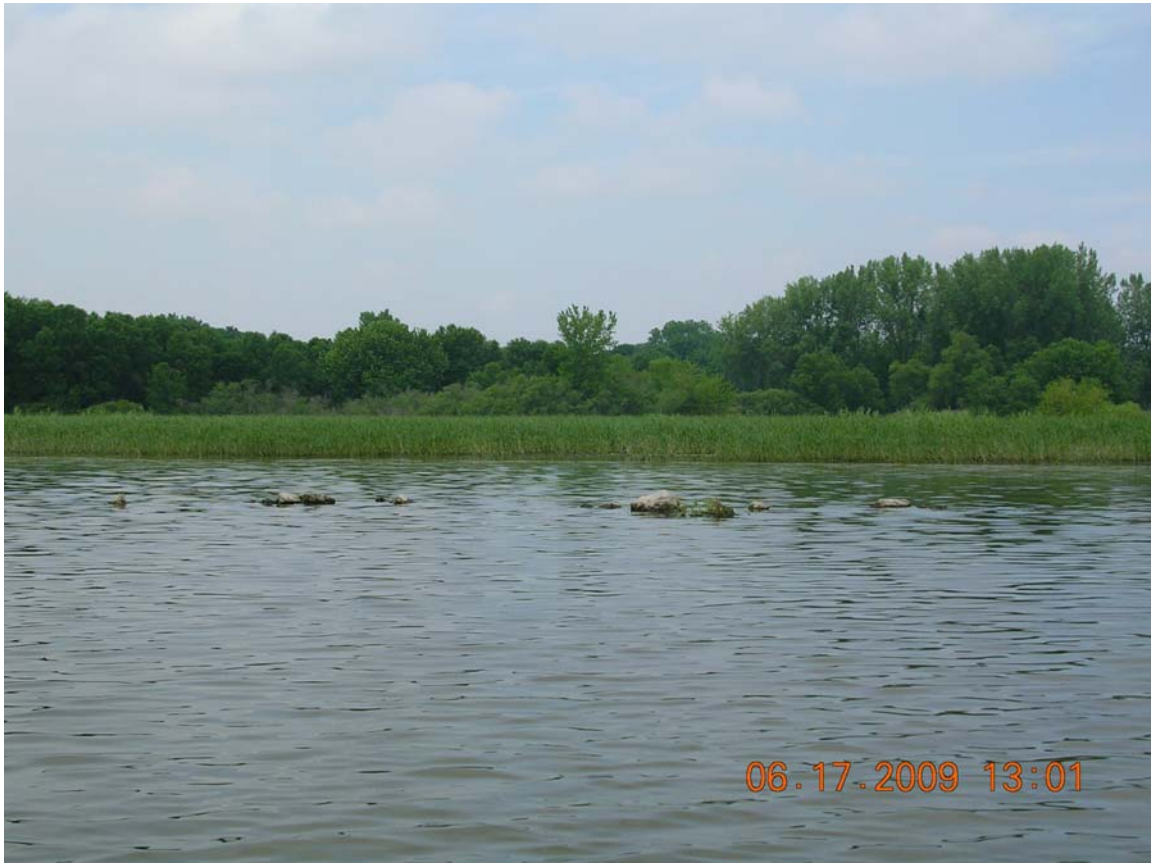
Photograph 13

1:00 PM Crescent Bay (central) GPS N 42.88478 W 88.99478  
Secchi Depth – 2.0' Total Depth 2.3' Green in color  
Scattered sago pondweed observed in depths of  $\leq$  3.0 feet of water. Photographs 13 and 14 below were taken from south of the Crescent Bay Hunt Club riprap looking north and northwest respectively.
