**WDNR/RKLD COOPERATIVE LAKE STUDY
LAKE KOSHKONONG, WISCONSIN**

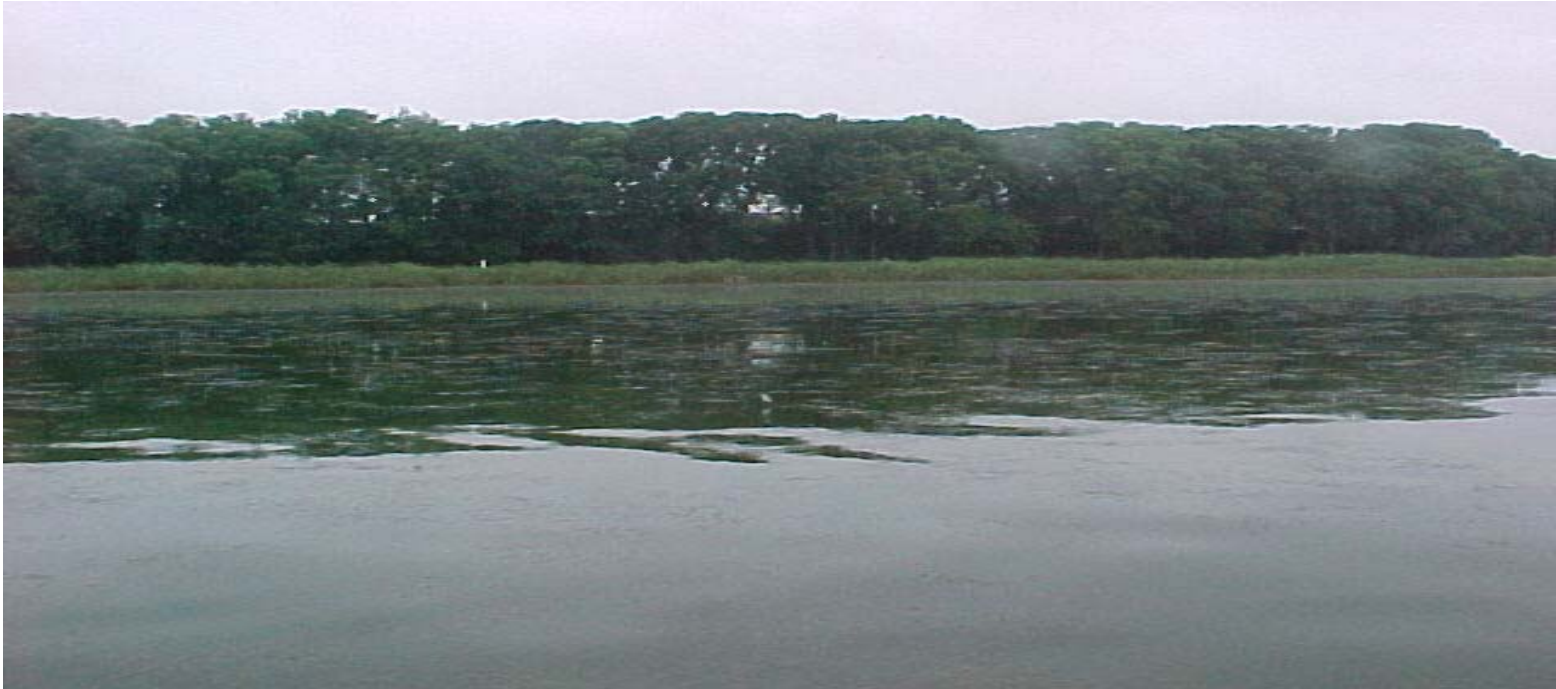
- Location: Hights Bay Shallow Marsh Date: 7/9/02 WL: 776.14 msl
- Photo Description: Photo of Hights Bay sago and coontail submergent bed. Depth of water 0 - 1.5 feet. This aquatic bed is denser than previous two years of observation.

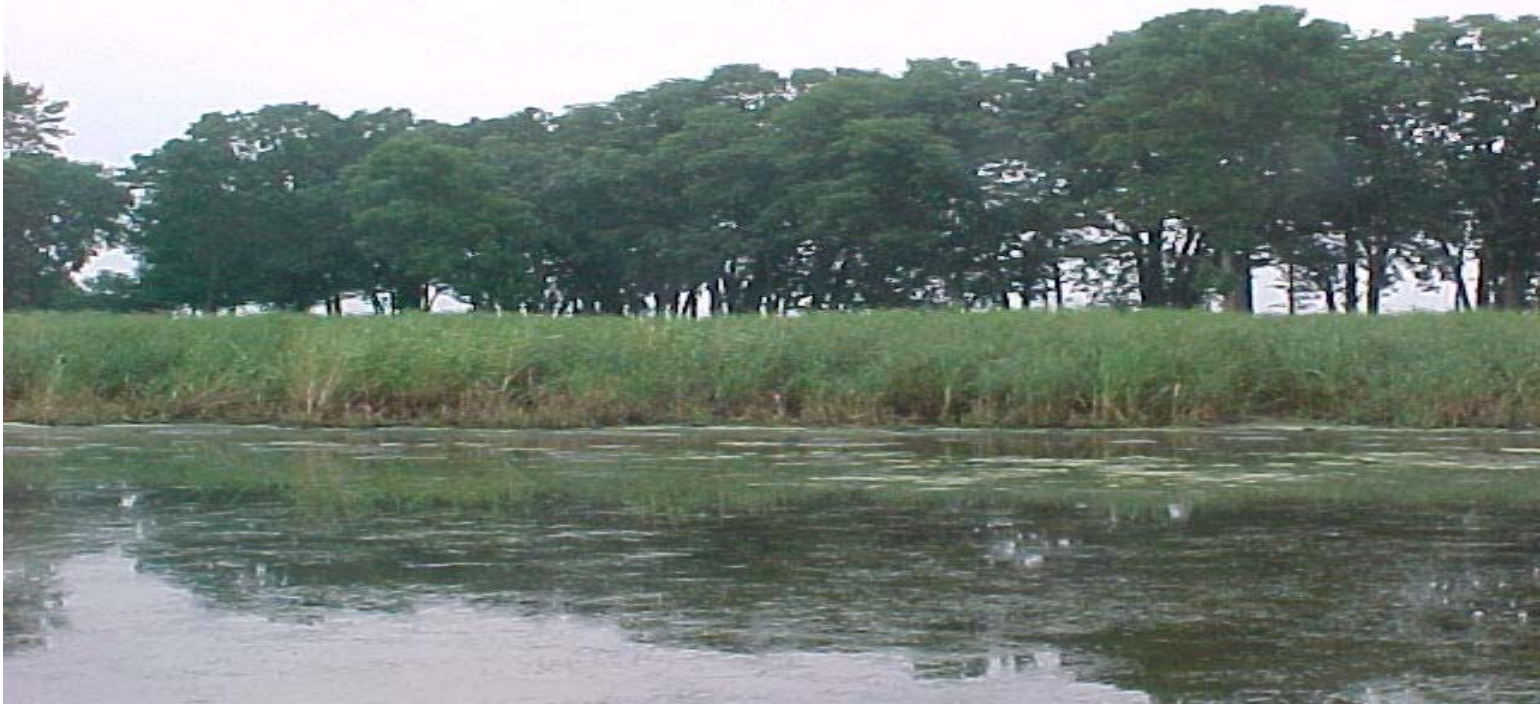
- Location: Hights Bay Shallow Marsh Date: 7/9/02 WL: 776.14 msl
- Photo Description: Photo of Hights Bay plot location. Sago and coontail submergent bed up to edge of emergent bed. Water depth at edge of emergent < 1 inch. Depth of water 15' out from middle of plot 1-inch with sago and coontail present. The emergent vegetation similar in density and composition to May 2002. River bulrush predation evident along lakeward edge of emergent bed.

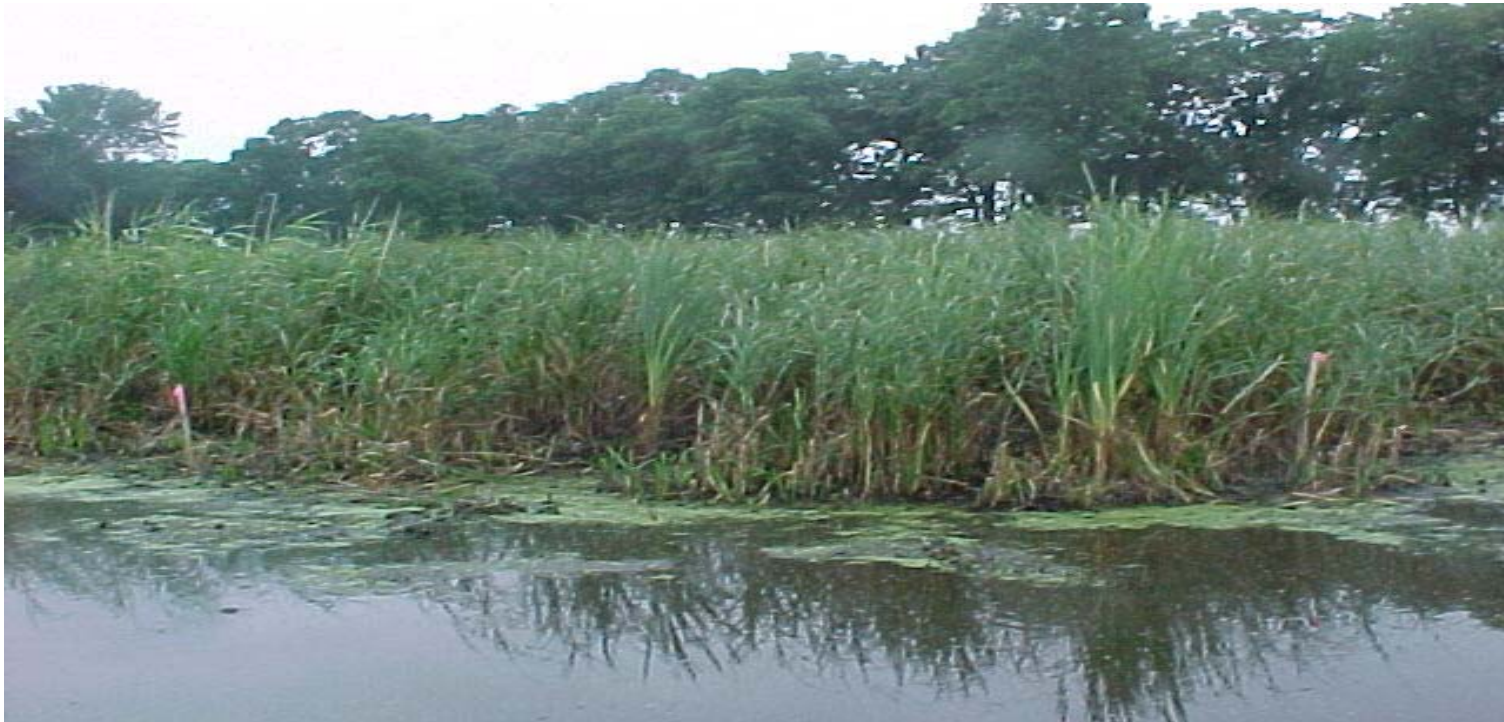
- Location: Hights Bay Shallow Marsh Date: 7/9/02 WL: 776.14 msl
- Photo Description: Photo of Hights Bay Quadrant A. Vegetation consists of river bulrush, common reed, wild iris and water smartweed.

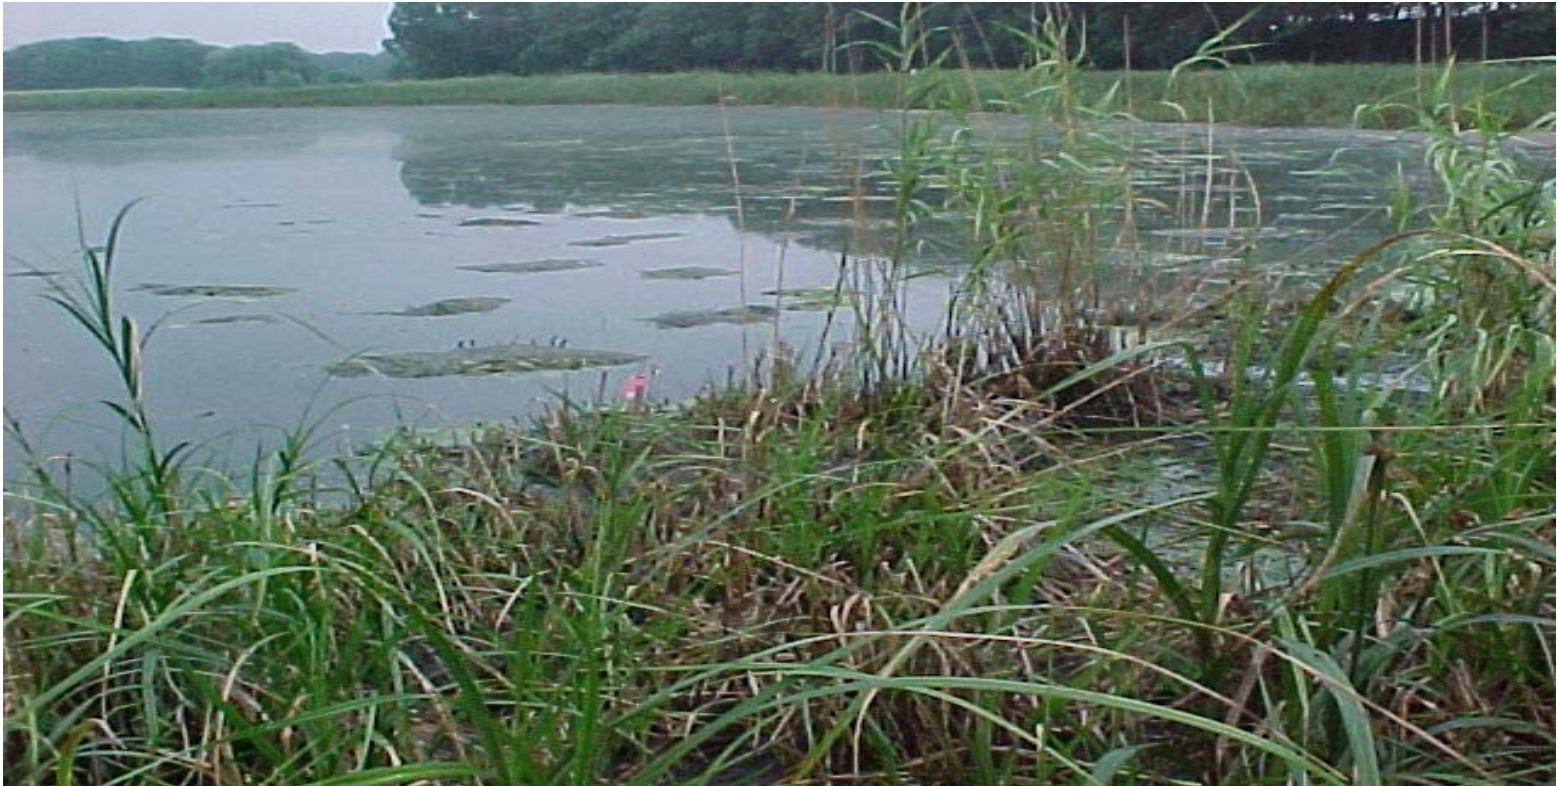
- Location: Hights Bay Shallow Marsh Date: 7/9/02 WL: 776.14 msl
- Photo Description: Photo of Hights Bay Quadrant A showing the predation of the river bulrush and common reed along the shoreline. Exposed sediments were observed in the nearshore areas in the background.

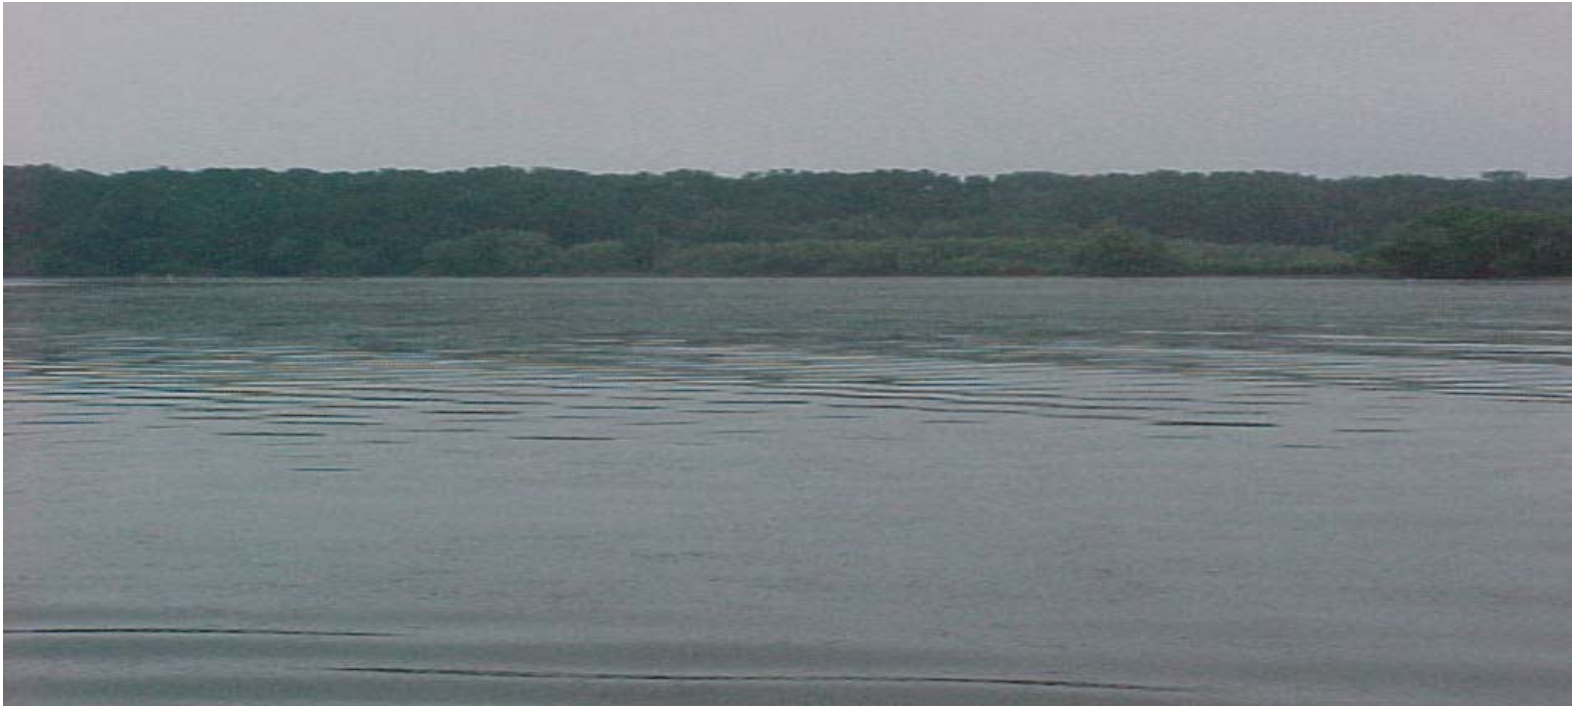
- Location: Gilberts Bay Forest Date: 7/9/02 WL: 776.14 msl
- Photo Description: Photo of Gilberts Bay sago submergent bed. Very isolated coontail was also observed. Depth of water 0 - 1.5 feet. This aquatic bed appears to be denser than previous two years of observation.

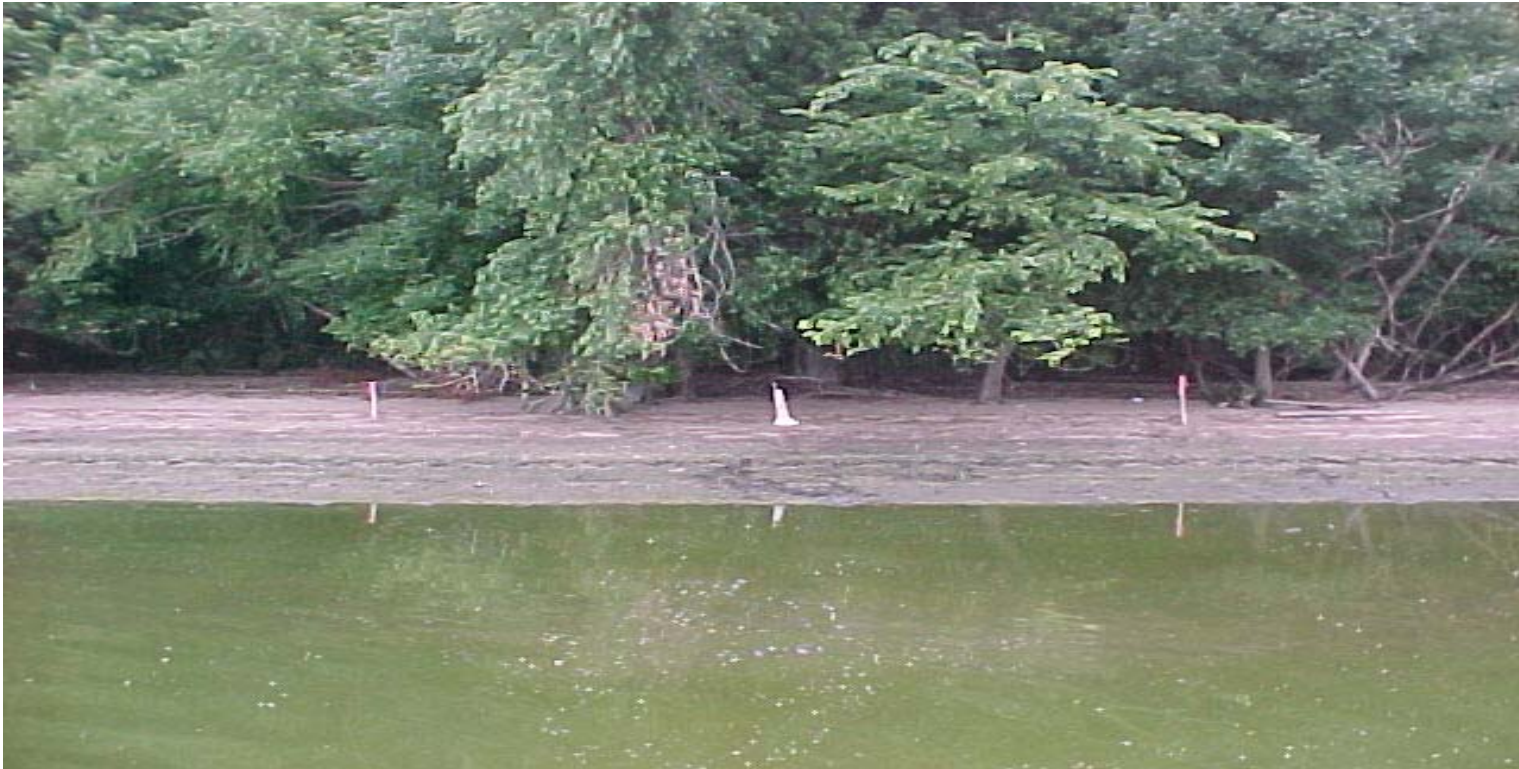
- Location: Gilberts Bay Forest Date: 7/9/02 WL: 776.14 msl
- Photo Description: Photo of plot from west looking east. Edge of water 20 feet from stakes (OHWM). Very little change in vegetation since May 2002. Two river bulrush plants (2-inch tall) growing on exposed sediments lakeward of stakes.

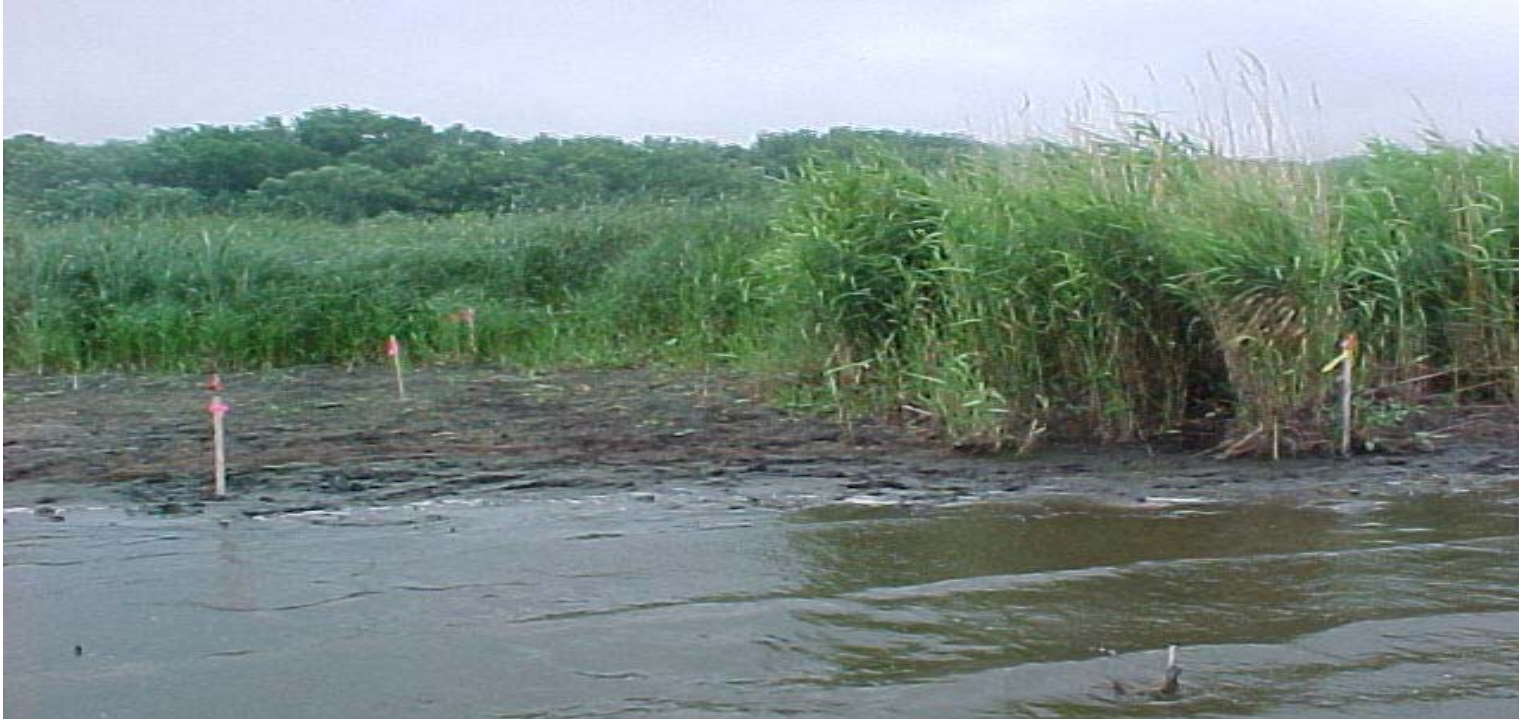
- Location: Carcajou Shallow Marsh Date: 7/9/02 WL: 776.14 msl
- Photo Description: Photo of Carcajou Shallow Marsh Quadrant A. Edge of water 3 feet from stakes. 70% of this quadrant unvegetated. 20% common reed, 3% river bulrush, 17% water smartweed.

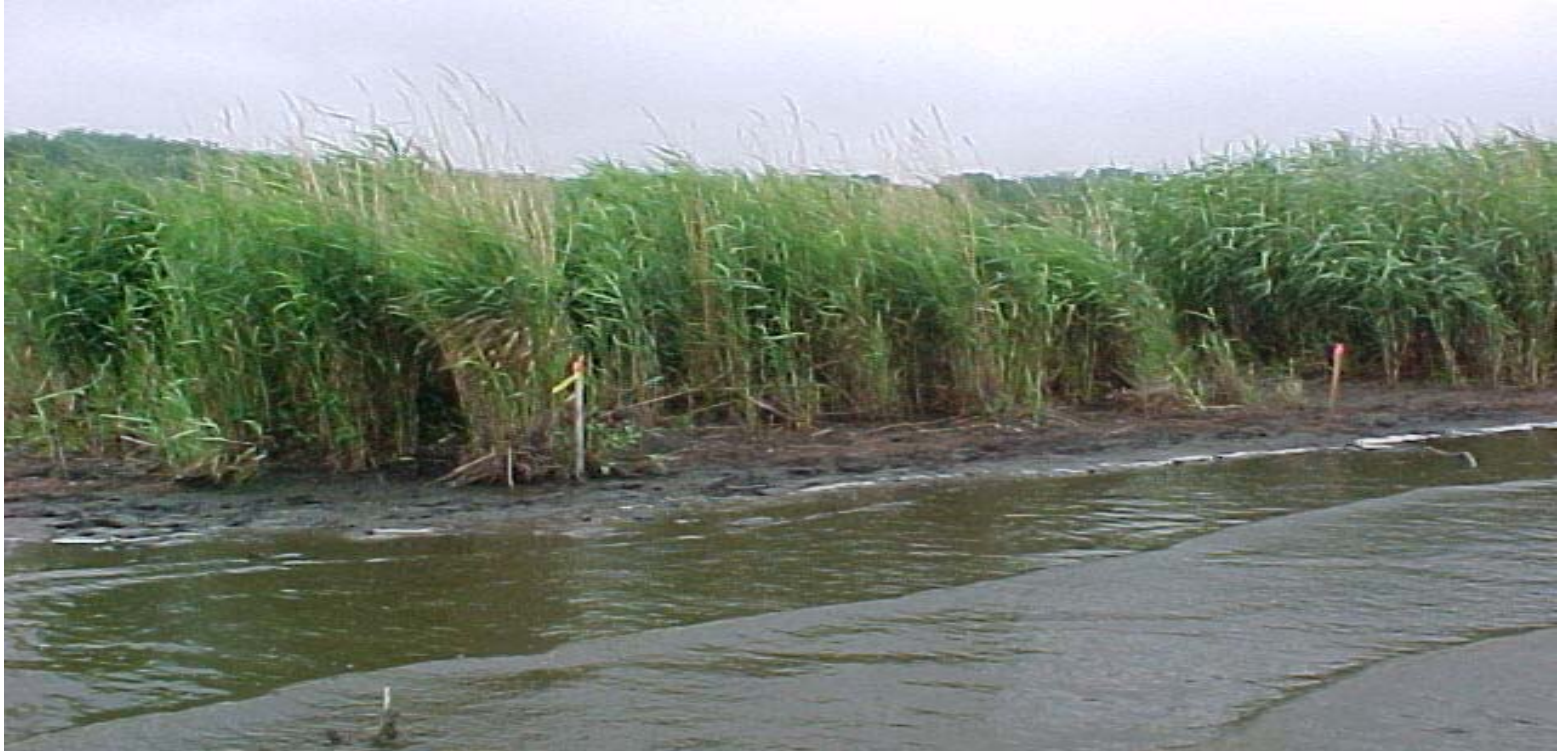
- Location: Carcajou Shallow Marsh Date: 7/9/02 WL: 776.14 msl
- Photo Description: Photo of Quadrant D. Evidence of predation on river bulrush and common reed along shore. 10% of this quadrant unvegetated. 70% common reed, 4% river bulrush, 5% water smartweed, 5% arrowhead. Some young river bulrush sprouted along edge of water.

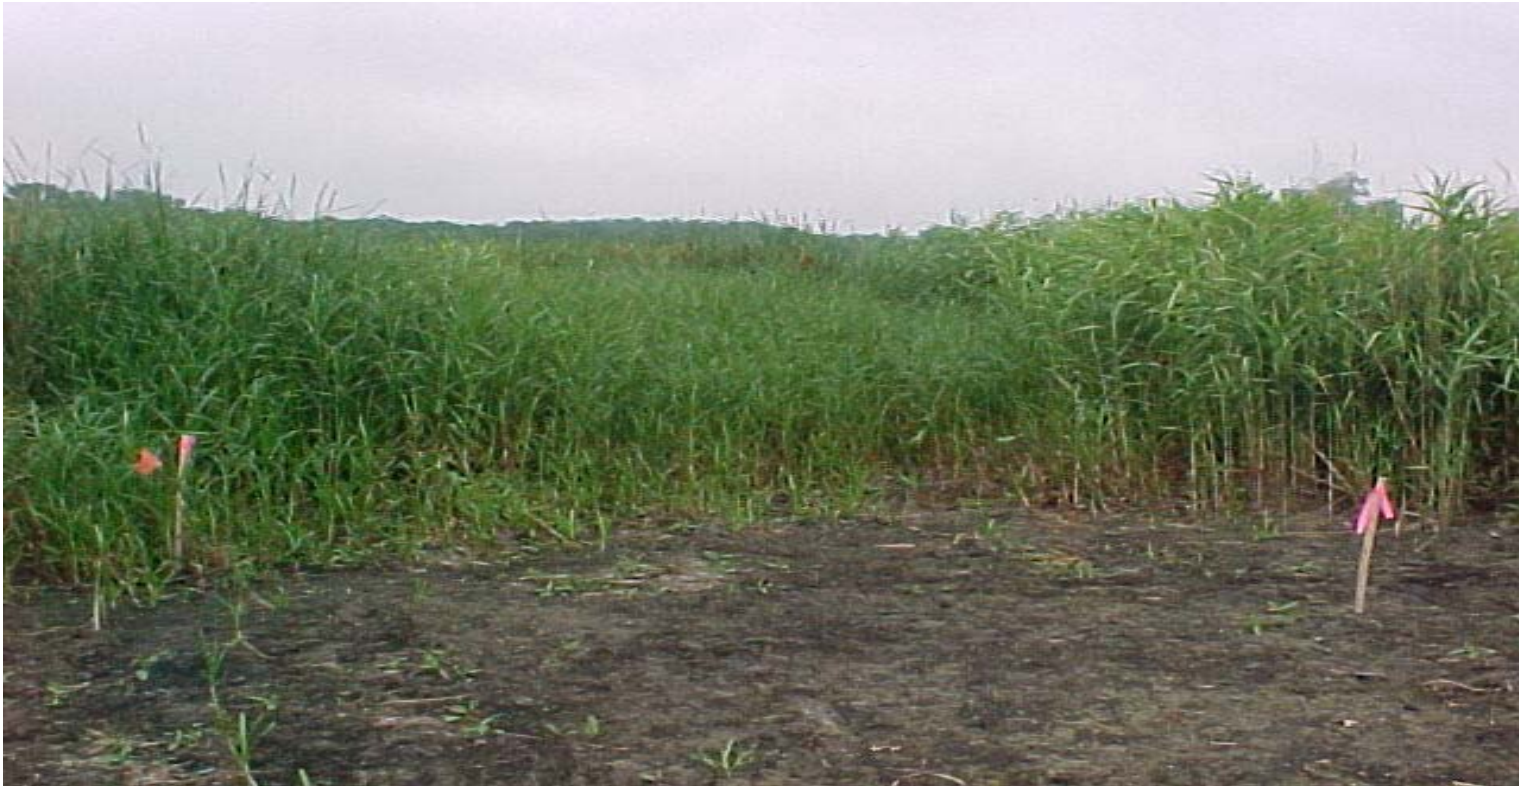
- Location: Carcajou Shallow Marsh Date: 7/9/02 WL: 776.14 msl
- Photo Description: Photo of Quadrant B. 38% of this quadrant unvegetated. 40% river bulrush, 20% water smartweed, 2% arrowhead.

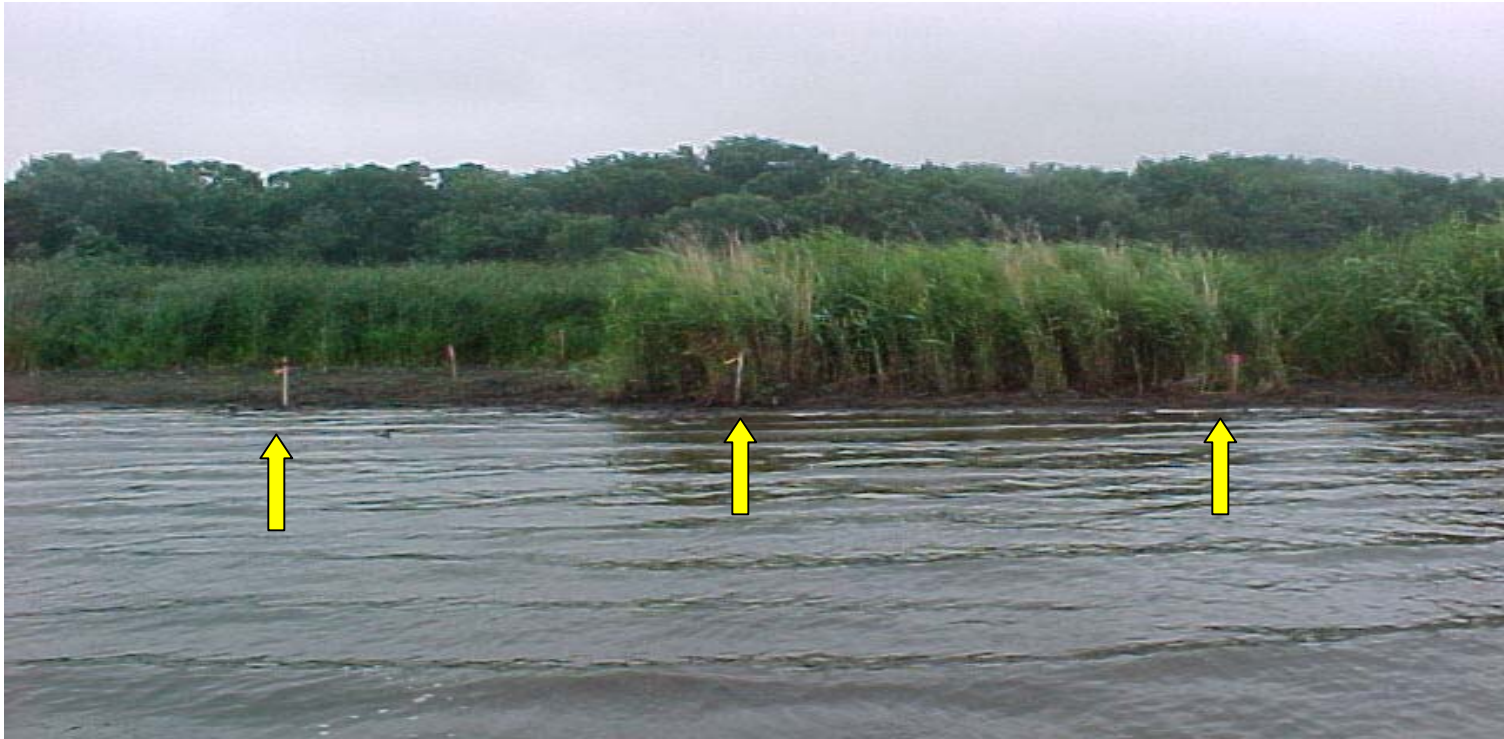
- Location: Carcajou Shallow Marsh Date: 7/9/02 WL: 776.14 msl
- Photo Description: Photo of entire plot arrows indicating stakes. Quadrant A (left side of photo) shows area void of emergent vegetation.

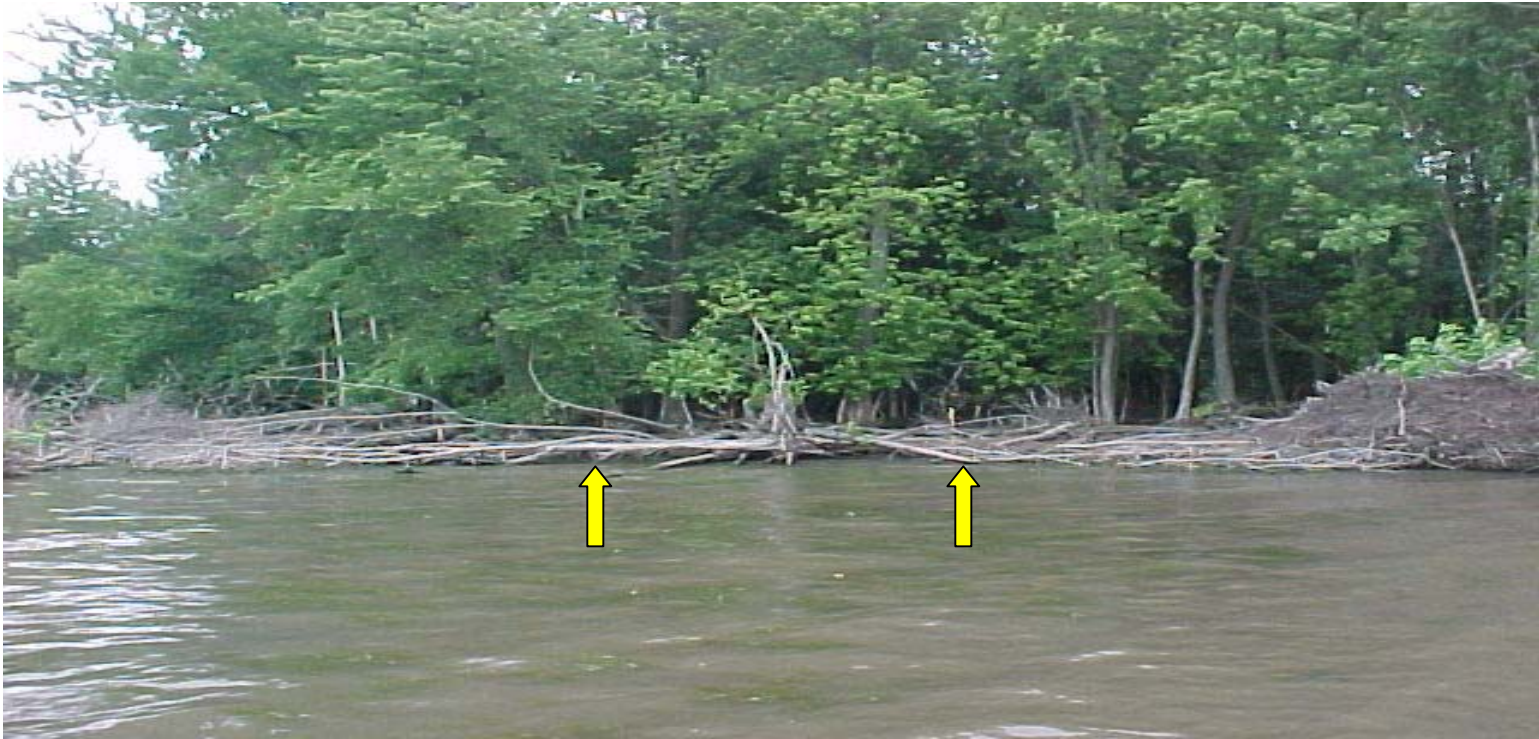
- Location: Carcajou Floodplain Forest Date: 7/9/02 WL: 776.14 msl
- Photo Description: Photo of entire plot. Arrows indicate stakes present, westernmost stake missing (replaced).

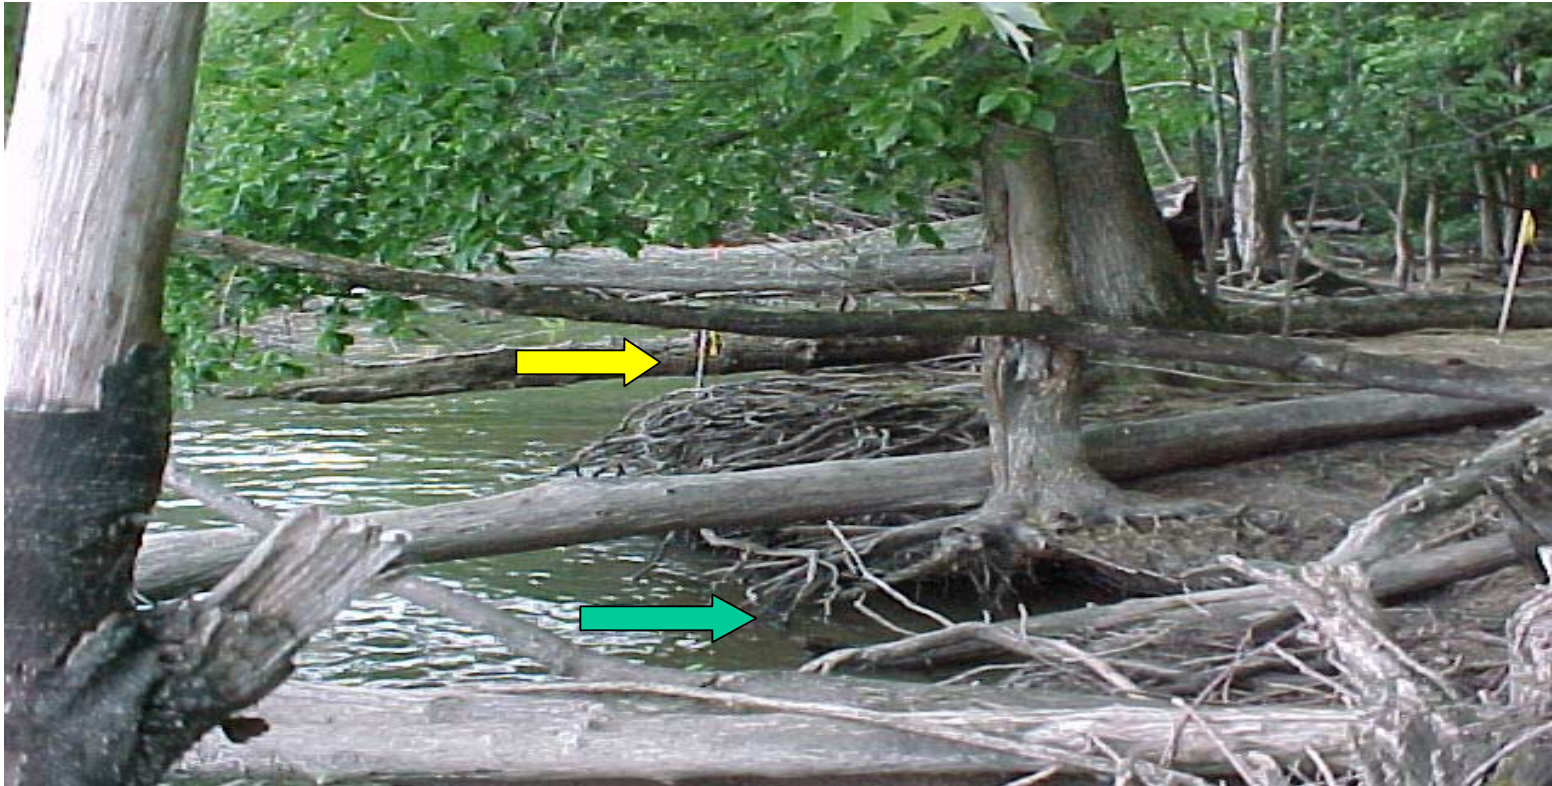
- Location: Carcajou Floodplain Forest Date: 7/9/02 WL: 776.14 msl
- Photo Description: Photo of Quadrant A, yellow arrow is SW corner of quadrant. Green arrow points to observed erosion under tree root systems. More than one foot of sediment loss since February 2002.

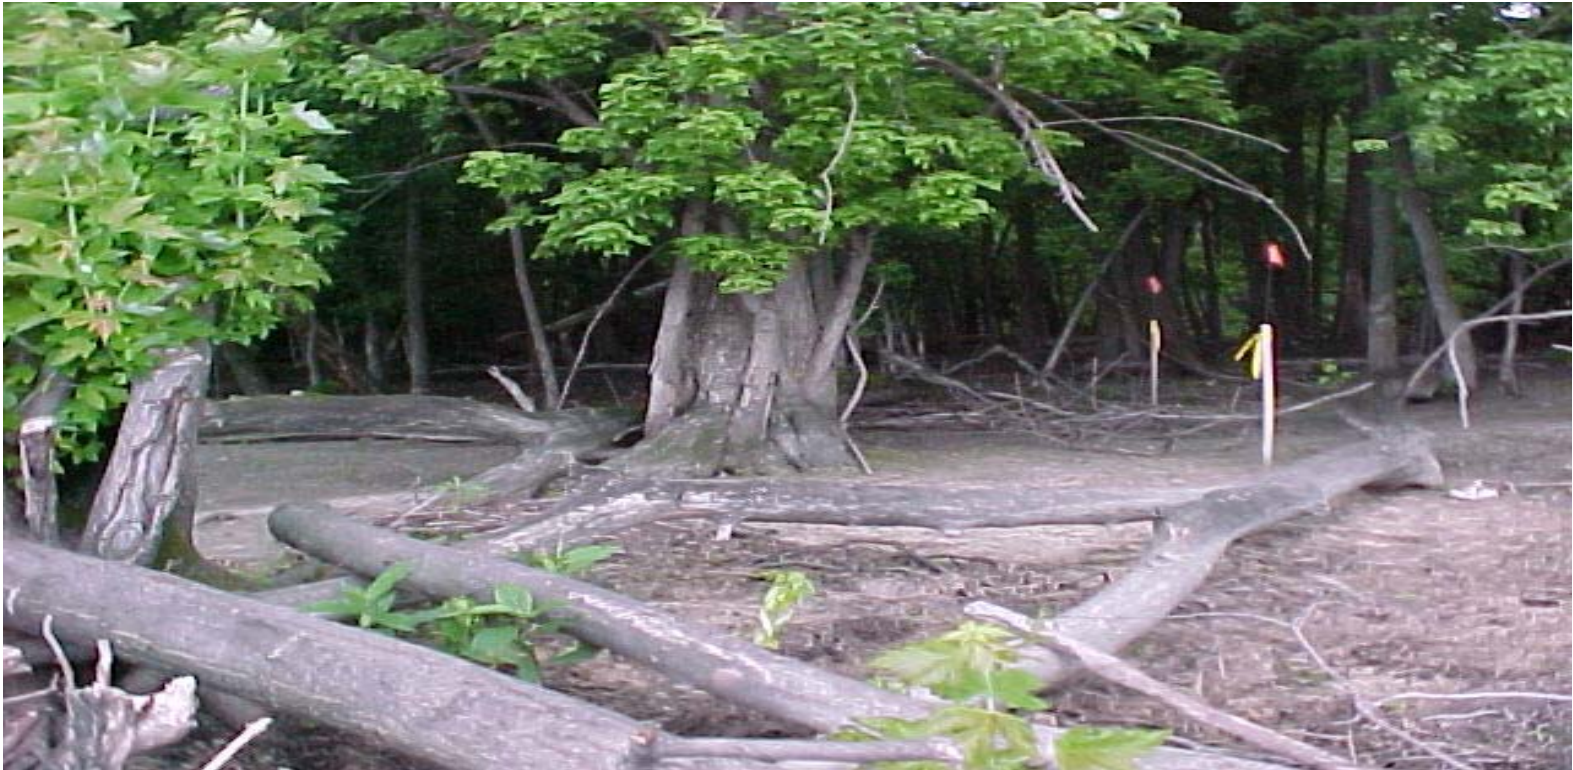
- Location: Carcajou Floodplain Forest Date: 7/9/02 WL: 776.14 msl
- Photo Description: Photo of Quadrant D in foreground and Quadrant C in background. Erosional sediment loss along shoreline root systems and water smartweed growing within five feet of shoreline edge.

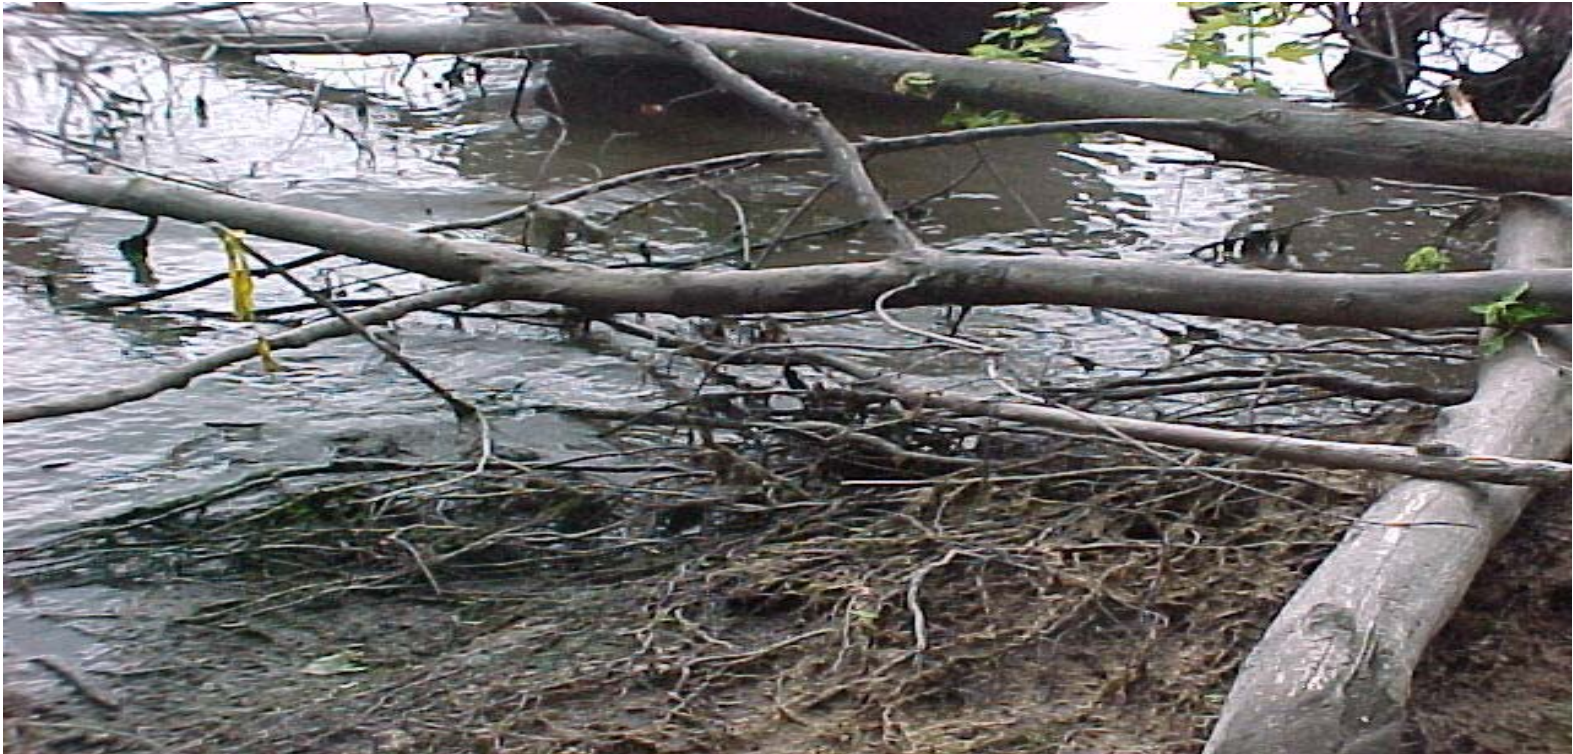
- Location: Carcajou Floodplain Forest Date: 7/9/02 WL: 776.14 msl
- Photo Description: Photo of Quadrant D, erosional sediment loss along shoreline root systems.

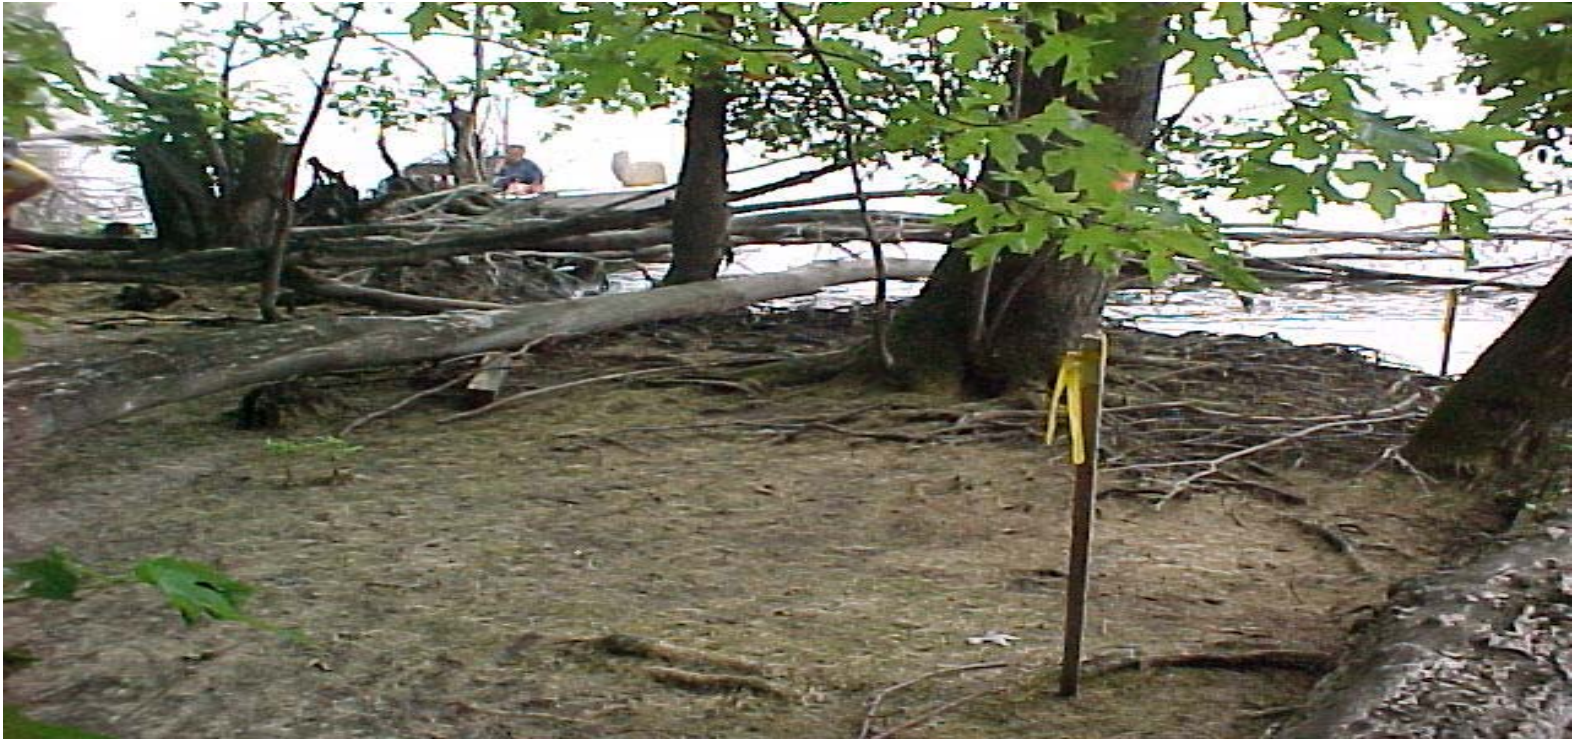
- Location: Carcajou Floodplain Forest Date: 7/9/02 WL: 776.14 msl
- Photo Description: Photo of Quadrant A, erosional sediment loss along shoreline root systems, < 1% water smartweed and unidentifiable grass seedlings present. No other changes observed.

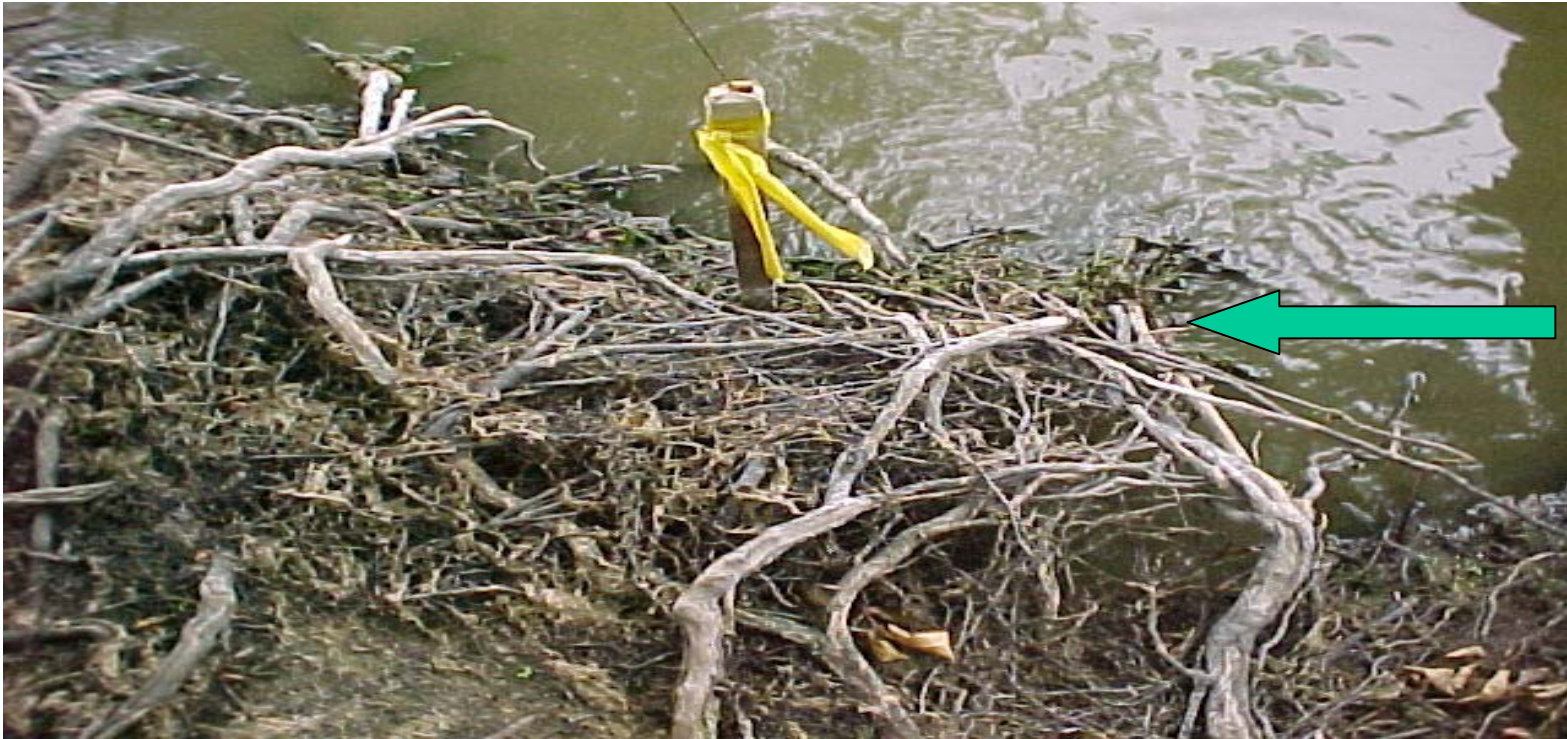
- Location: Carcajou Floodplain Forest Date: 7/9/02 WL: 776.14 msl
- Photo Description: Photo of Quadrant A, erosional sediment loss along shoreline root systems. Green arrow indicates location of sediment in February, 2002. Sediment loss approximately 1 foot laterally and 8 inches vertically.
