WDNR/RKLD COOPERATIVE LAKE STUDY, LAKE KOSHKONONG

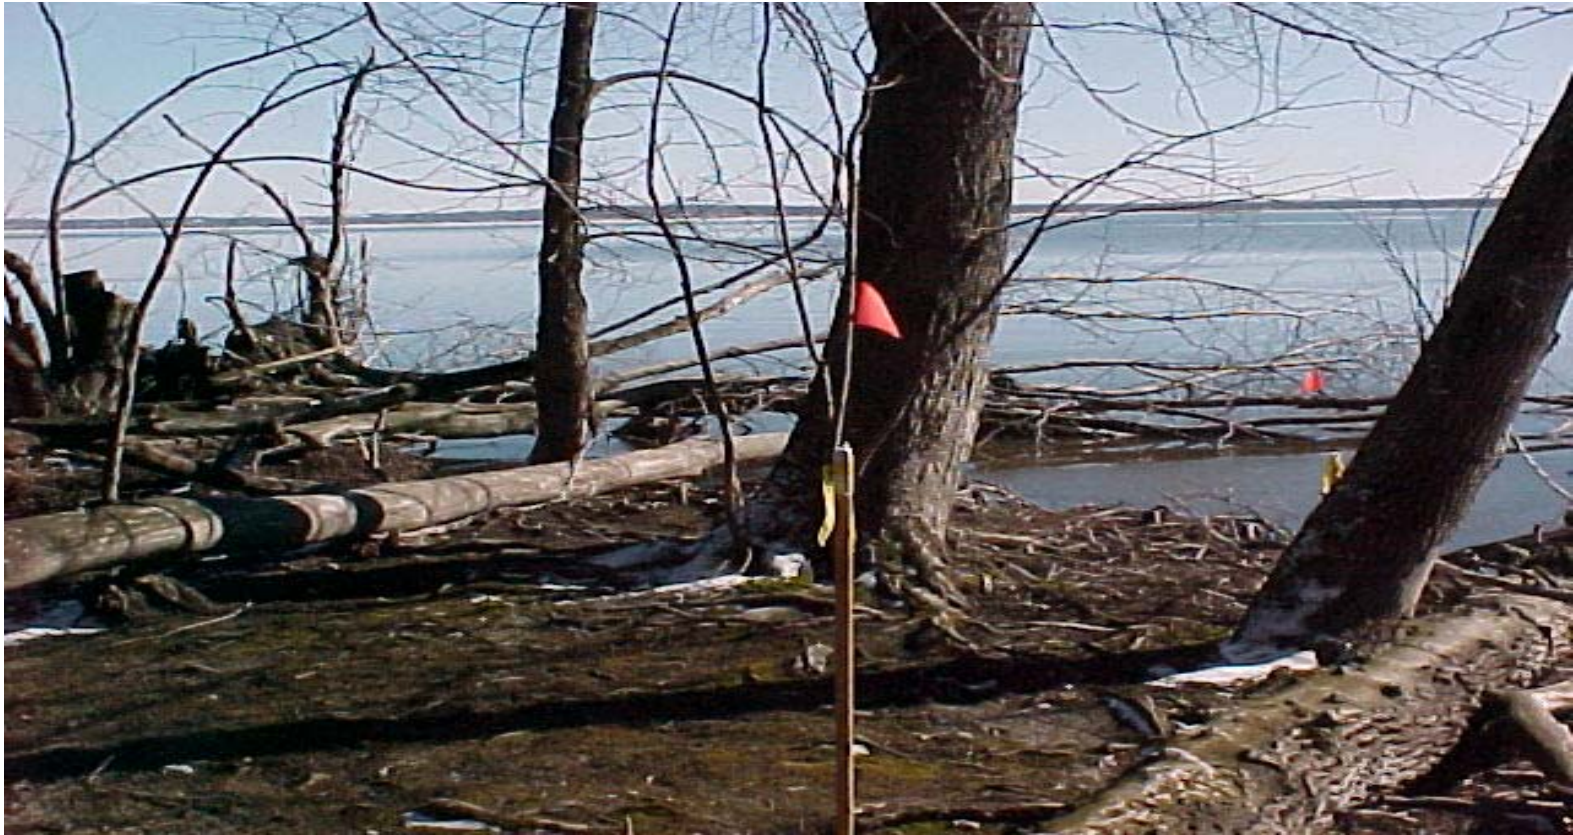
- Location: Carcajou Forested Floodplain Date: 2/22/02 WL: 776.48 msl
- Description: Photo taken from northwest of Quadrant A looking southeast. 25% moss layer coverage and sparse leaf litter. 8" dbh American elm tree healthy with small winter buds and some exposed roots that are scarred. 7" and 18" dbh double trunk silver maple with 4 suckers (.75", 1", 1" and 1.75").

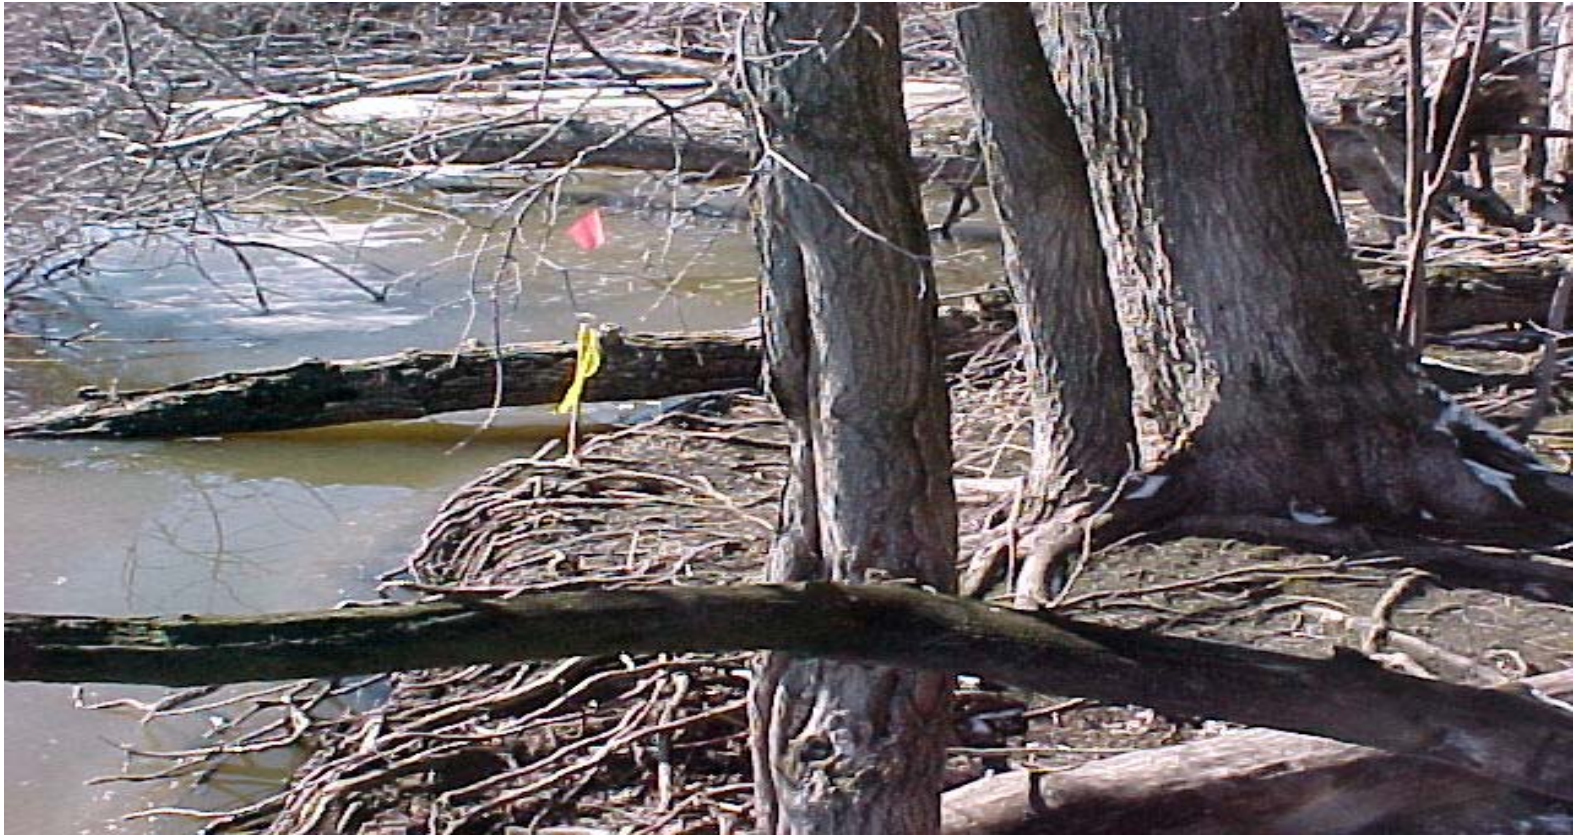
- Location: Carcajou Forested Floodplain Date: 2/22/02 WL: 776.48 msl
- Description: Photo taken from east of Quadrant A looking west. Shoreline showing evidence of erosion on exposed root systems.

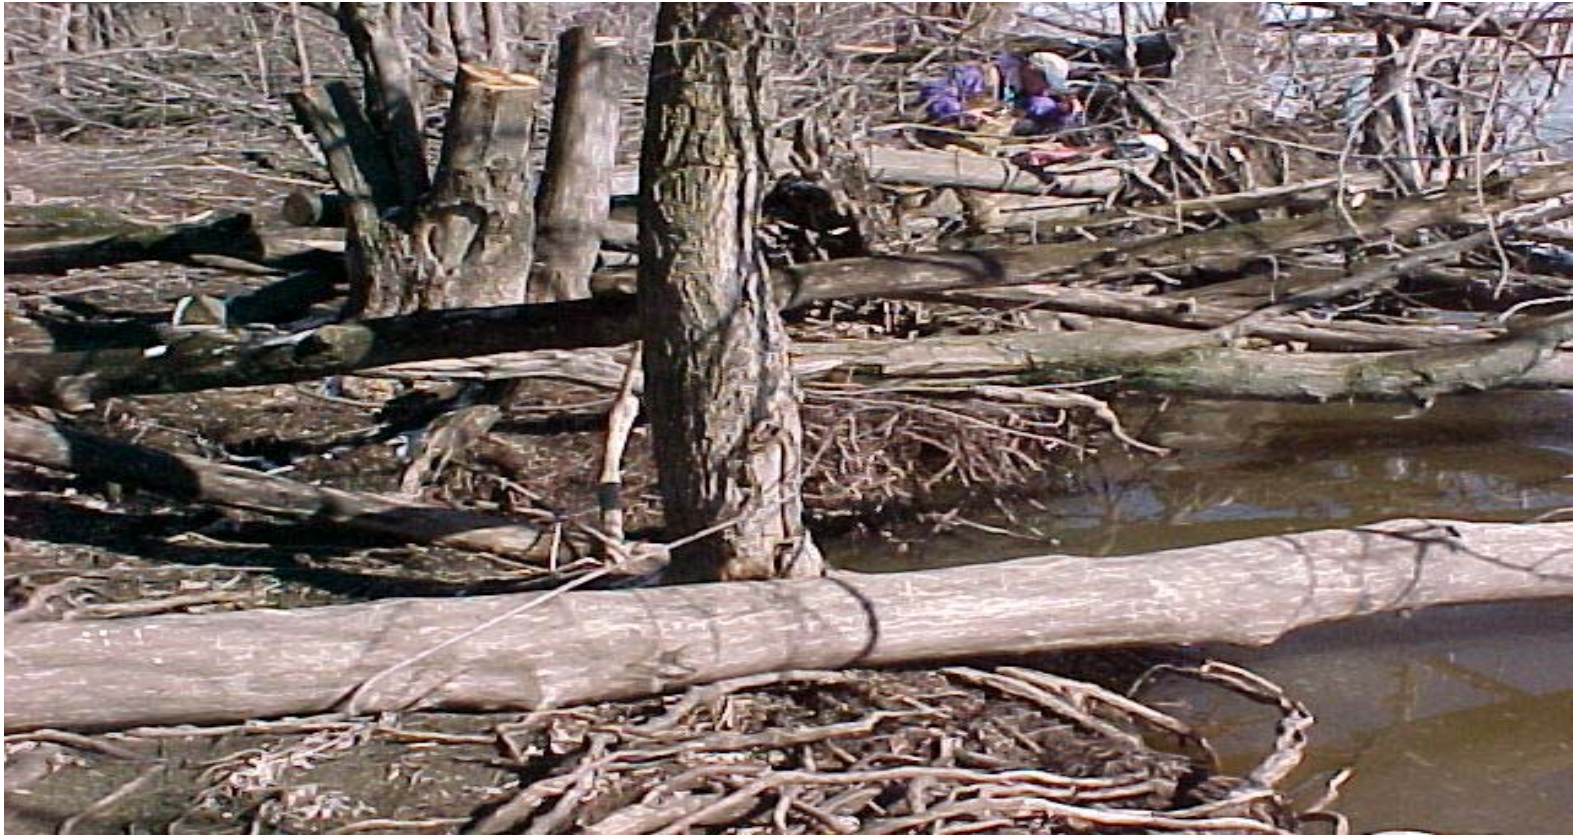
- Location: Carcajou Forested Floodplain Date: 2/22/02 WL: 776.48 msl
- Description: Photo taken from west of Quadrant D looking east. Multiple trunk silver maple (12", 9", 7" and 6" cut off trunks with 2" and 2.5" live suckers) with exposed root system along shoreline. Sparse leaf litter in Quad with a small ice push along shore in SE corner.

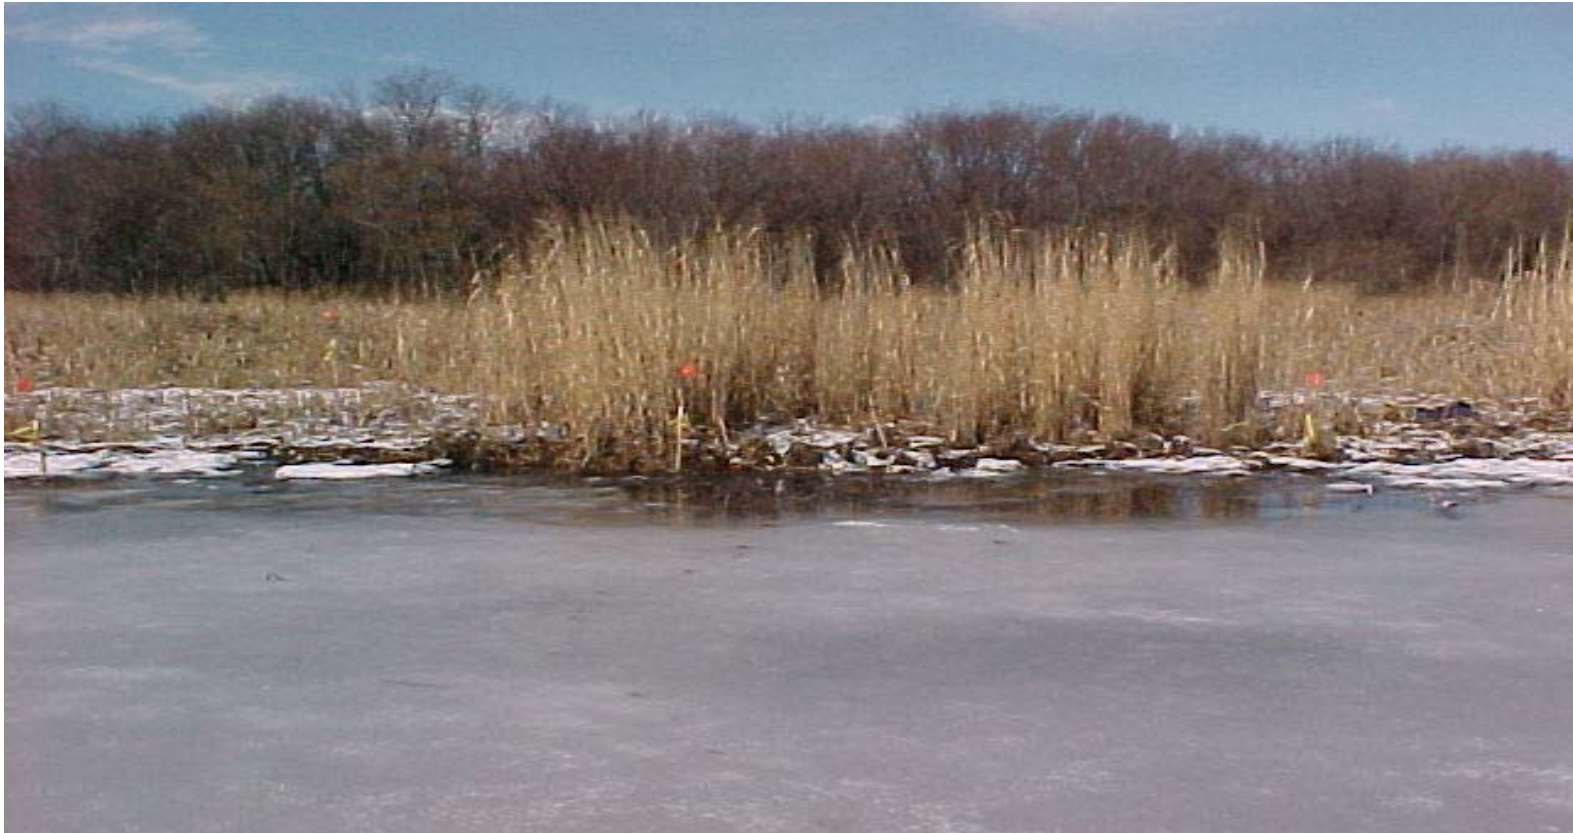
- Location: Carcajou Shallow Marsh Date: 2/22/02 WL: 776.48 msl
- Description: Photo of plot taken from north looking south. 0% tree cover 90% herb layer cover, soil description organic silt/muck,

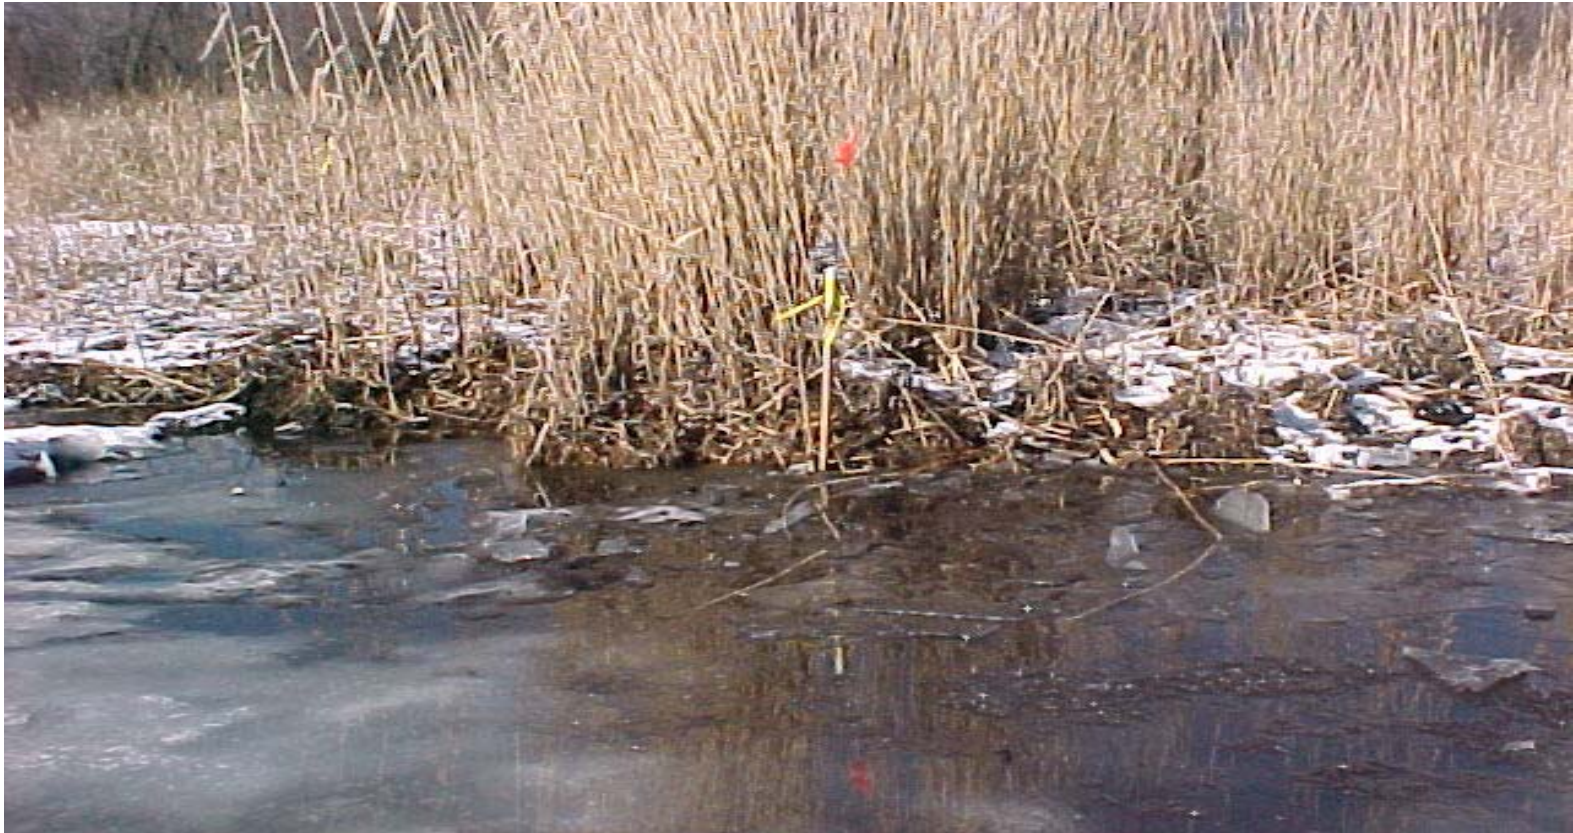
- Location: Carcajou Shallow Marsh Date: 2/22/02 WL: 776.48 msl
- Description: Photo taken from north of Quadrant A looking south. 0% tree cover, 30% Phragmites, 20% smartweed, 10% river bulrush, 5% cocklebur, 1% field mint. Soil description organic silt/muck.

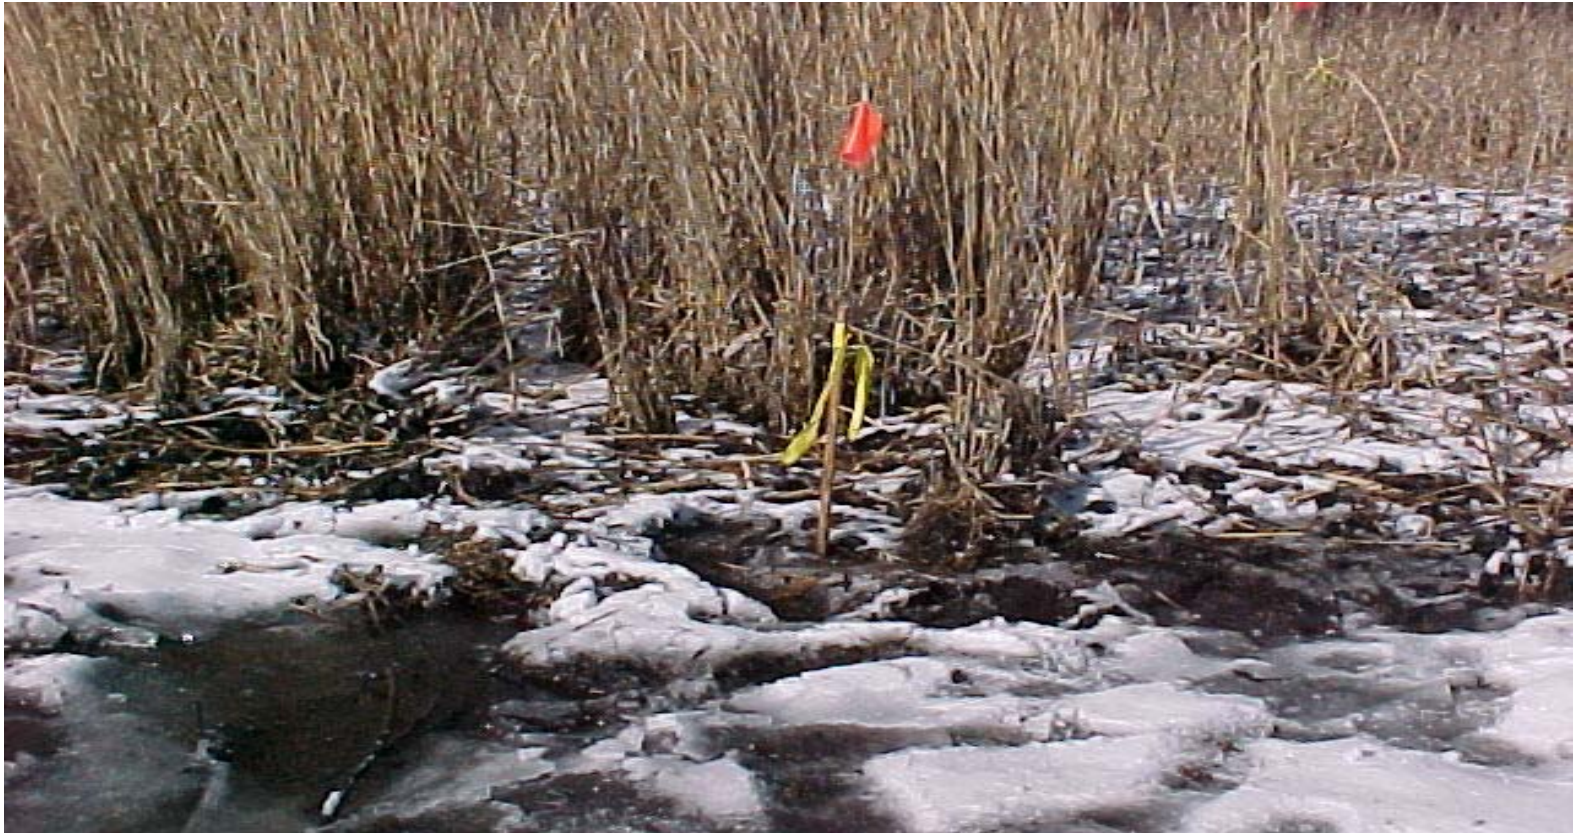
- Location: Carcajou Shallow Marsh Date: 2/22/02 WL: 776.48 msl
- Description: Photo taken from northeast of Quadrant A looking southwest. 0% tree cover, 0% tree cover, 30% Phragmites, 20% smartweed, 10% river bulrush, 5% cocklebur, 1% field mint. Soil description organic silt/muck.

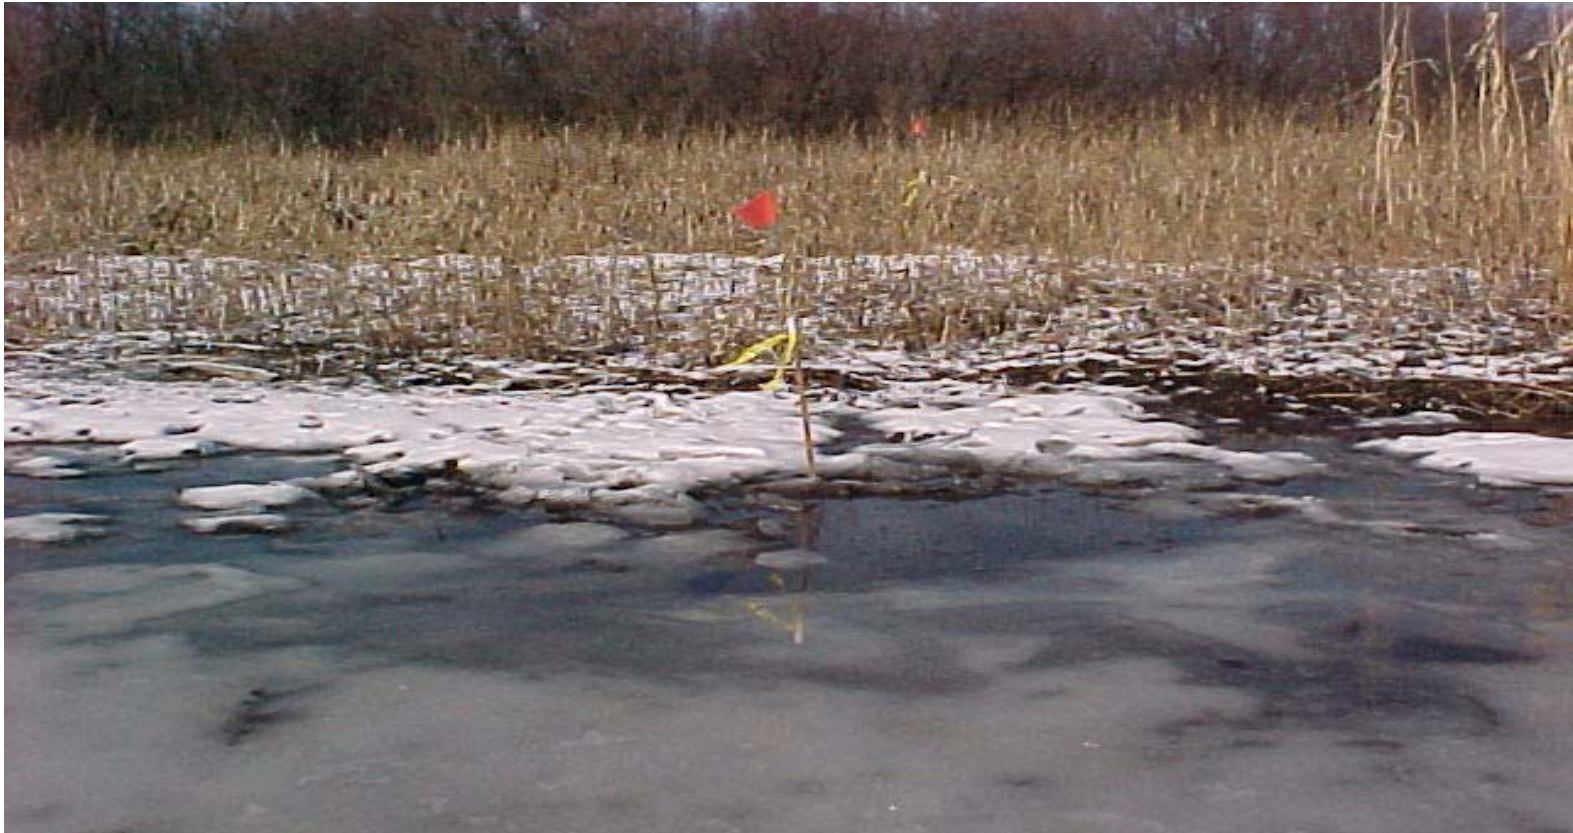
- Location: Carcajou Marsh Date: 2/22/02 WL: 776.48 msl
- Description: Photo taken from south of Quadrant A looking north. 0% tree cover, 30% Phragmites, 20% smartweed, 10% river bulrush, 5% cocklebur, 1% field mint. Soil description organic silt/muck.

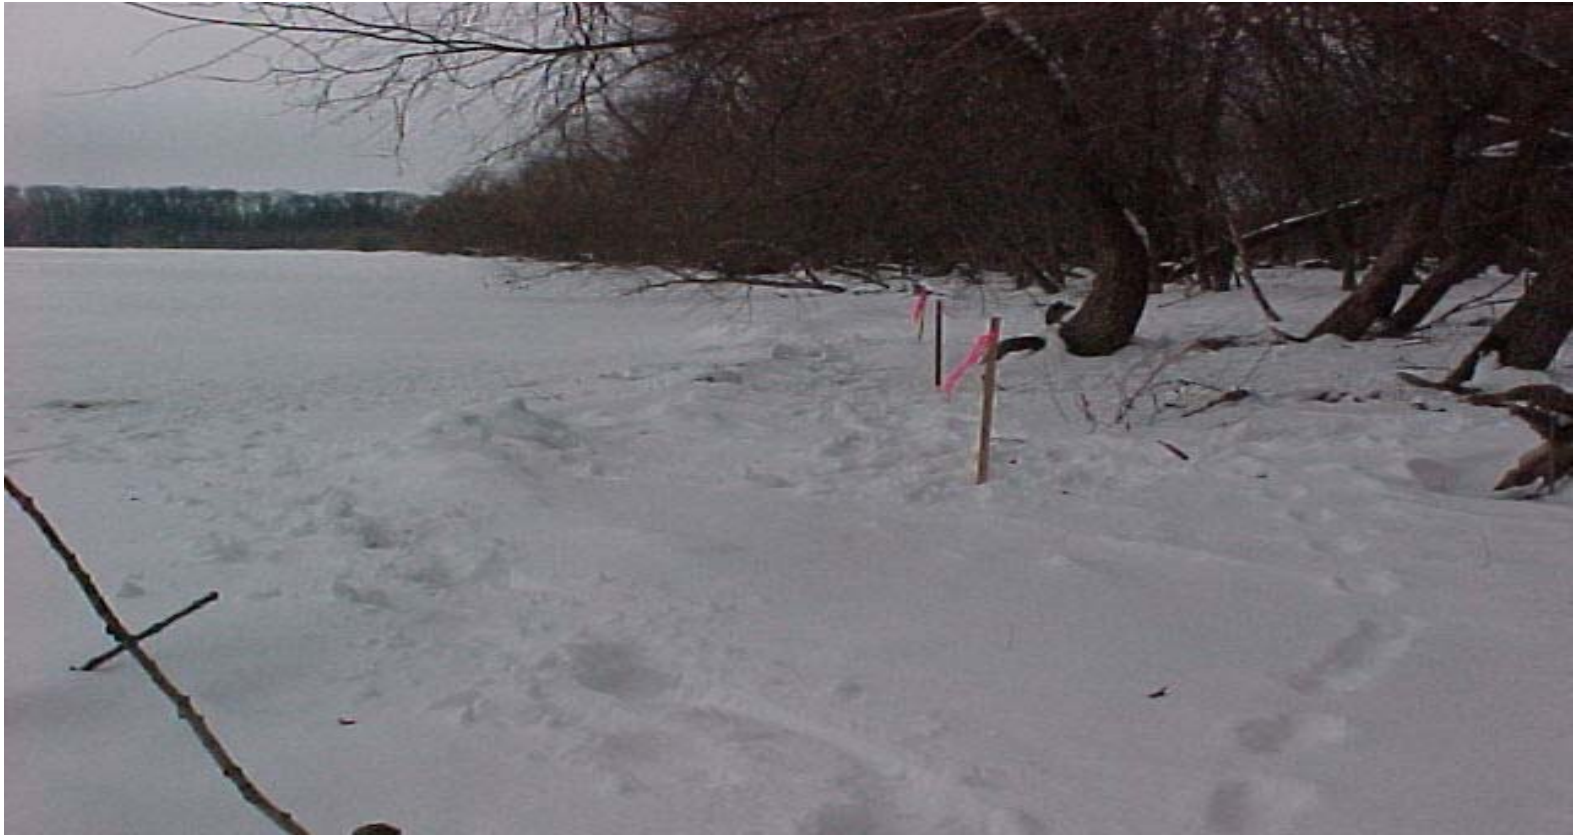
- Location: Gilberts Bay Forest Date: 3/7/02 WL: 777.12 msl
- Description: Photo taken from south of Quadrant D looking north showing ice heave in central portion of photo. Ice heave height averages 13 inches, ice depth of 7 inches 15 feet lakeward of transect center.

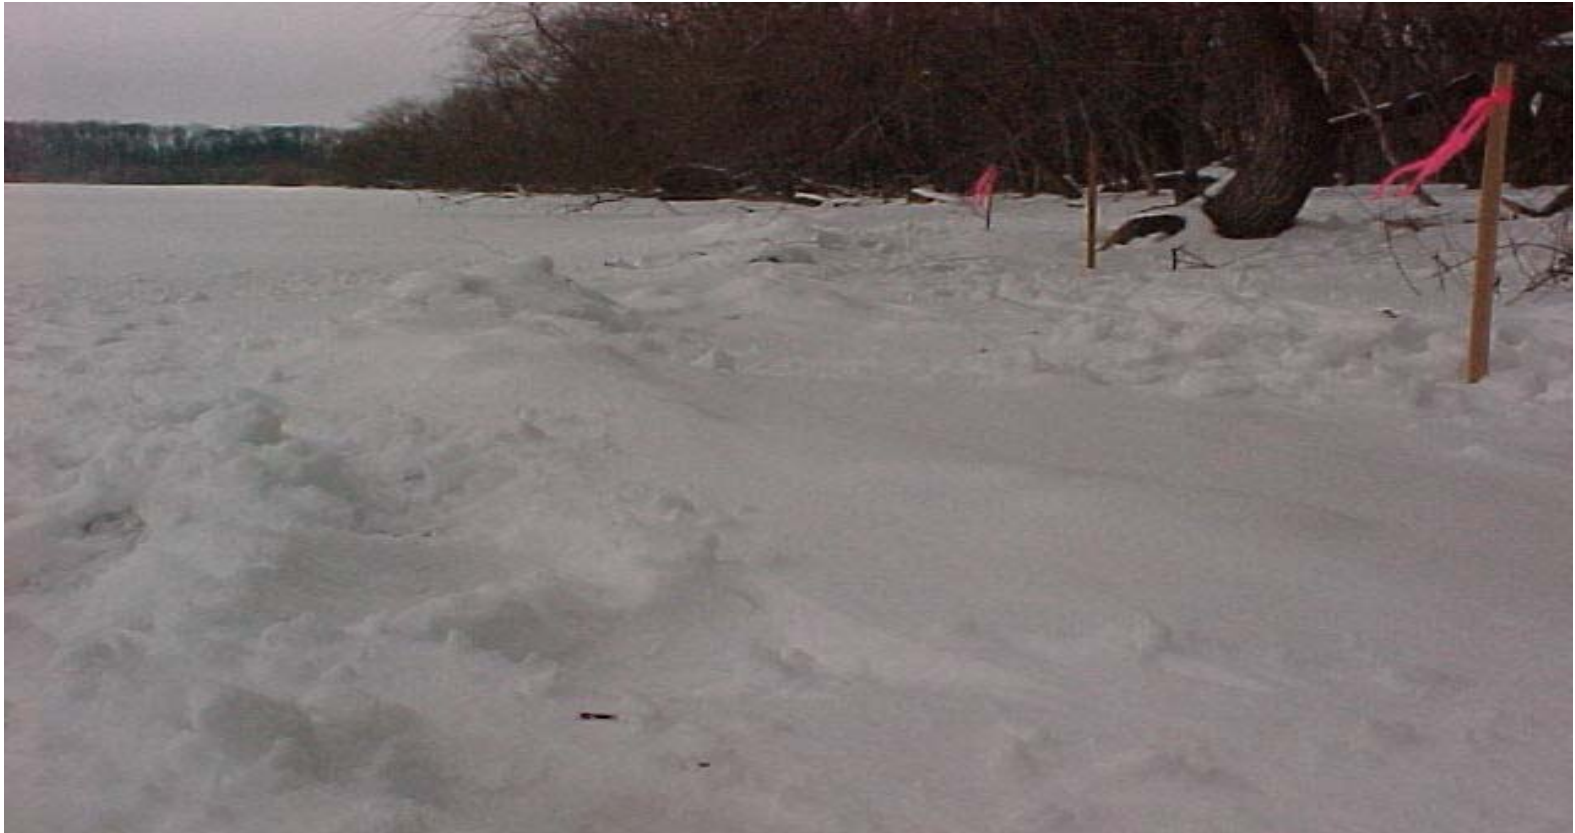
- Location: Gilberts Bay Forest Date: 3/7/02 WL: 777.12 msl
- Description: Photo taken from south of Quadrant D looking north showing ice heave in central portion of photo (zoom). Ice heave height averages 13 inches, ice depth of 7 inches 15 feet lakeward of transect center.

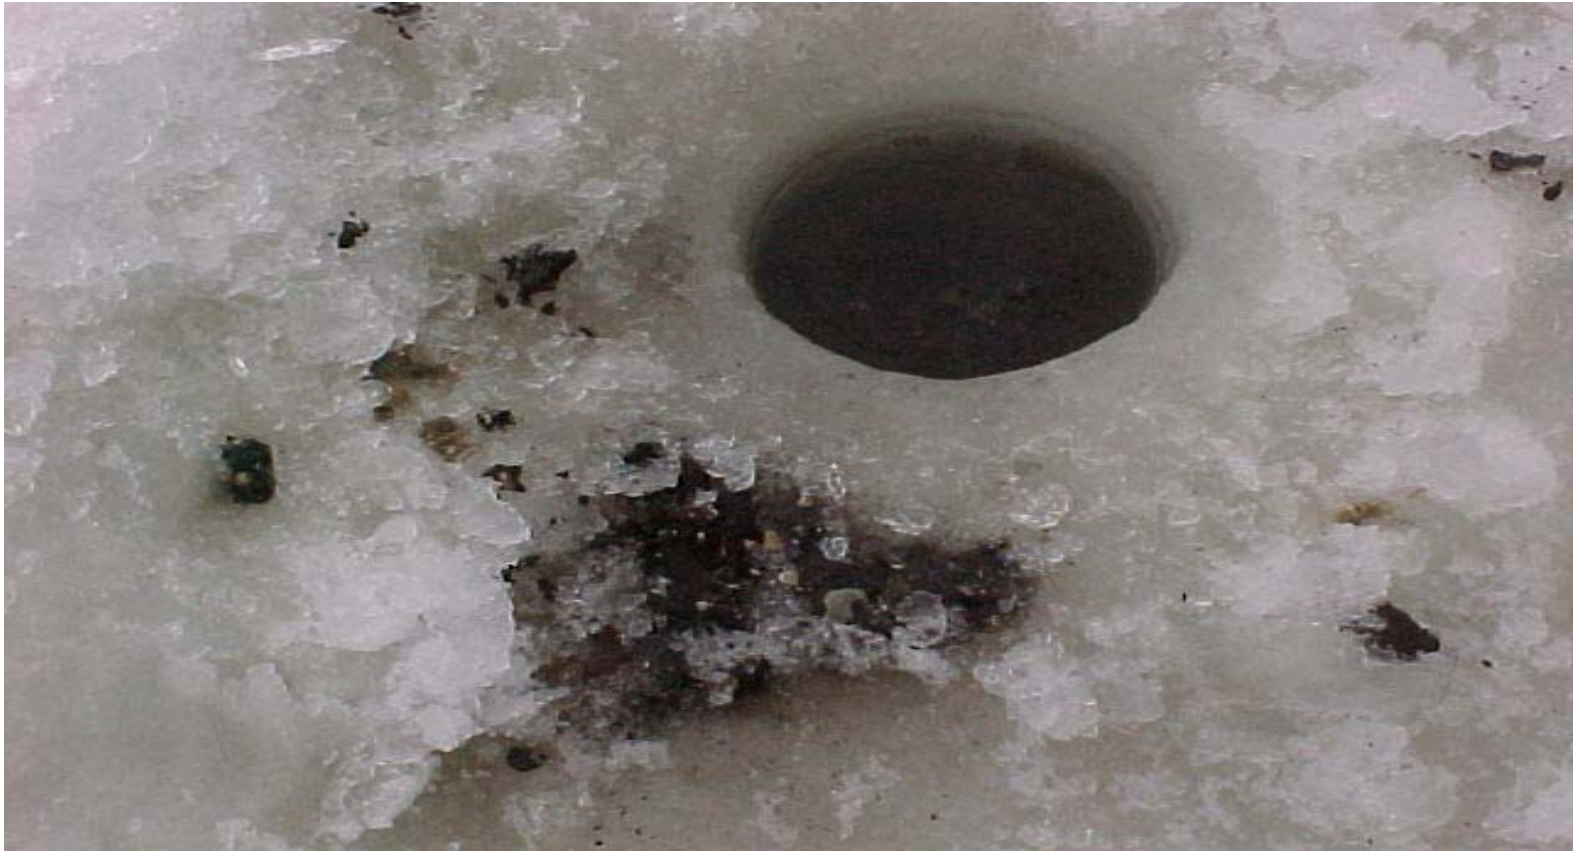
- Location: Gilberts Bay Forest Date: 3/7/02 WL: 777.12 msl
- Description: Photo of lake sediment 15 feet lakeward of center of transect plot. Lake sediment profile consisted of 1 inch of 10YR 2/1 organic silt underlain by well-graded sand and gravel. Gravel subrounded < 1 inch diameter.

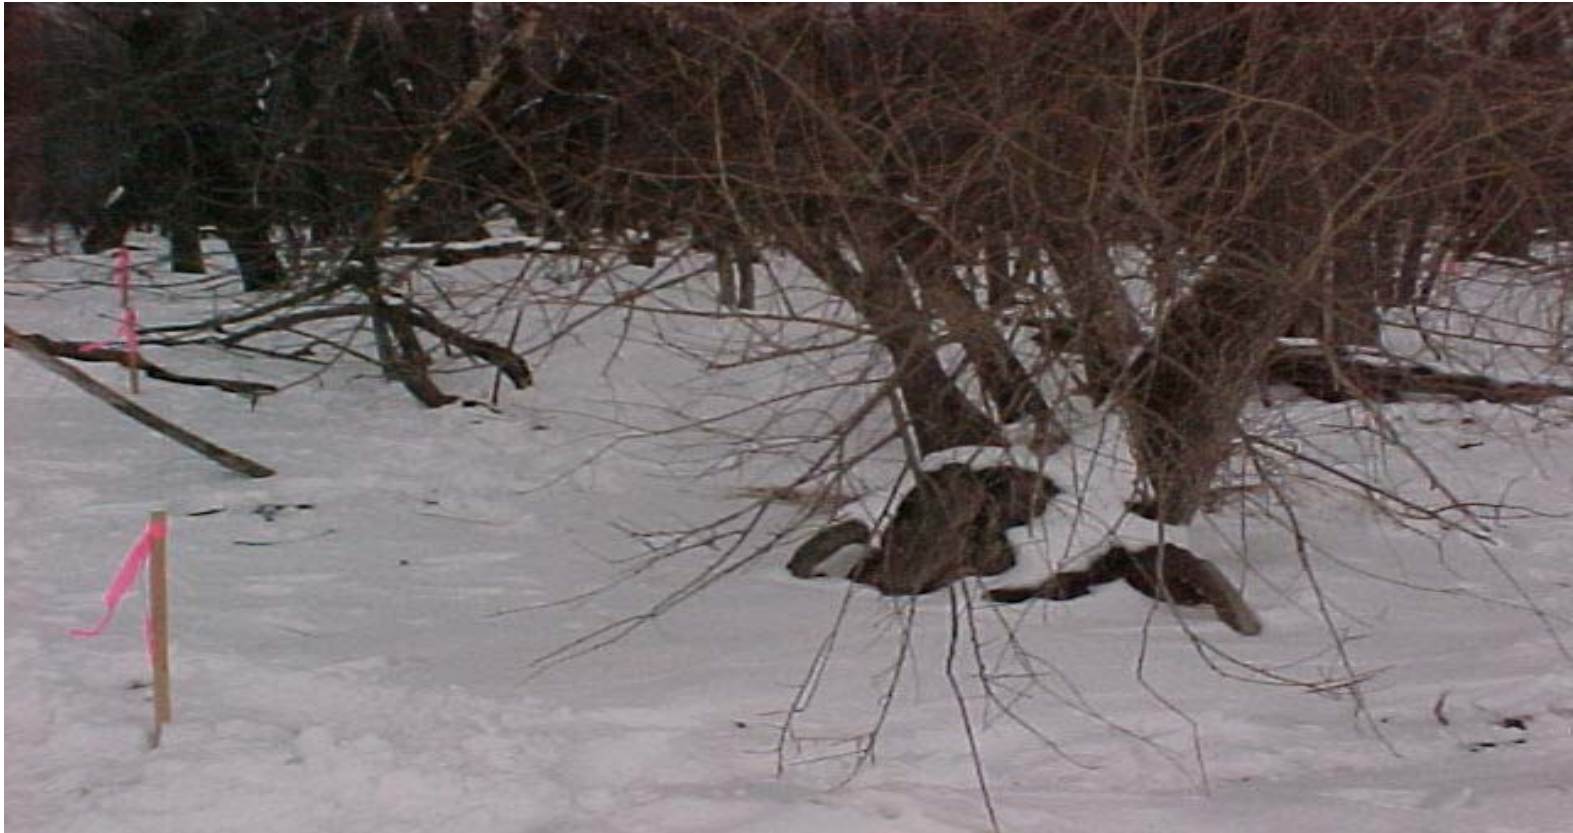
- Location: Gilberts Bay Forest Date: 3/7/02 WL: 777.12 msl
- Description: Photo taken from west of Quadrant A looking east. Photo includes black willow (Salix nigra) and silver maple (Acer saccharinum). No ground cover present, soils are sand and gravel.

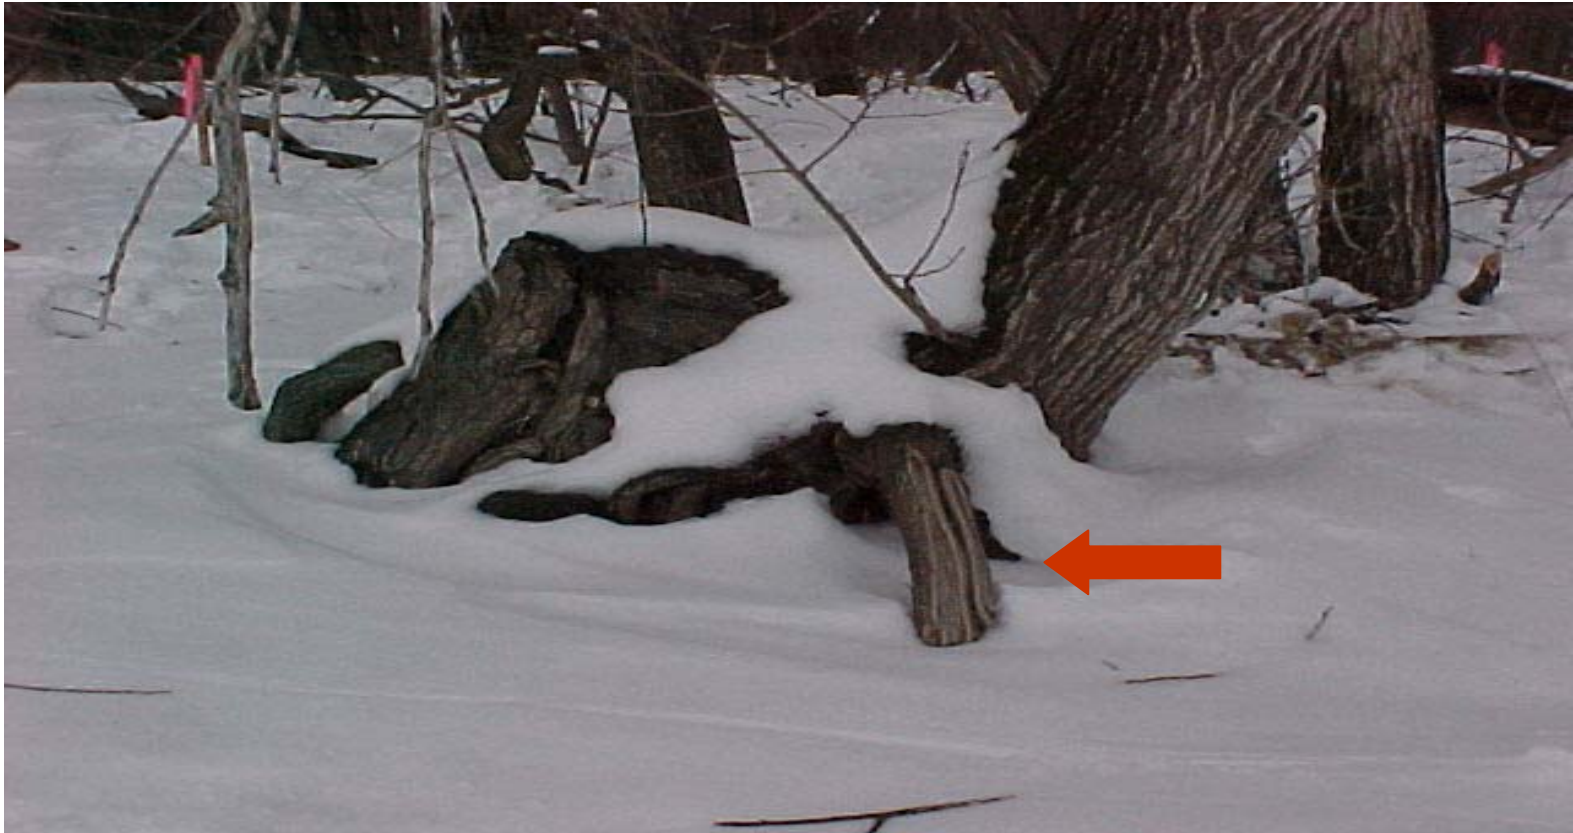
- Location: Gilberts Bay Forest Date: 3/7/02 WL: 777.12 msl
- Description: Photo taken from south of Quadrant A looking north showing ice damage to the root system of the black willow (red arrow). Soils are sand and gravel.

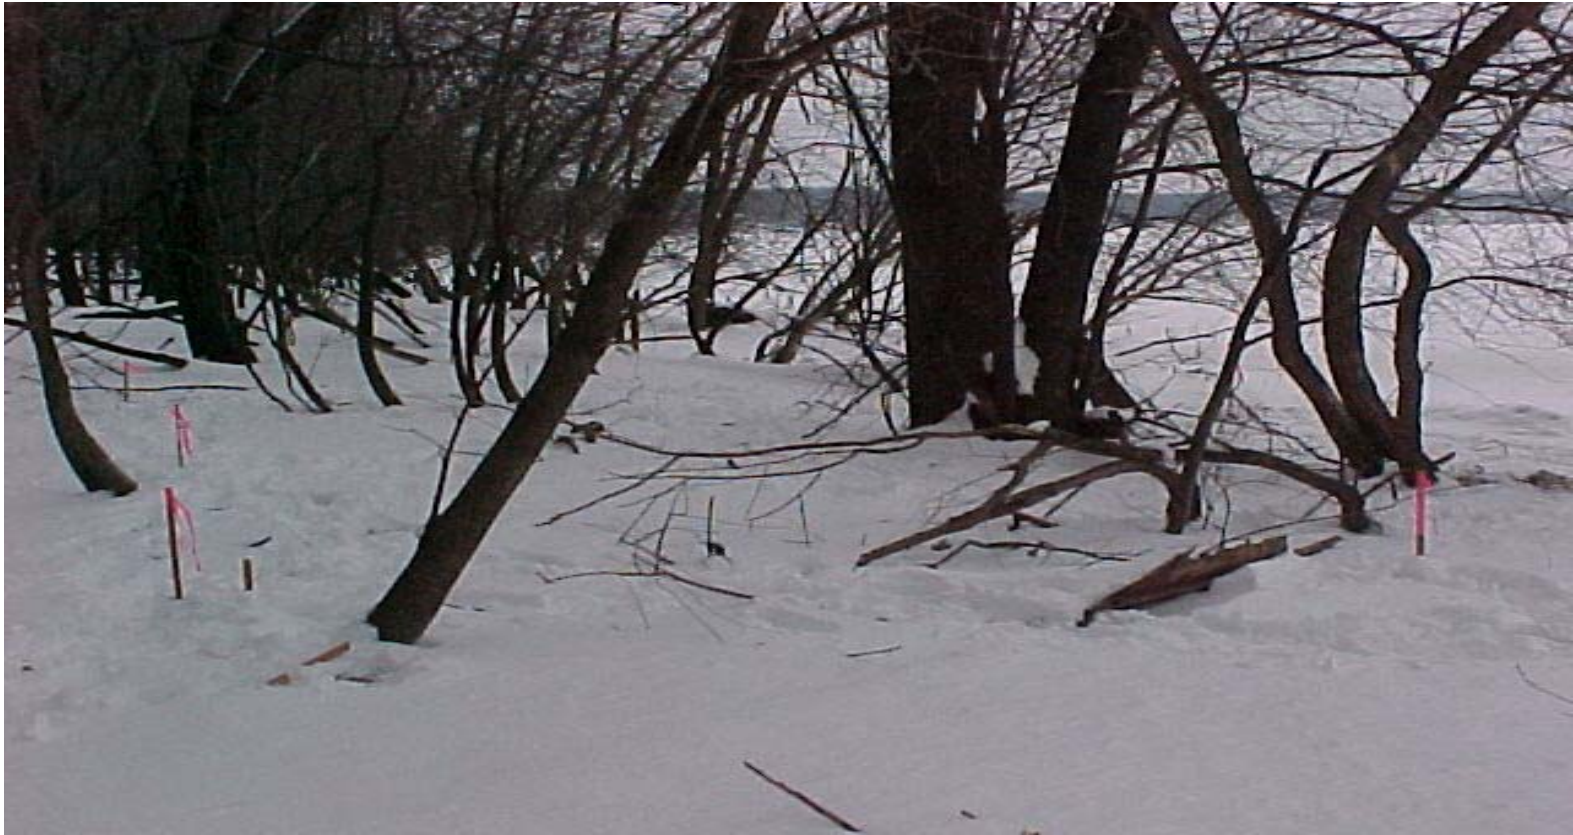
- Location: Gilberts Bay Forest Date: 3/7/02 WL: 777.12 msl
- Description: Photo taken from north of Quadrant B looking south. Trees include 2" green ash and a large multiple trunk silver maple, 20" and 15" main trunks with 4.5", 2.5" and 3" secondary trunks. Soils are sand.

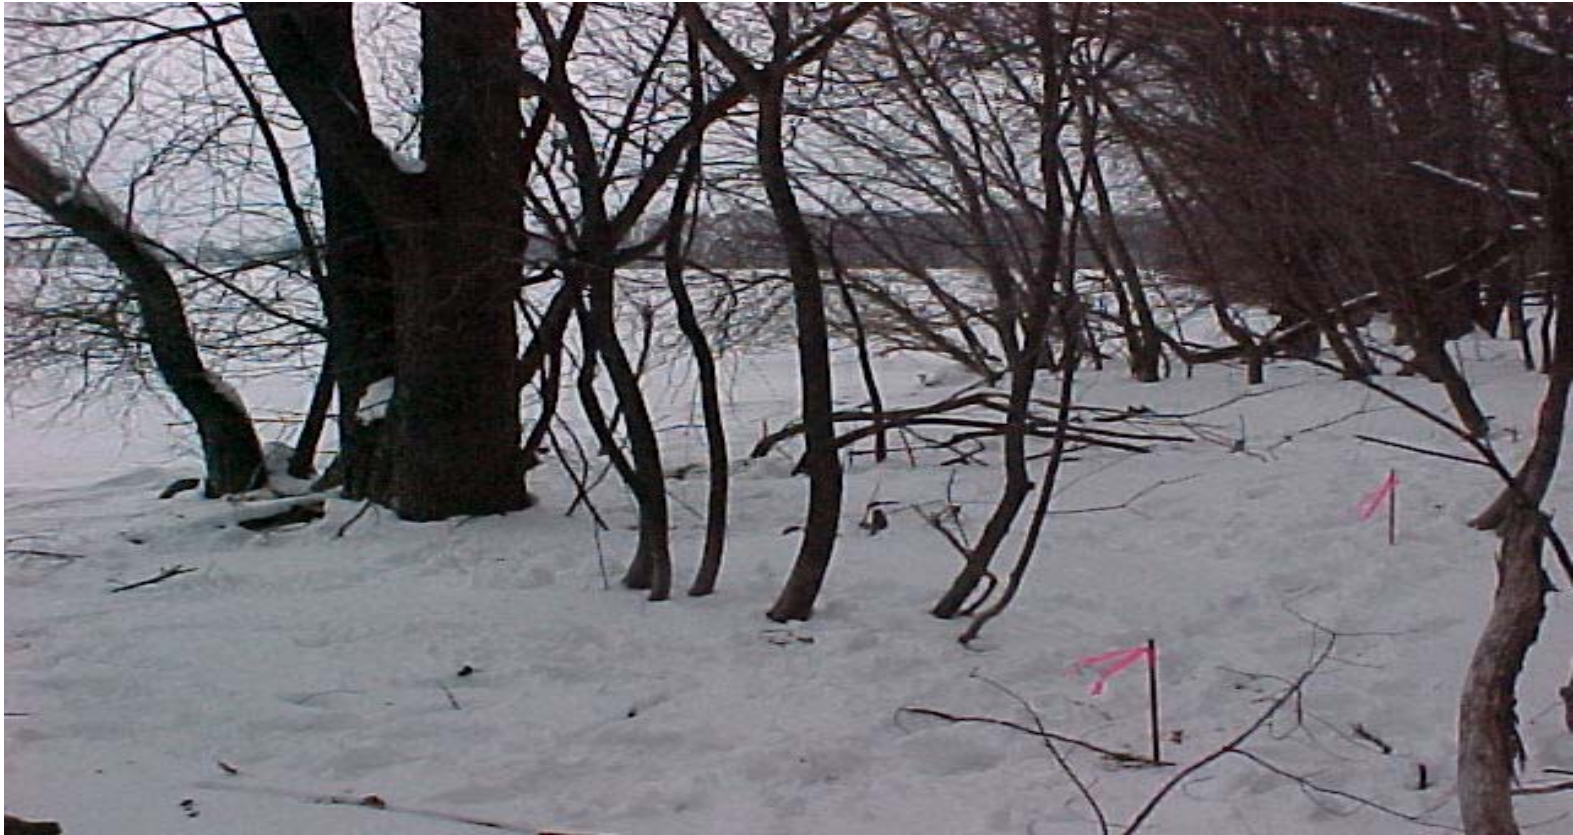
- Location: Gilberts Bay Forest Date: 3/7/02 WL: 777.12 msl
- Description: Photo taken from south of Quadrant C looking north showing six small silver maple trees, 3.5", 3", 2", 2", 1.5" and 1". No ground cover observed in quadrant, soils are sand.

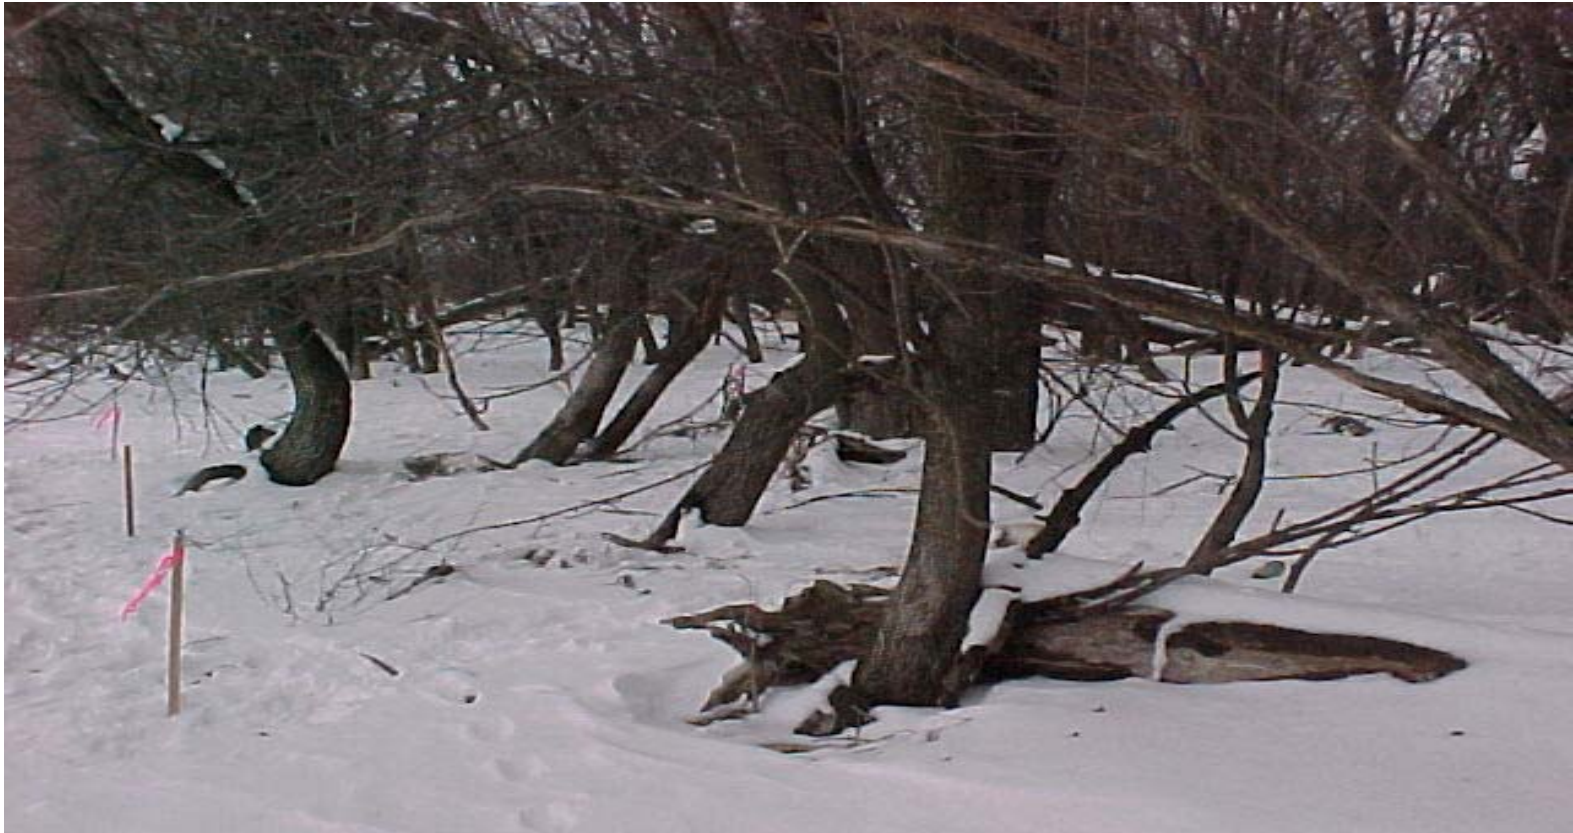
- Location: Gilberts Bay Forest Date: 3/7/02 WL: 777.12 msl
- Description: Photo taken from south of Quadrant D looking north showing American elm (Ulmus americana) in the foreground, and large silver maples in the central background. No ground cover observed. Soils are sand and gravel.

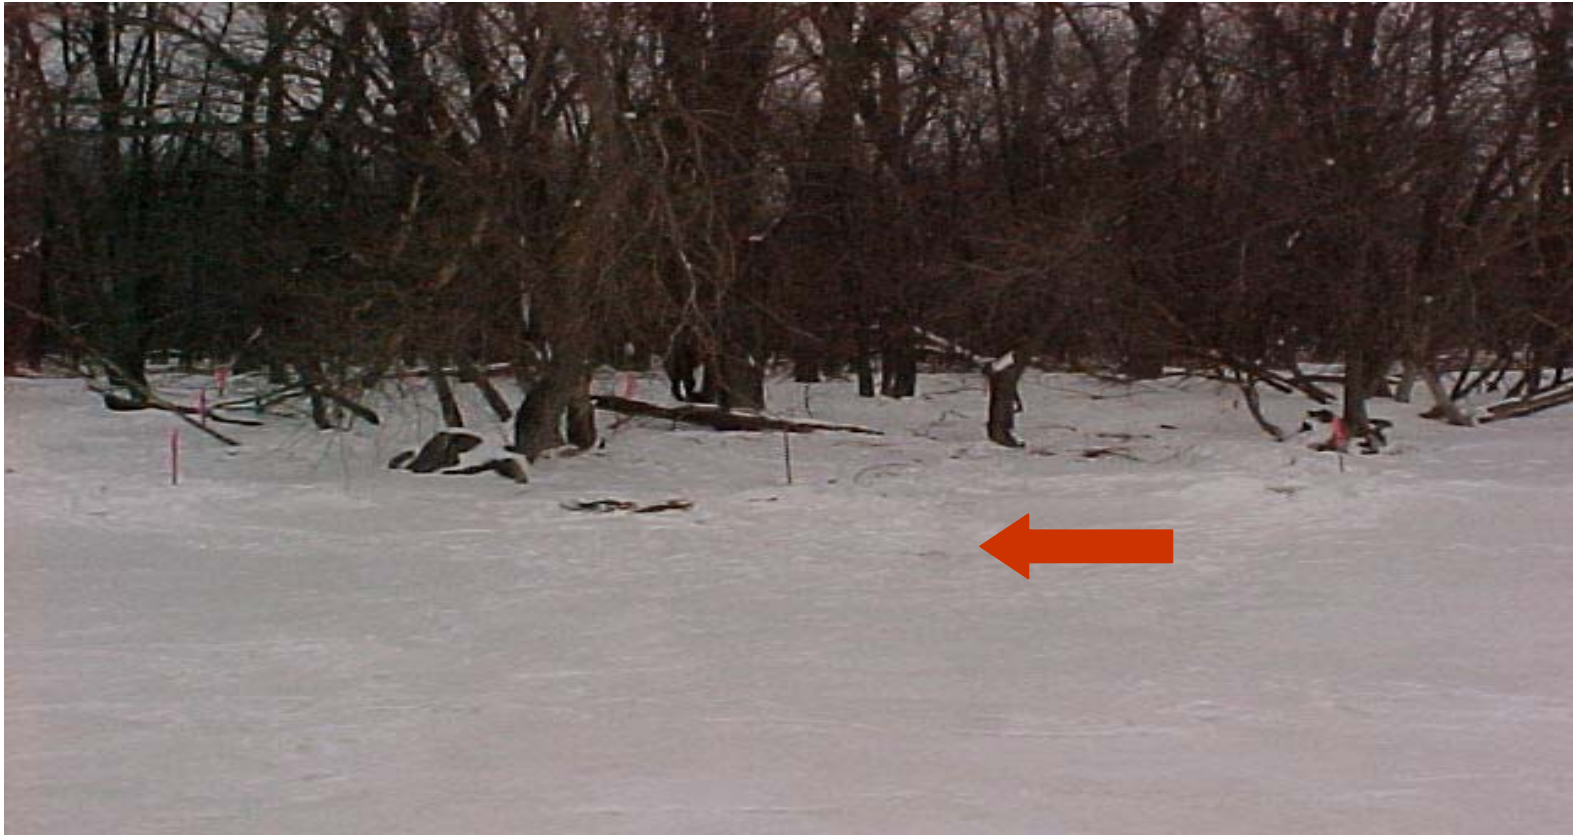
- Location: Gilberts Bay Forest Date: 3/7/02 WL: 777.12 msl
- Description: Photo taken from west of the transect plot looking east showing the 30 foot width of the plot. Red arrow indicates hole augered into ice 15 feet lakeward of transect center.
