**WDNR/RKLD COOPERATIVE LAKE STUDY
LAKE KOSHKONONG, WISCONSIN**

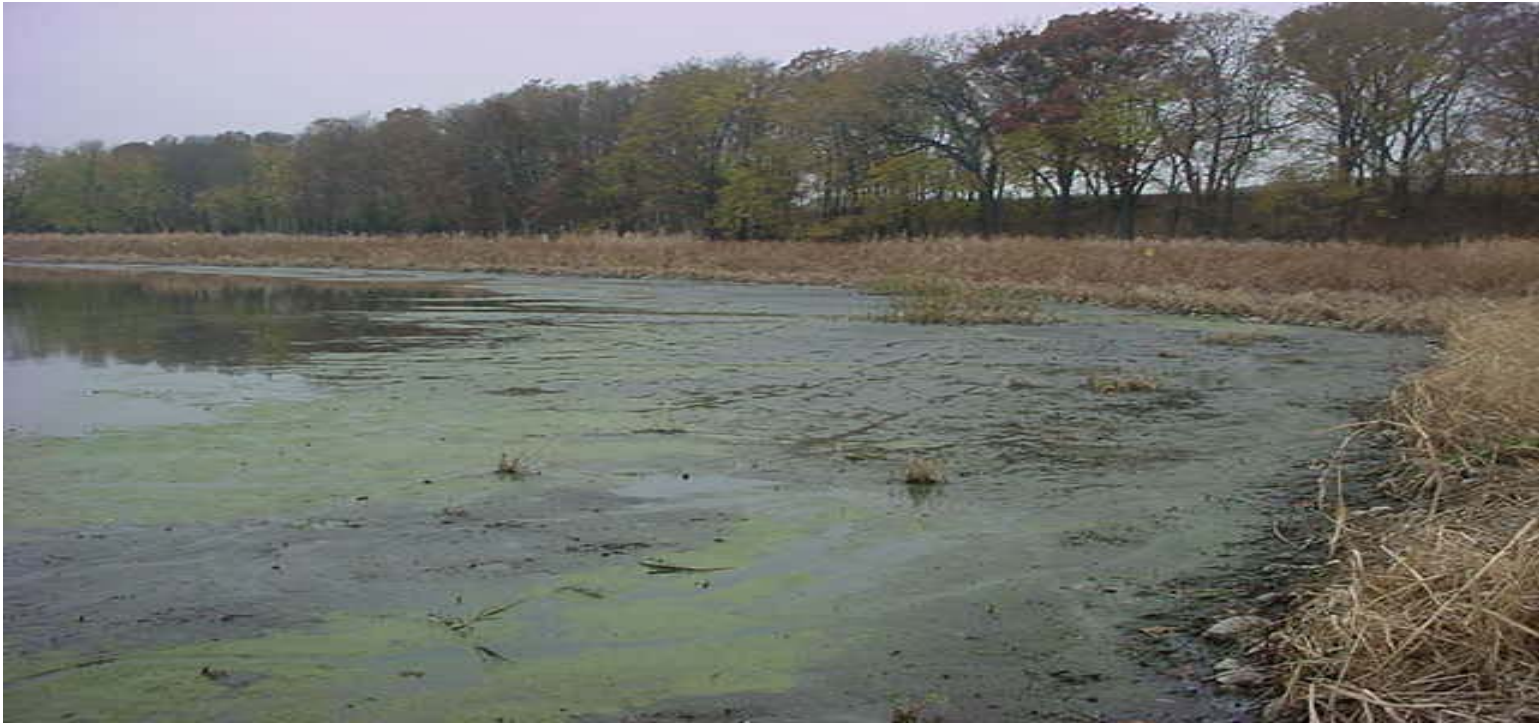
- Location: Hights Bay Shallow Marsh Date: 10-31-2003 Water Elevation: 775.96 msl
- Photo of area lakeward of plot showing riprap on right with new river bulrush, millet and cattail growing outside of riprap. Millet is growing on top of riprap.

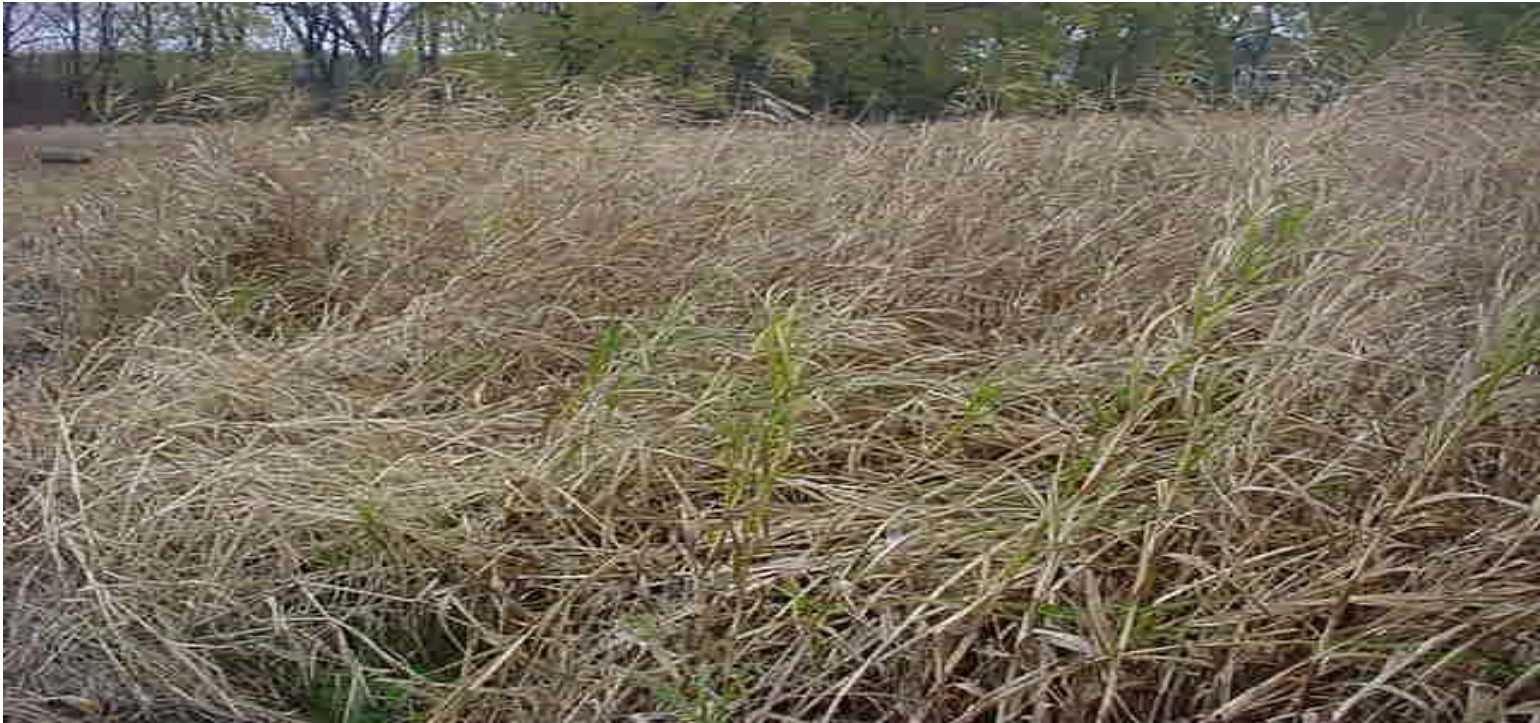
- Location: Hights Bay Shallow Marsh Date: 10-31-2003 Water Elevation: 775.96 msl
- Photo of Quads A and D. Quad D in foreground and Quad A in background. Both Quads are fully vegetated with river bulrush, Phragmites, smartweed and some new millet.

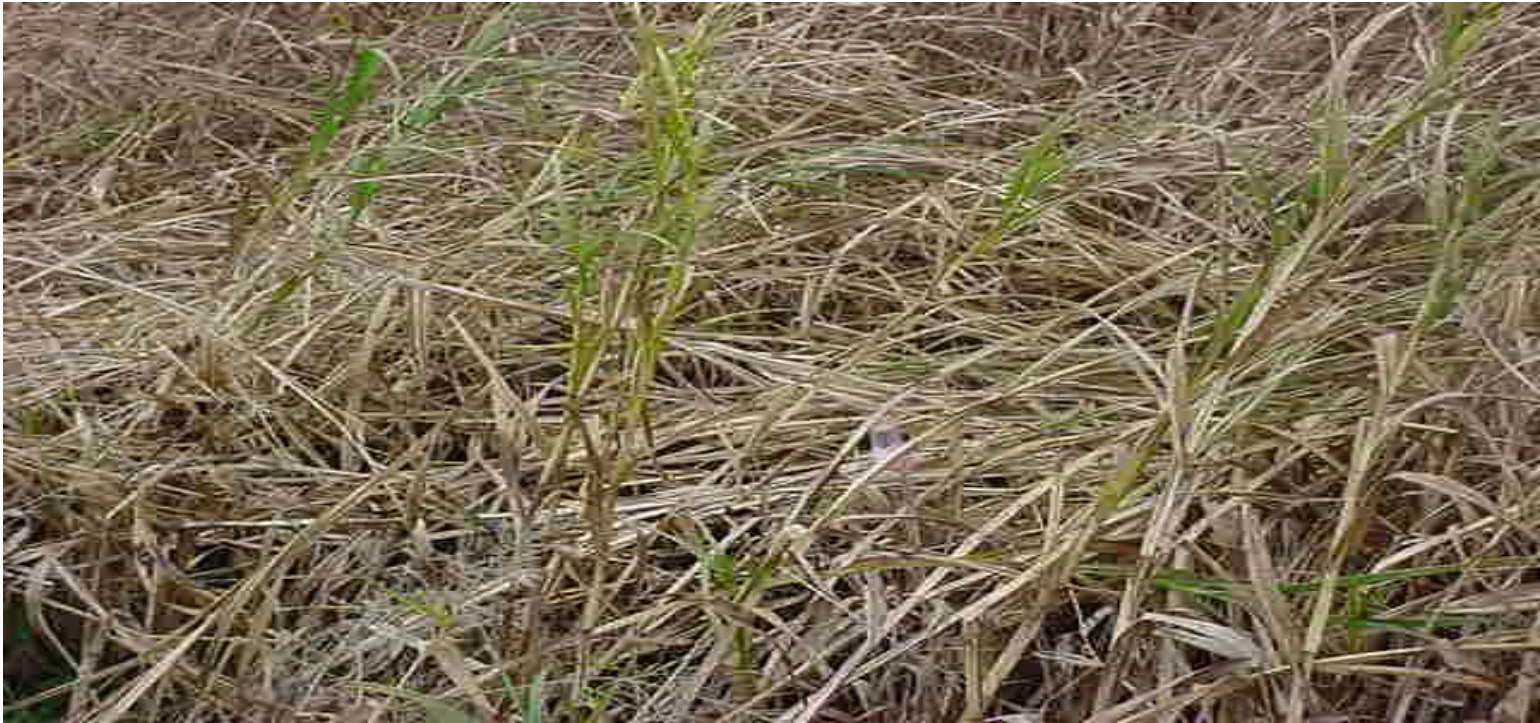
- Location: Hights Bay Shallow Marsh Date: 10-31-2003 Water Elevation: 775.96 msl
- Photo of Quad B. Quad B is fully vegetated with river bulrush, Phragmites, stinging nettle and some newly observed Canada thistle.

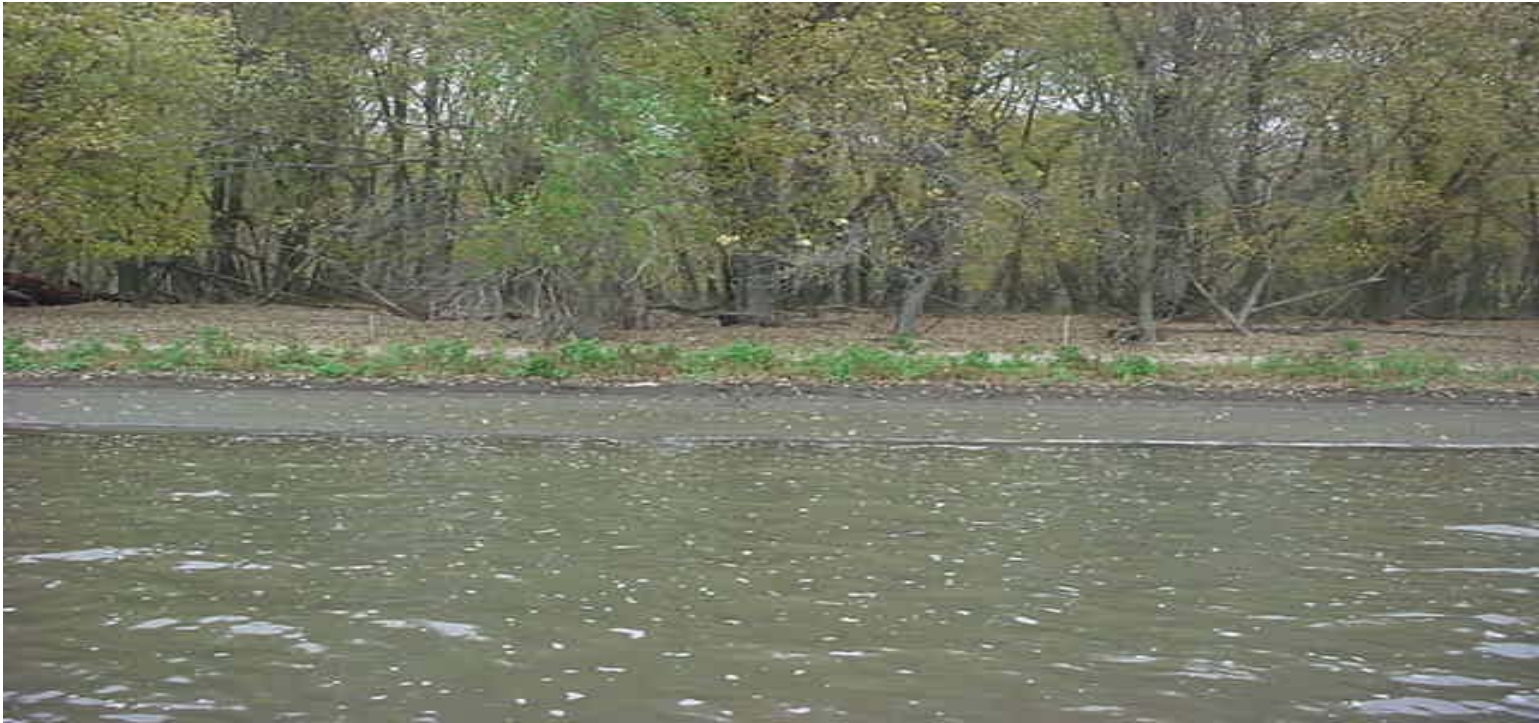
- Location: Vinne Ha Ha Forest Date: 10-31-2003 Water Elevation: 775.96 msl
- Photo of plot from lake. Lower lake levels have allowed new colonization of herb layer about 10 feet lakeward of plot. Herb layer consisting of stinging and wood nettle, garlic mustard, pepperweed, foxtail grass, lambs quarters, evening nightshade, millet and wild mint.

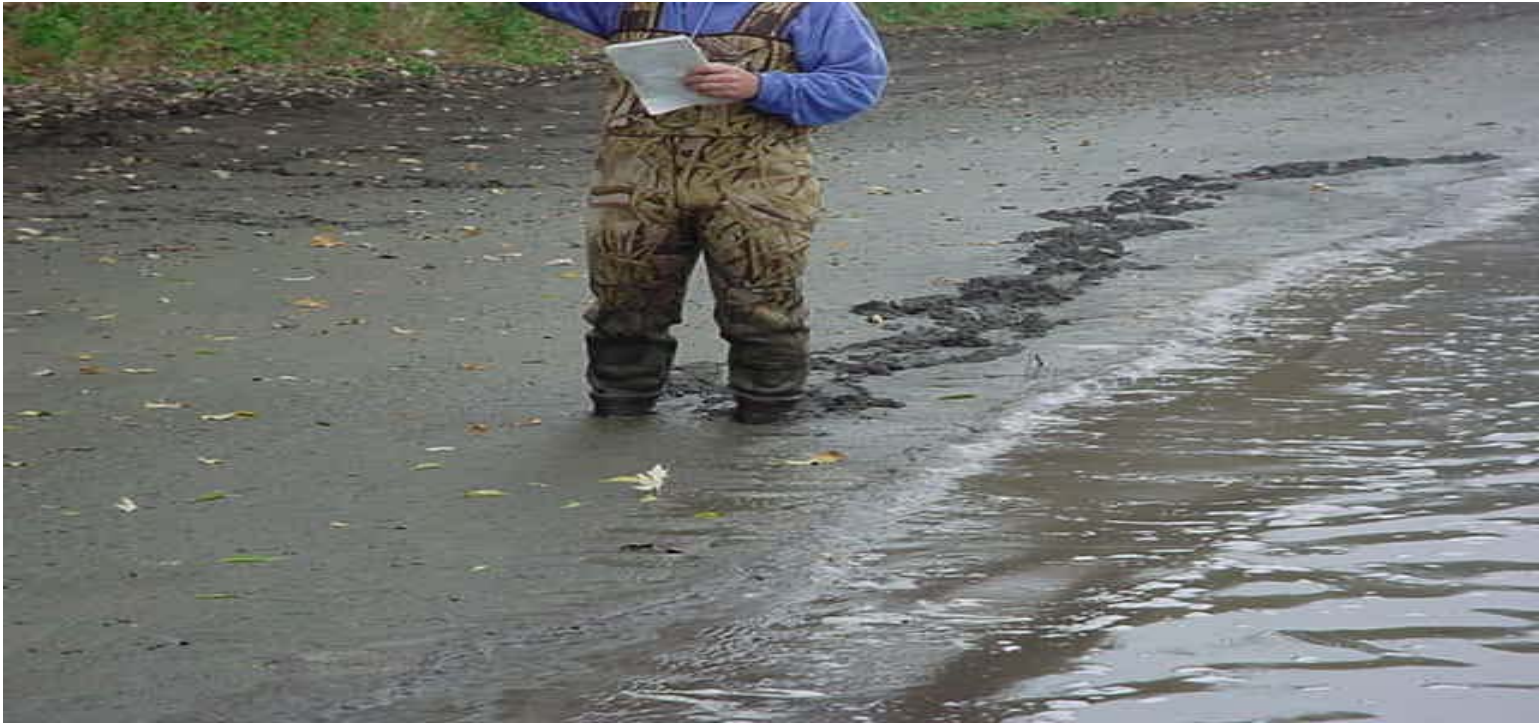
- Location: Vinne Ha Ha Forest Date: 10-31-2003 Water Elevation: 775.96 msl
- Photo of lake shore lakeward of plot showing 6-8 inch layer of soft sediment that has been deposited likely from recent windy conditions.

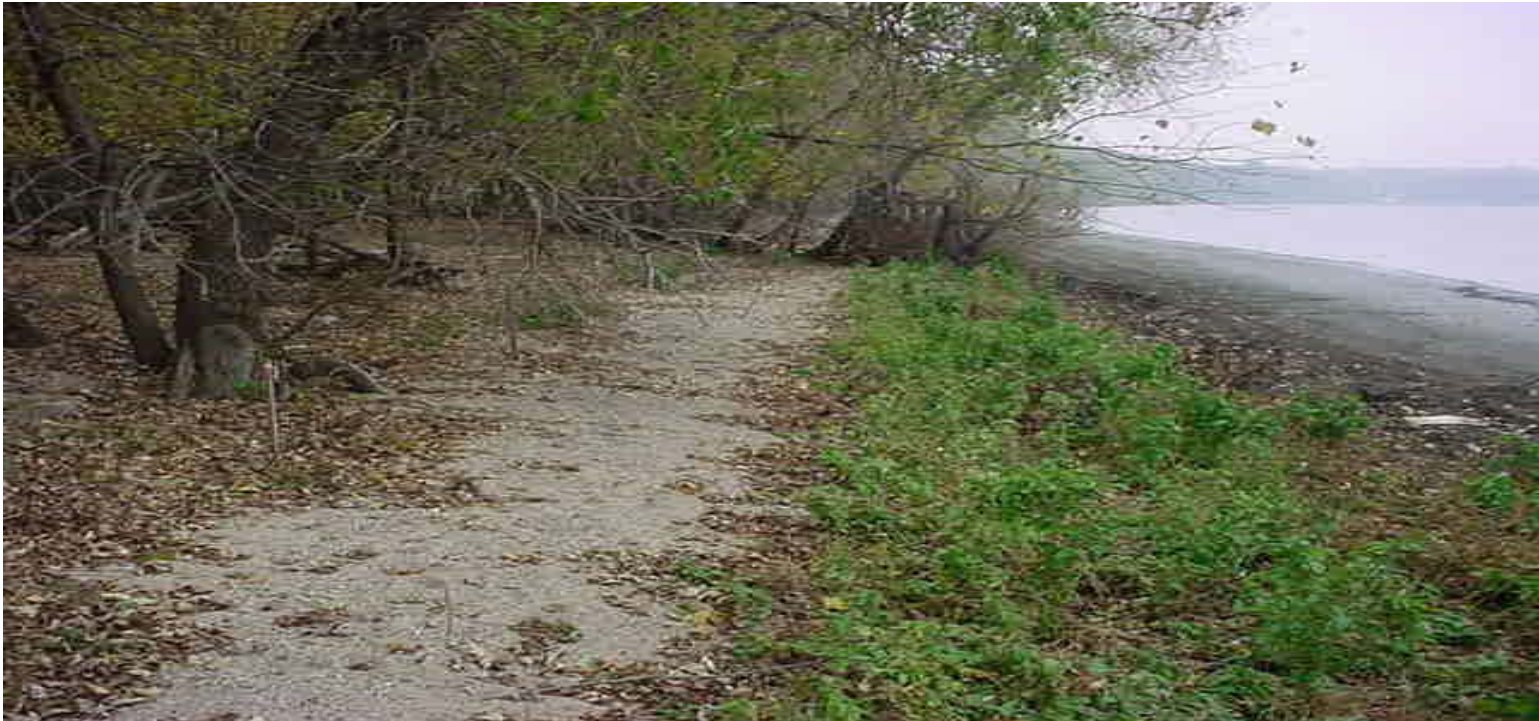
- Location: Vinne Ha Ha Forest Date: 10-31-2003 Water Elevation: 775.96 msl
- Photo of plot from lake. Lower lake levels have allowed new colonization of herb layer about 10 feet lakeward of plot. Herb layer consisting of stinging and wood nettle, garlic mustard, pepperweed, foxtail grass, lambs quarters, evening nightshade, millet and wild mint.

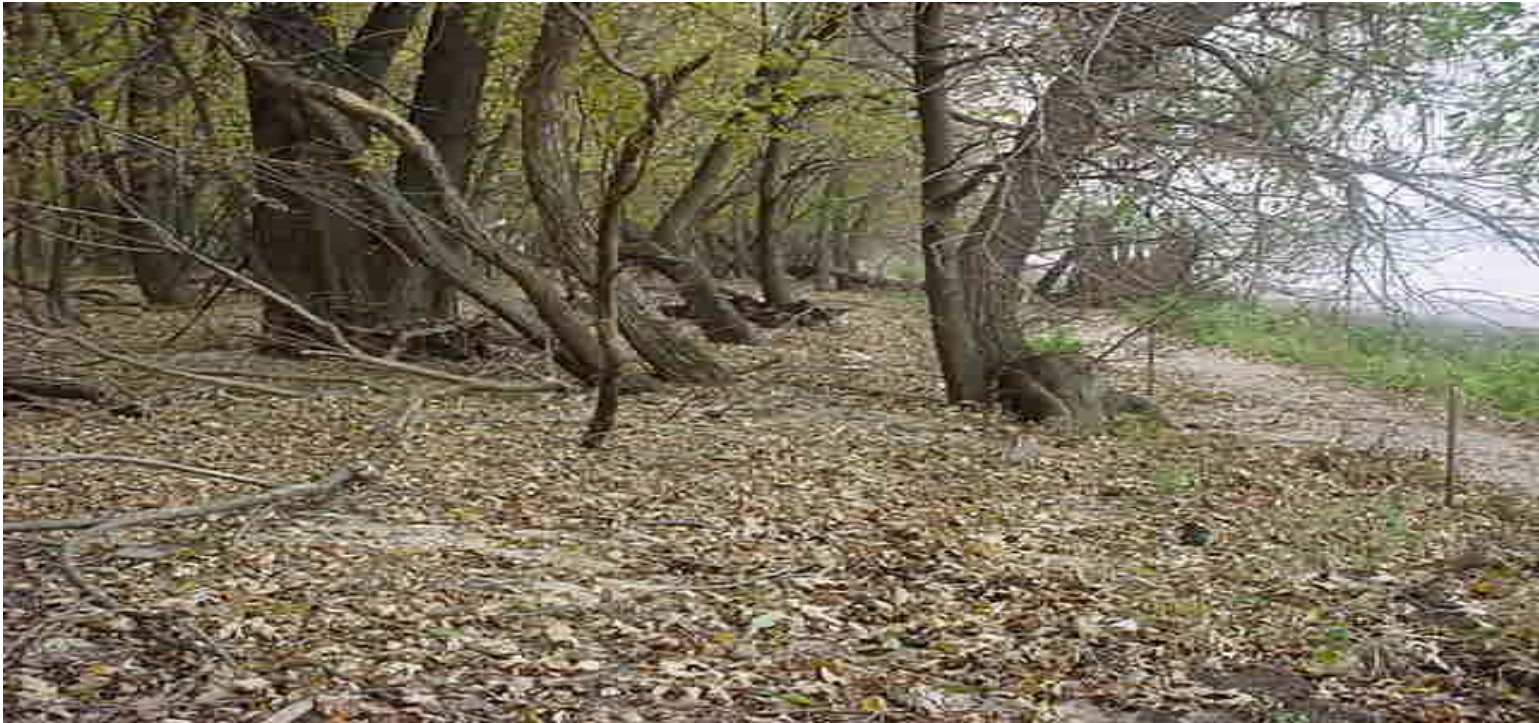
- Location: Vinne Ha Ha Forest Date: 10-31-2003 Water Elevation: 775.96 msl
- Photo of Quads A and D. Quad A is in foreground and Quad D is in background. Same herb layer vegetation as noted in July 2003.

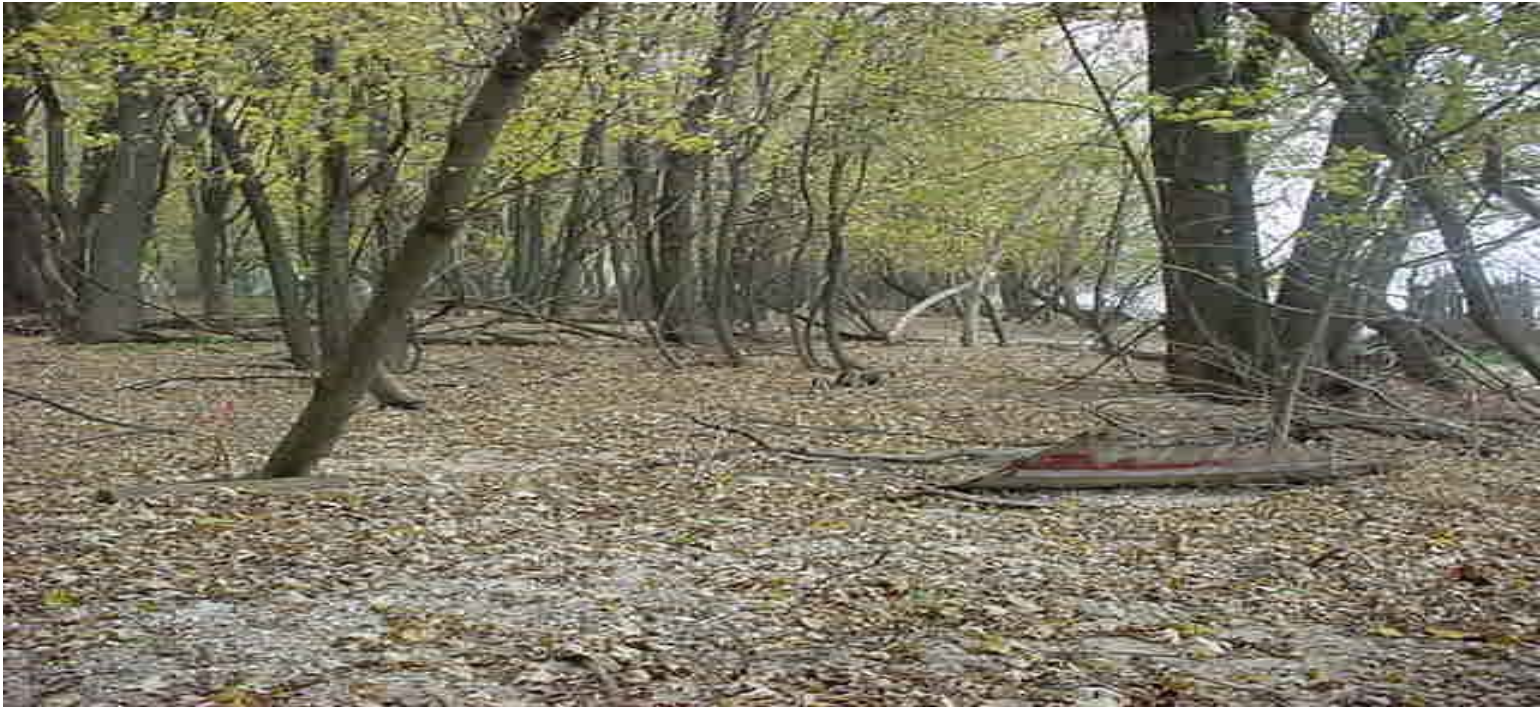
- Location: Vinne Ha Ha Forest Date: 10-31-2003 Water Elevation: 775.96 msl
- Photo of Quads B and C. Quad B is in foreground and Quad C is in background. Same tree and herb layer vegetation as noted in July 2003.

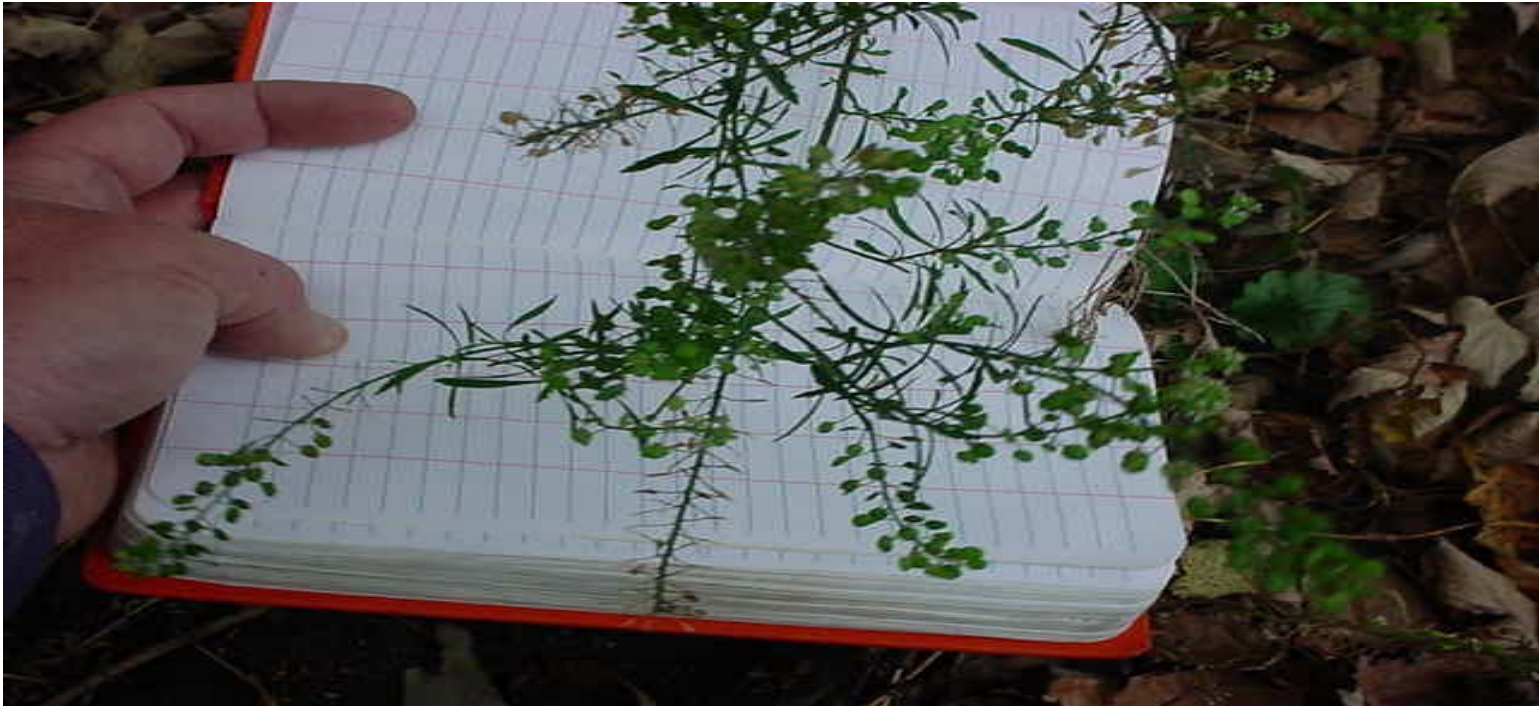
- Location: Vinne Ha Ha Forest Date: 10-31-2003 Water Elevation: 775.96 msl
- Photo of pepperweed (Lepidium campestre) seen for the first time in plot.

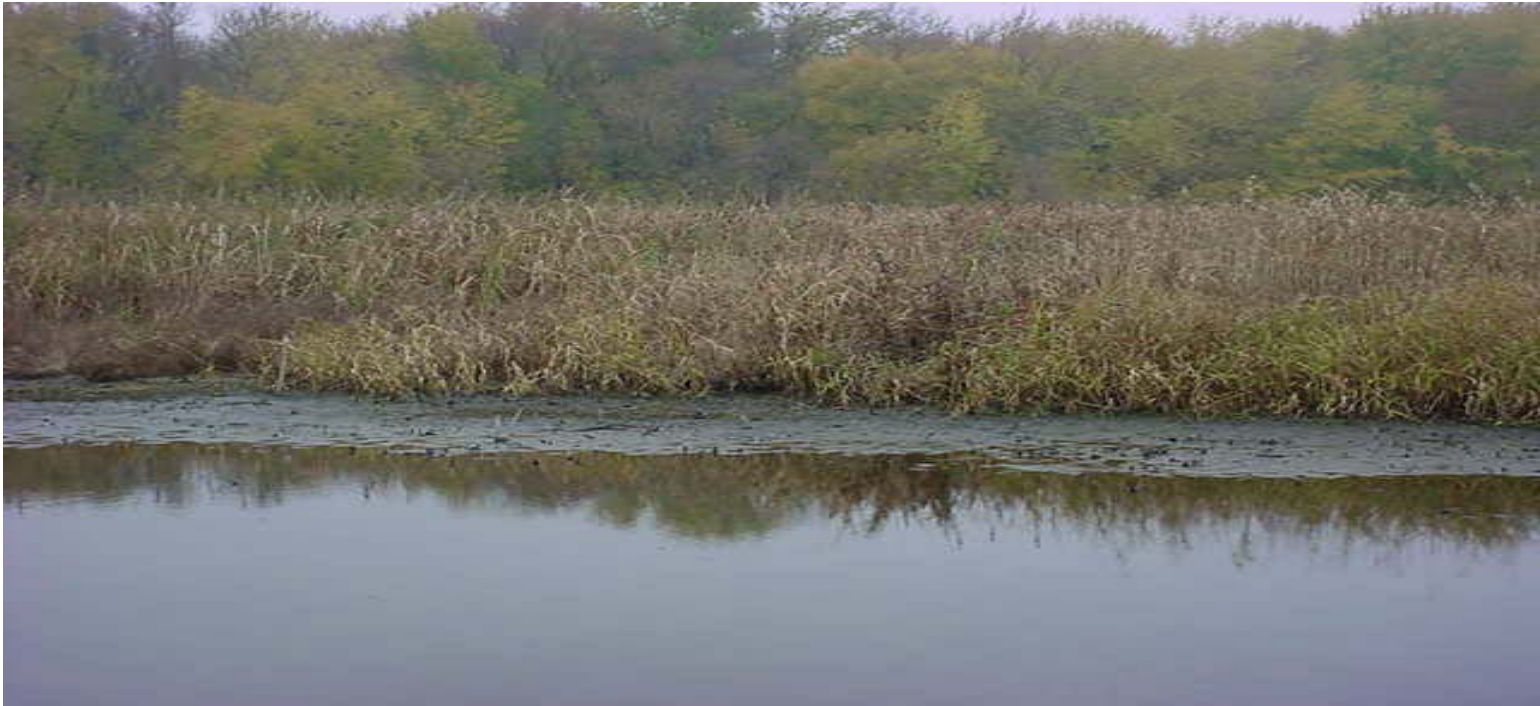
- Location: Carcajou Shallow Marsh Date: 10-31-2003 Water Elevation: 775.96 msl
- Photo of plot from lake. Plot has almost completely revegetated and new river bulrush is extending lakeward of plot boundary on east side (Quad D).

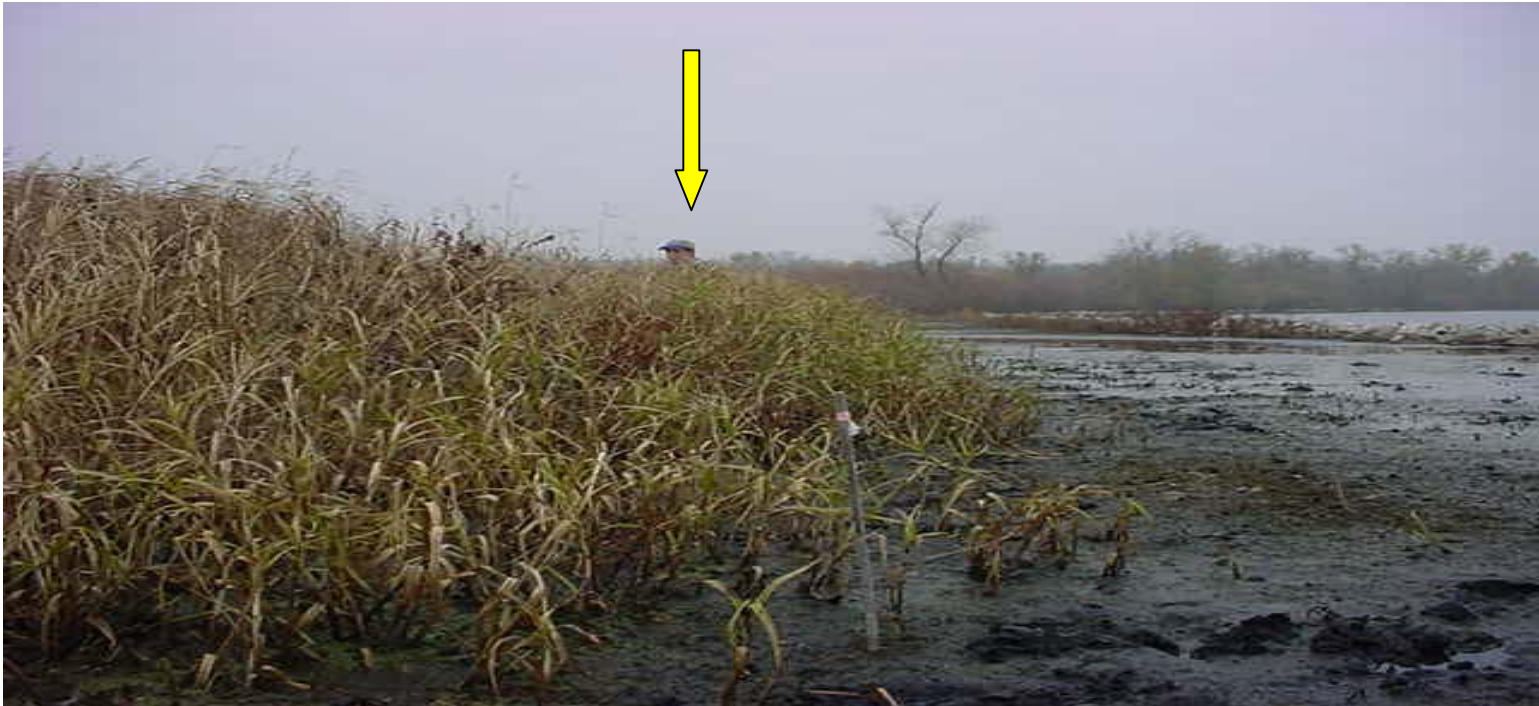
- Location: Carcajou Shallow Marsh Date: 10-31-2003 Water Elevation: 775.96 msl
- Photo of Quads A and D taken from west of plot looking east. Plot has almost completely revegetated and new river bulrush is extending lakeward of plot boundary on east side. Arrow depicts location of southeast corner of plot that is now shoreward of edge of river bulrush.

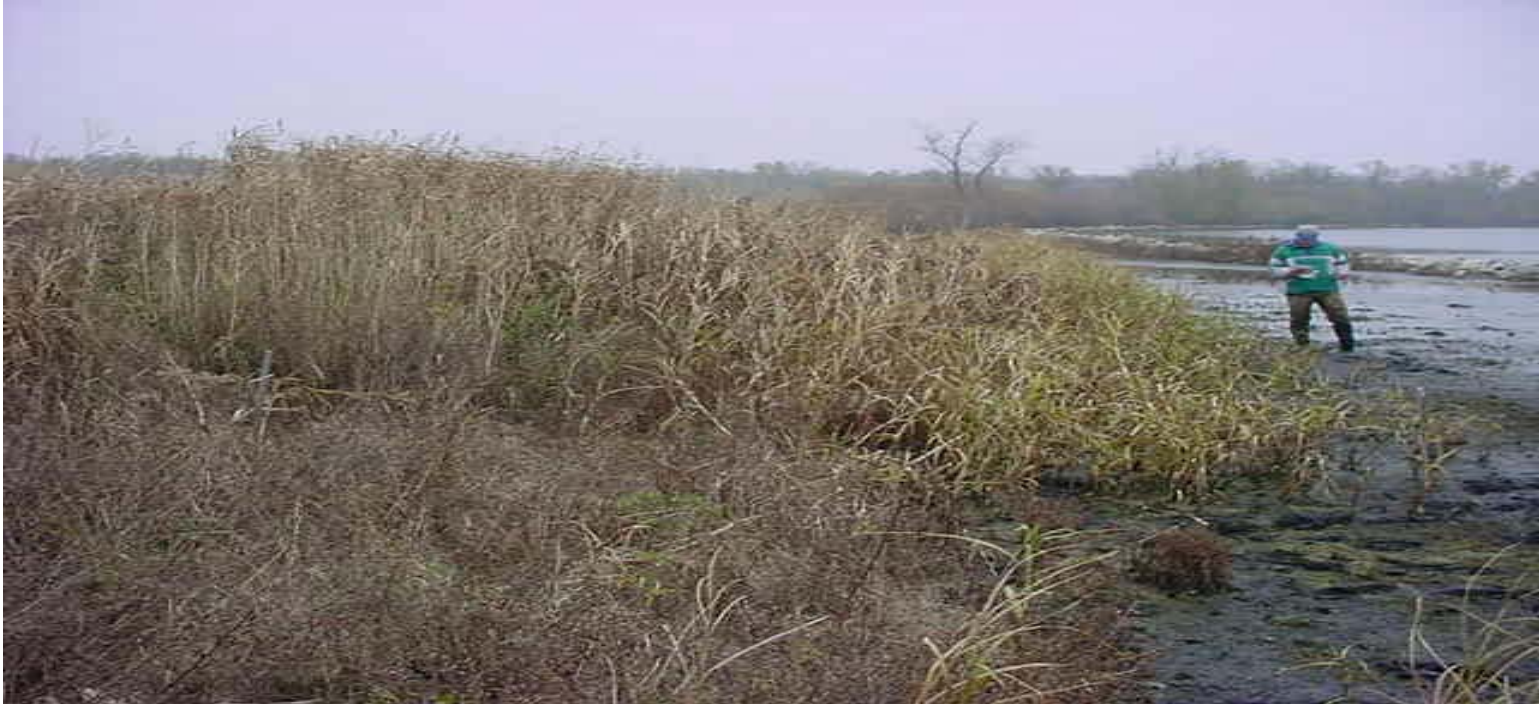
- Location: Carcajou Shallow Marsh Date: 10-31-2003 Water Elevation: 775.96 msl
- Photo of Quads B and C taken from west of plot looking east. Vegetation is the same as July 2003 observations with the addition of evening nightshade (*Solanum dulcamara*) in plot for the first time. Cocklebur and stinging nettle have increased in density of these two Quads.

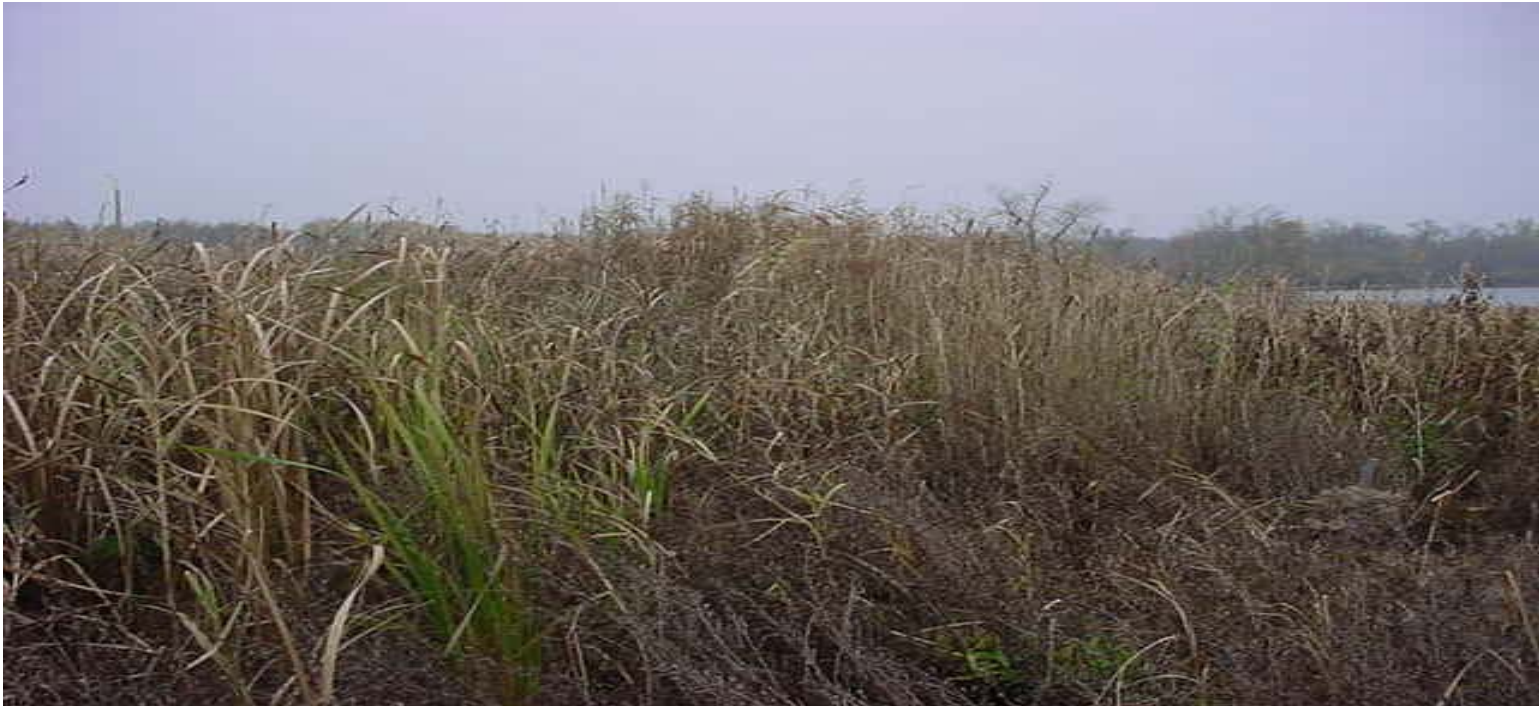
- Location: Carcajou Shallow Marsh Date: 10-31-2003 Water Elevation: 775.96 msl
- Photo of Quads B and C taken from west of plot looking east. Vegetation is the same as July 2003 observations with the addition of evening nightshade (Solanum dulcamara) in plot for the first time. Cocklebur and stinging nettle have increased in density of these two Quads.

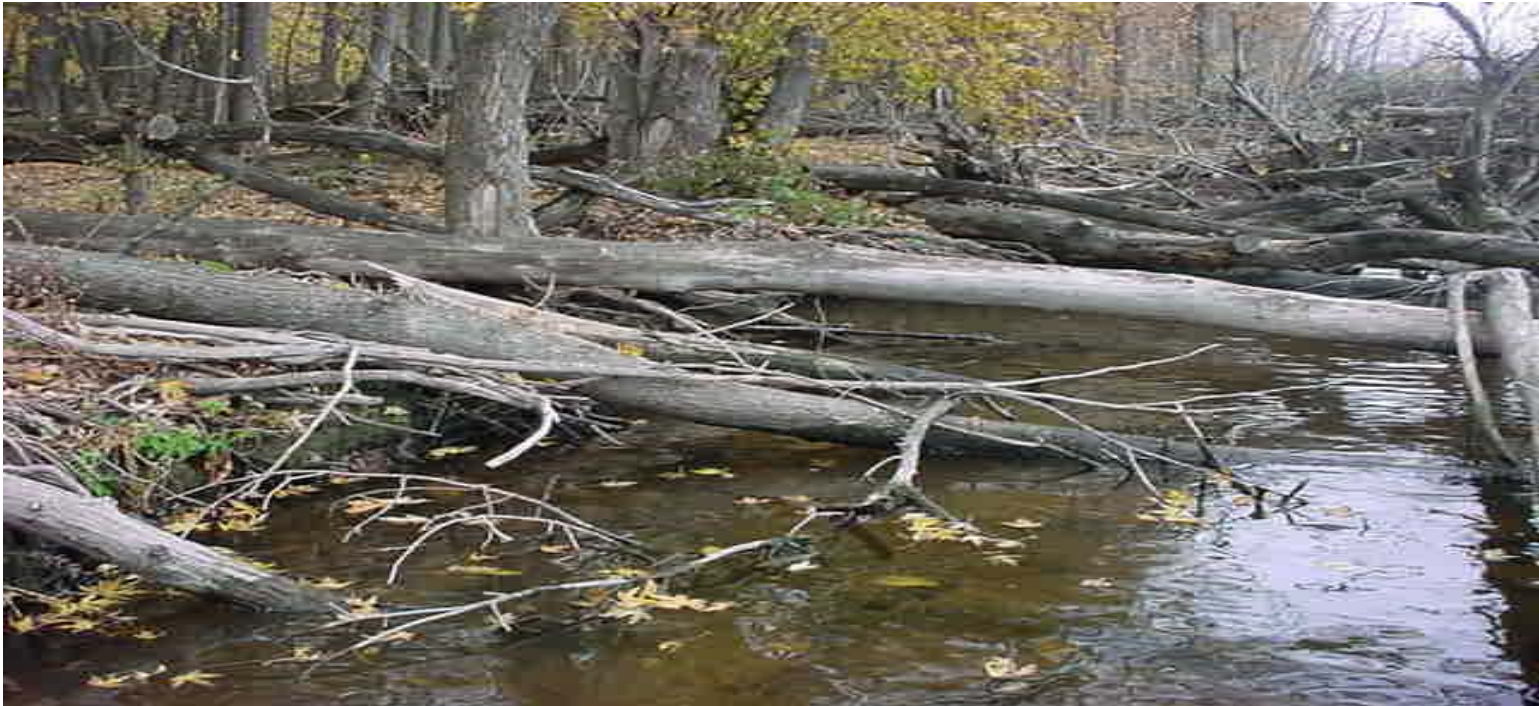
- Location: Carcajou Floodplain Forest Date: 10-31-2003 Water Elevation: 775.96 msl
- Photo of Quads A and D taken from west of plot looking east. Continued erosion occurring on the shoreline. A little more herb layer coverage since July 2003.

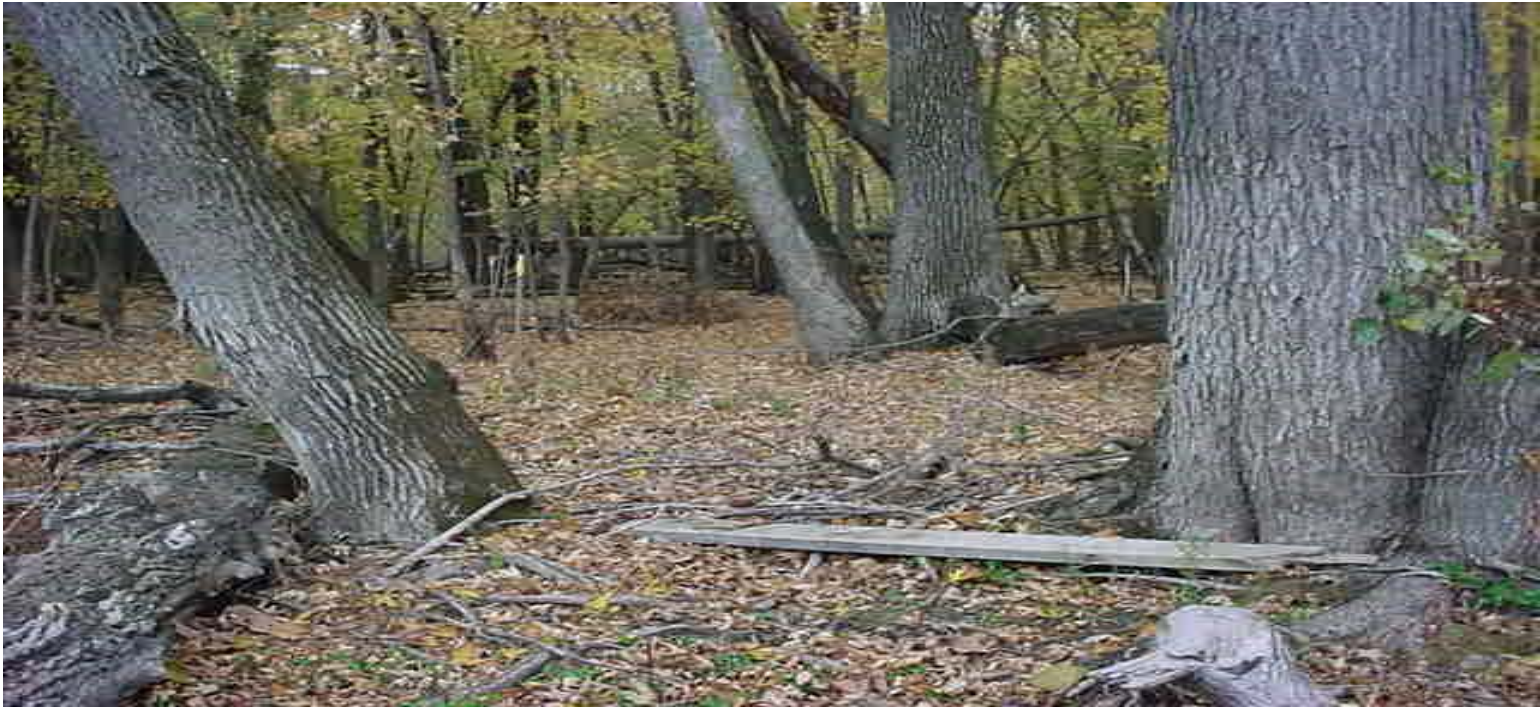
- Location: Carcajou Floodplain Forest Date: 10-31-2003 Water Elevation: 775.96 msl
- Photo of Quads B and C taken from east of plot looking west. A little more herb layer coverage since July 2003.

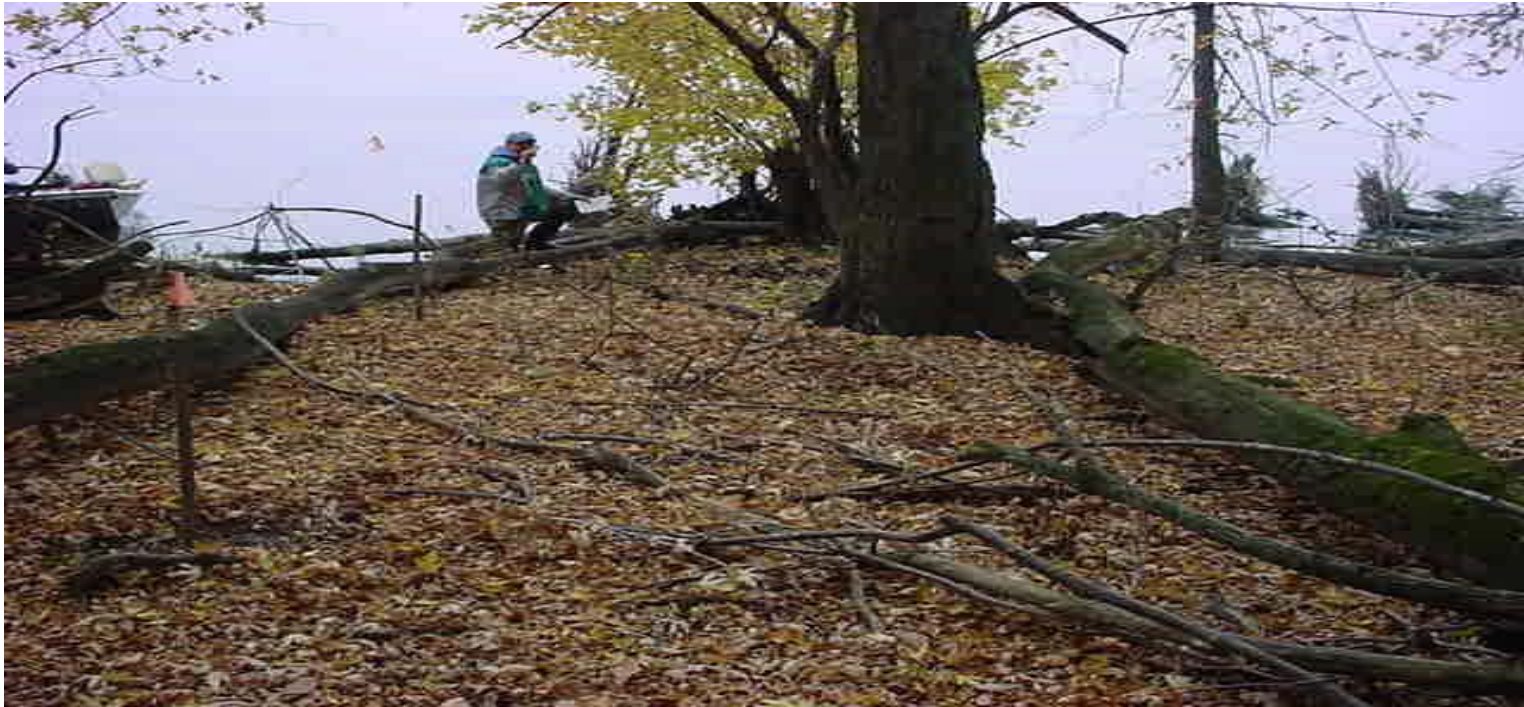
- Location: Carcajou Floodplain Forest Date: 10-31-2003 Water Elevation: 775.96 msl
- Photo of Quads C and D taken from north of plot looking south. Continued erosion occurring on the shoreline. A little more herb layer coverage since July 2003.

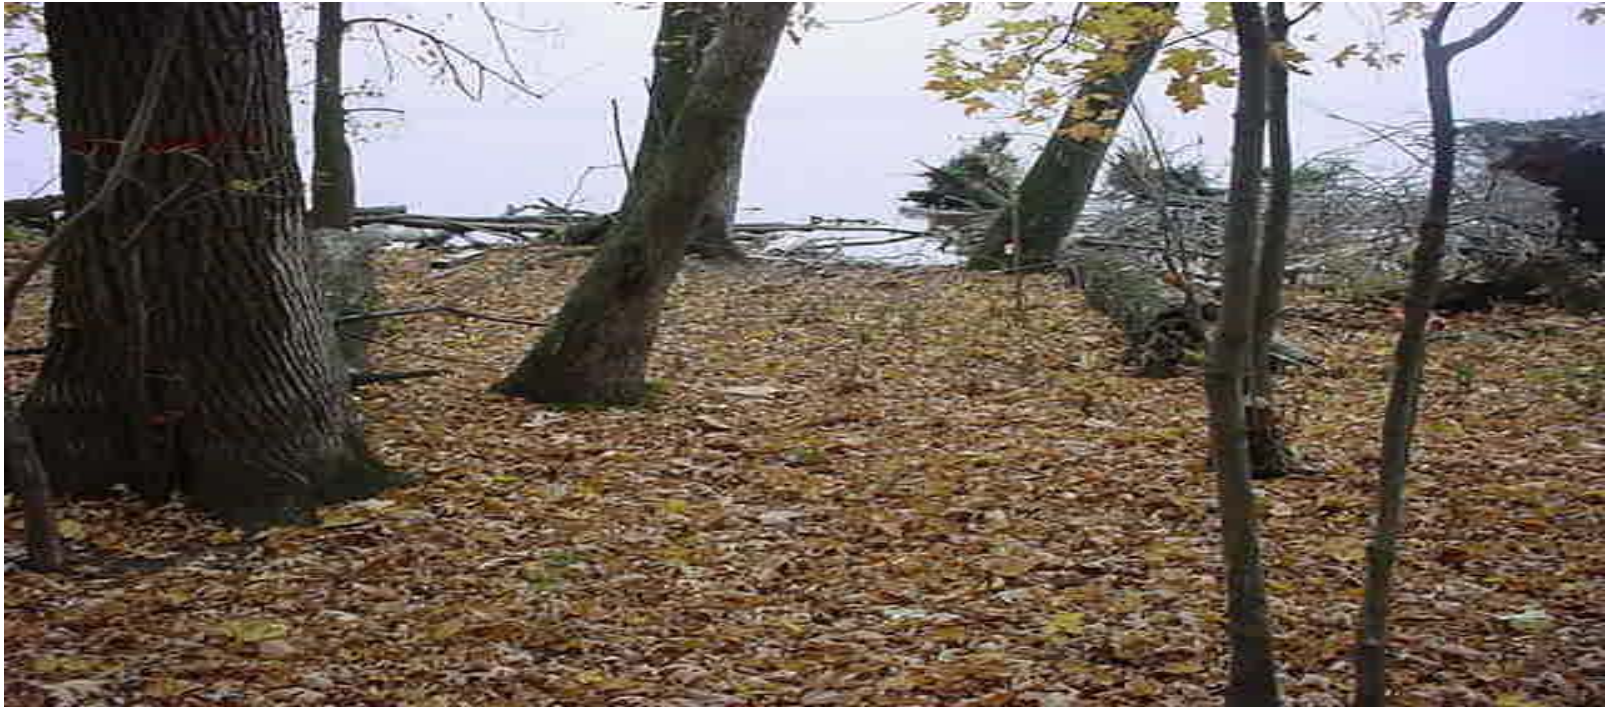
- Location: Carcajou Floodplain Forest Date: 10-31-2003 Water Elevation: 775.96 msl
- Photo of Quads A and B taken from north of plot looking south. Continued erosion occurring on the shoreline. A little more herb layer coverage since July 2003.

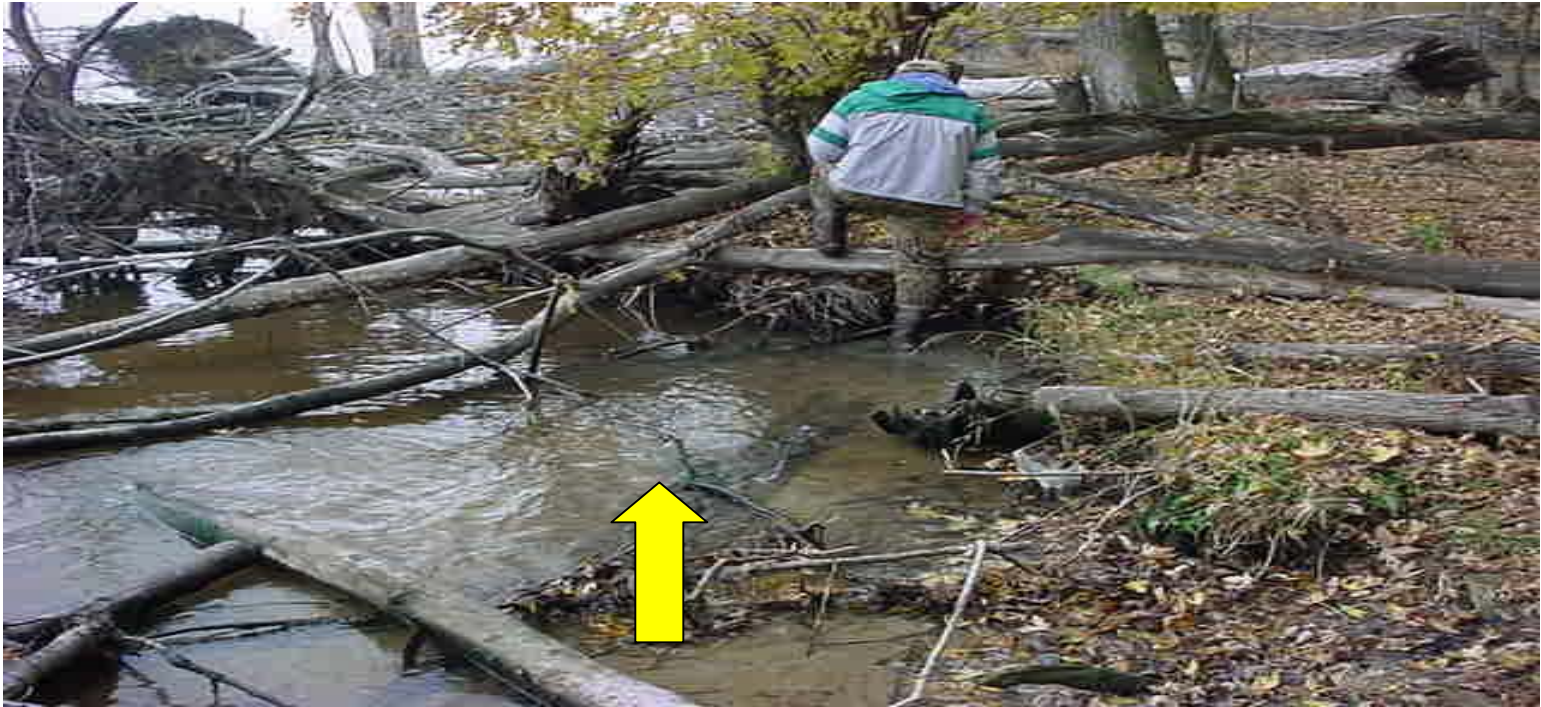
- Location: Carcajou Floodplain Forest Date: 10-31-2003 Water Elevation: 775.96 msl
- Photo of Quad D taken from east of plot looking west showing continued erosion. Arrow indicates location of original plot corner.

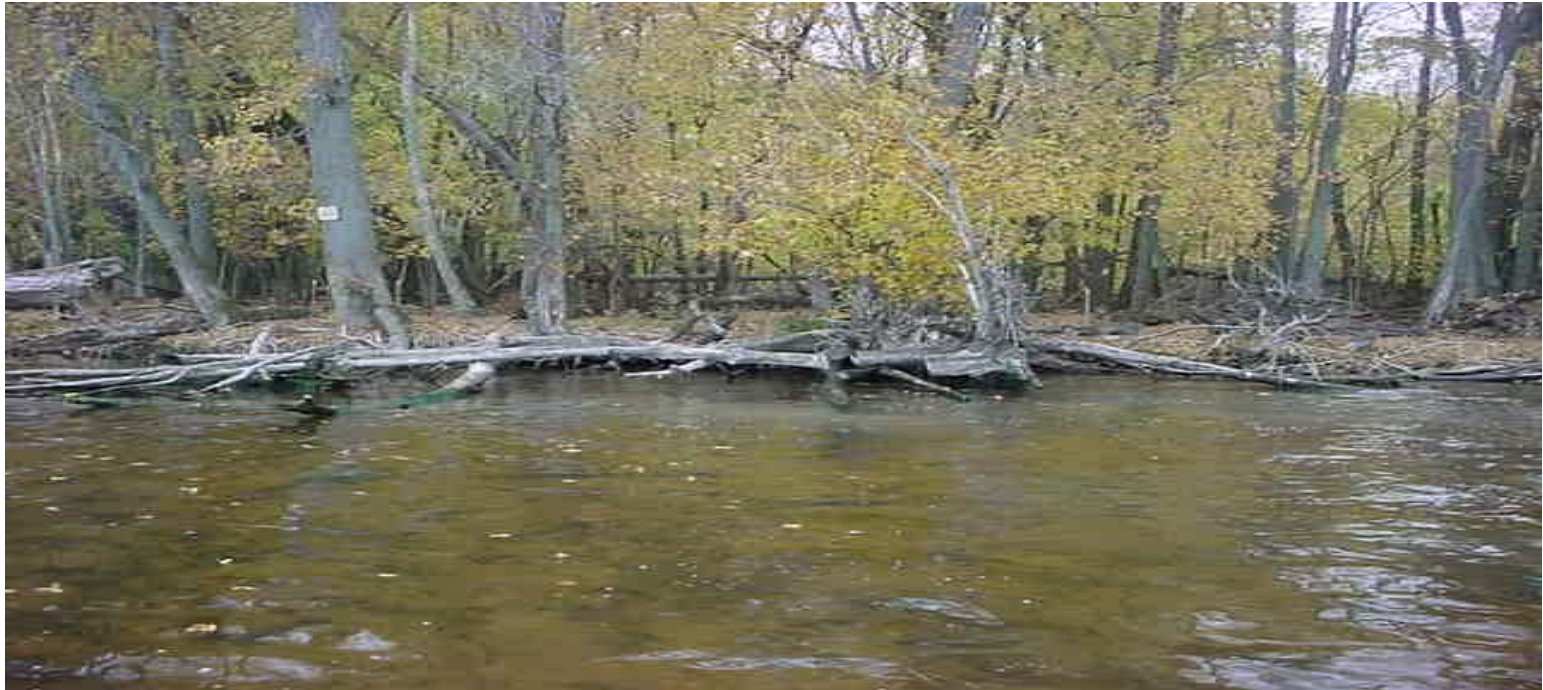
- Location: Carcajou Floodplain Forest Date: 10-31-2003 Water Elevation: 775.96 msl
- Photo of plot from lake looking north. Water very clear along shore, this is likely due to discharge of Koshkonong Creek on the right side of photo. General lake water clarity is much less than this area.
