## AFFECTED ENVIRONMENT

### Historical Setting

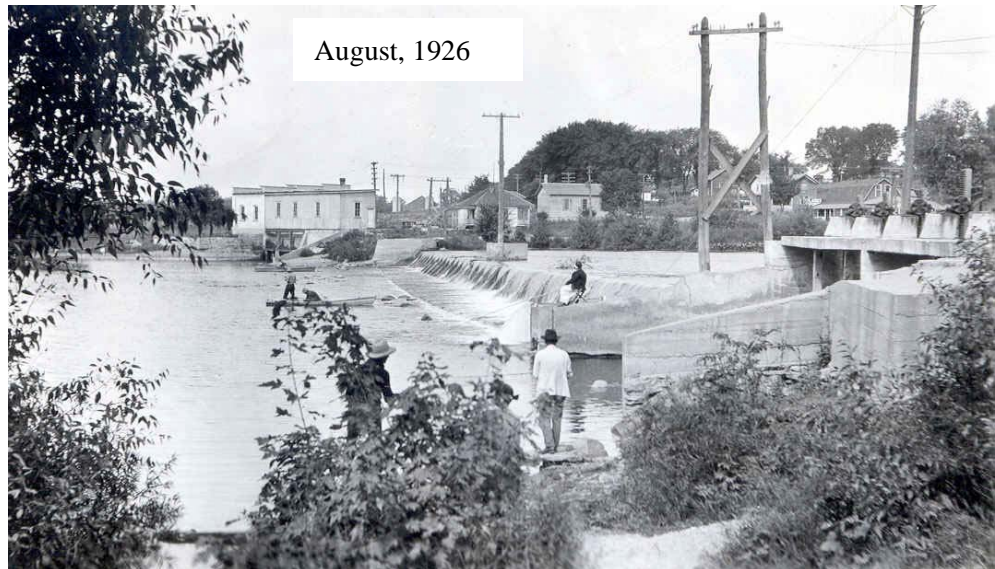
John W. Robbins et al vs Janesville Electric Company before Wisconsin Railroad Commission – volume 20, page 397 (February 1918). The floodgate section at the east end of the dam had been completed. The construction included six wooden lift gates averaging 6 feet in width. The nature of the lifting gear is not apparent, but probably consisted of a cog and wheel apparatus. The sill elevation at the gate section was

approximately 7.6 feet (W.R.C.) and the elevation of the main spillway crest was described as **11.44 feet** (W.R.C.), 0.18 feet higher than the old spillway which it had replaced. Because the new floodgate section gave the dam a discharge capacity much in excess of the old dam, Janesville Electric Company was not directed to restore the spillway elevation to 11.26 feet (W.R.C.) by flashboards or other means. In addition, the electric company was directed to remove an old coffer dam obstructing the floodgates by dredging a channel 45 feet wide at the bottom (with bottom elevation not higher than 8.0 feet W.R.C.), leading from the main channel of the river to the floodgate section. The Commission directed that at least two gates be fully open when the water elevation at the dam exceeded 12.1 feet and that all six gates be fully open when the water elevation exceeded 12.6 feet (W.R.C.). The gates were to be closed when the water elevation dropped below the crest of the spillway unless special authority had been received from the Commission.

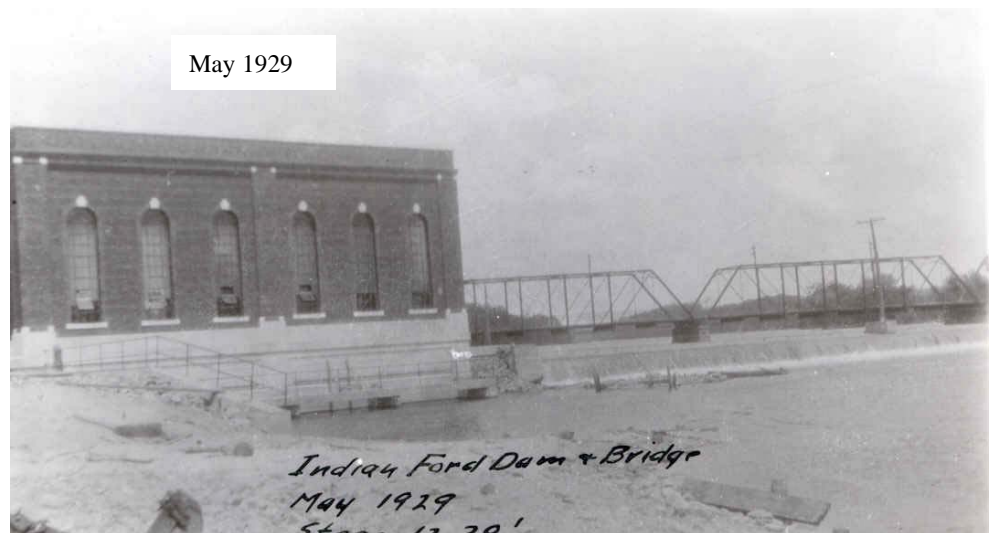
The main spillway was reconstructed in 1931 and Railroad Commission engineers confirmed construction of the spillway crest at an average elevation of 11.44 feet (W.R.C.). There was no modification of the floodgate section. However, the coffer dam upstream of this section had apparently been entirely removed by this time. In 1931, representatives of Wisconsin Power and Light Company and property owners on Lake

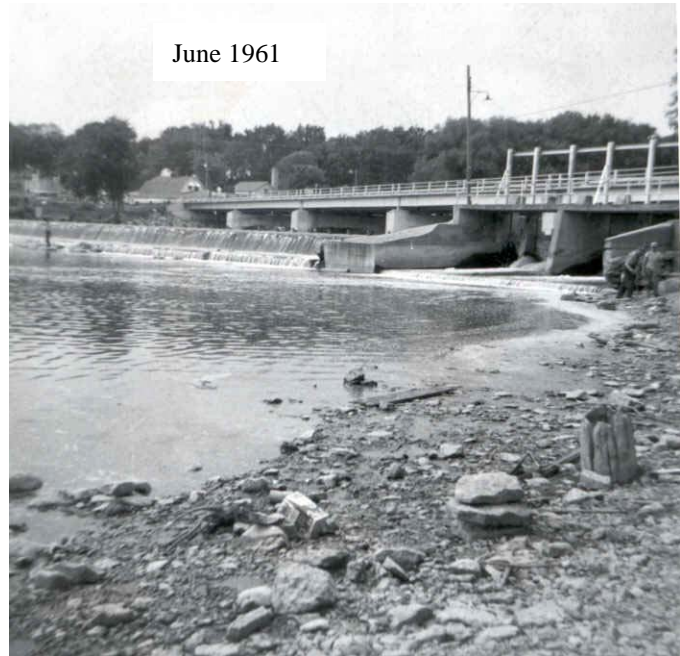
Figure 1. Generalized schematic of a wicket gate. Wicket gates are a series of vanes arranged radially around a opening that open and close to allow variable amounts of flow to drive the turbine.

In the late 1960's wicket gates in the powerhouse became rusted shut making that discharge capacity unavailable. Manipulating the manually operated floodgates was a very time consuming proposition and the operating orders for the lift gates were not rigidly adhered to. This period is marked by extreme vacillation in water levels, accelerated erosion and loss of peripheral wetlands on Lake Koshkonong. These conclusions are documented in Department of Natural Resources memoranda and in correspondence from the general public.

Wisconsin Electric Power Company in a December 20, 1974 report investigated the restoration of the powerhouse at Indianford as a means of stabilizing water levels on Lake Koshkonong. The report was authorized by the Rock County Planning Commission and the Wisconsin Department of Natural Resources. The report describes three metal head gates in place upstream of the wicket gate in flume no. 1. This wicket gate had frozen in the 7/10 open position and the wicket gates in unit no. 2 were frozen completely shut. The report detailed two alternatives:

1. The wicket gates could be rejuvenated and used to regulate flow through the powerhouse.
2. The head gates in unit 1 could be rejuvenated and new gates installed in unit 2. Both sets of gates would have to be fitted with a lifting mechanism. The wicket gates would then have to be jacked fully open or removed.
