Ordinary High Water Mark

ECOLOGICAL RESPONSE TO OPERATING ORDER CHANGE

**WDNR/RKLD COOPERATIVE LAKE STUDY,
LAKE KOSHKONONG**

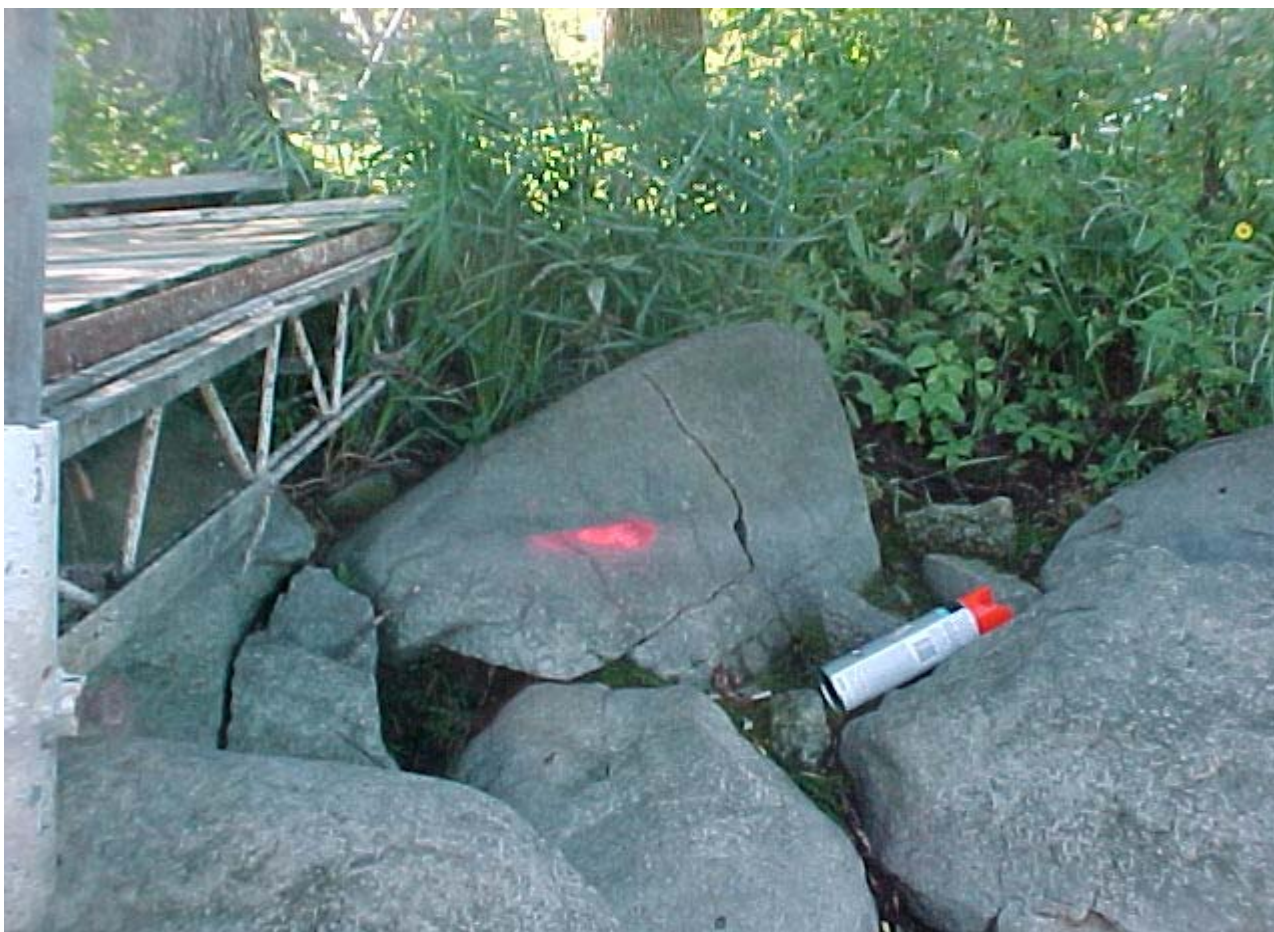
OHWM at Mallwood Subdivision shoreline. OHWM elevation 778.31 msl.

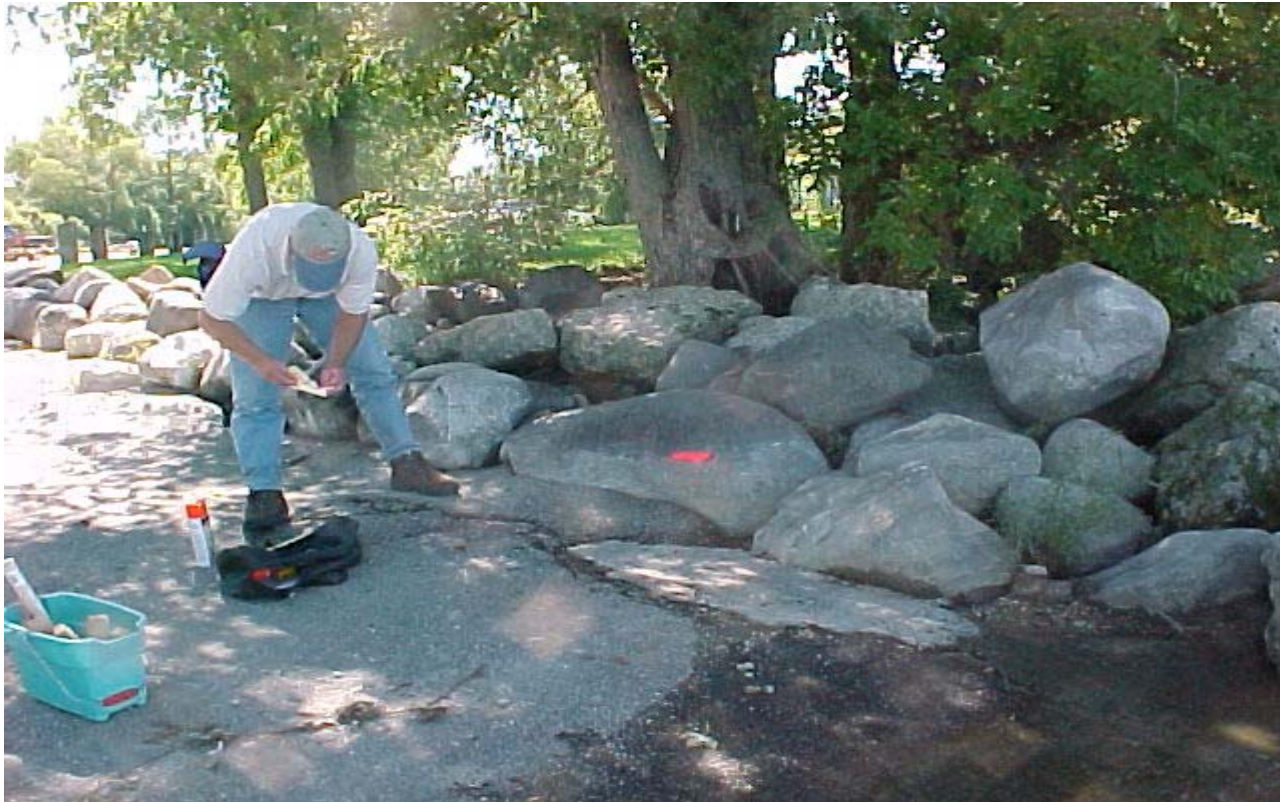
OHWM at Charlie Bluff boat landing shoreline. OHWM elevation 778.23 msl.

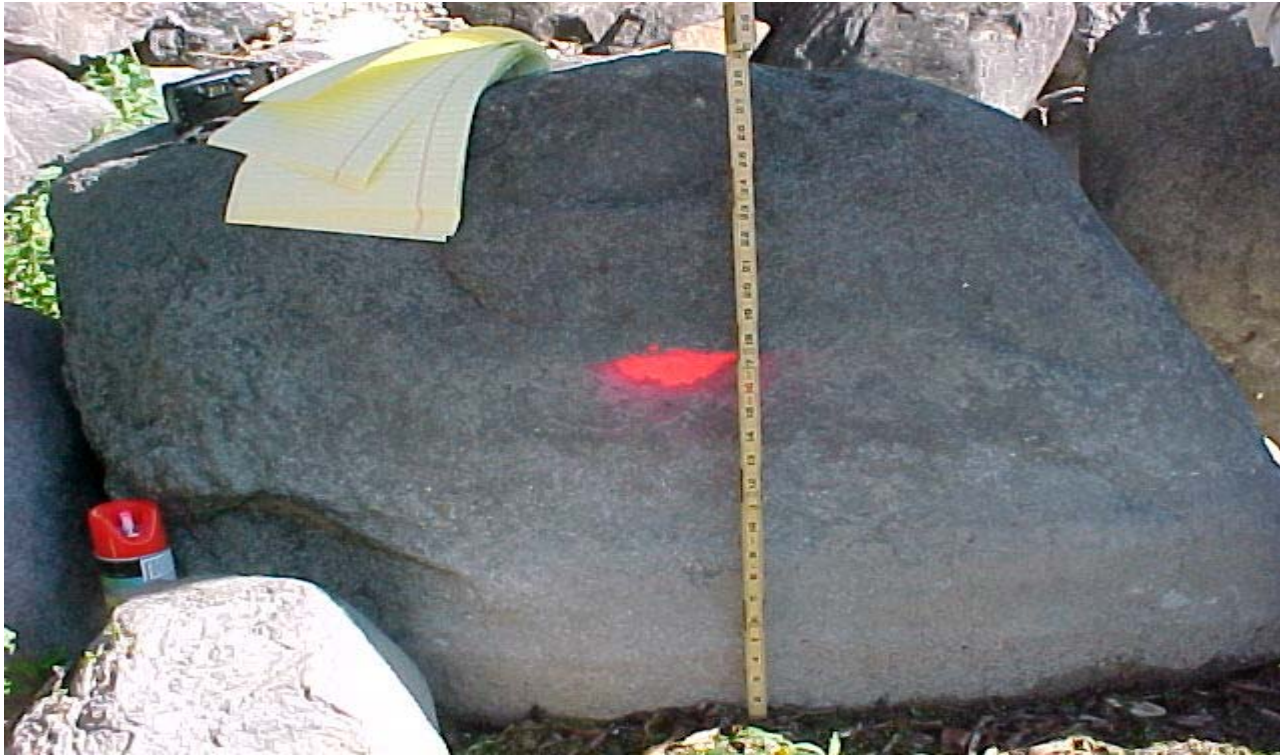
OHWL at Gilberts Bay (Vinnie Ha Ha) shoreline. OHWL elevation 778.83 msl.

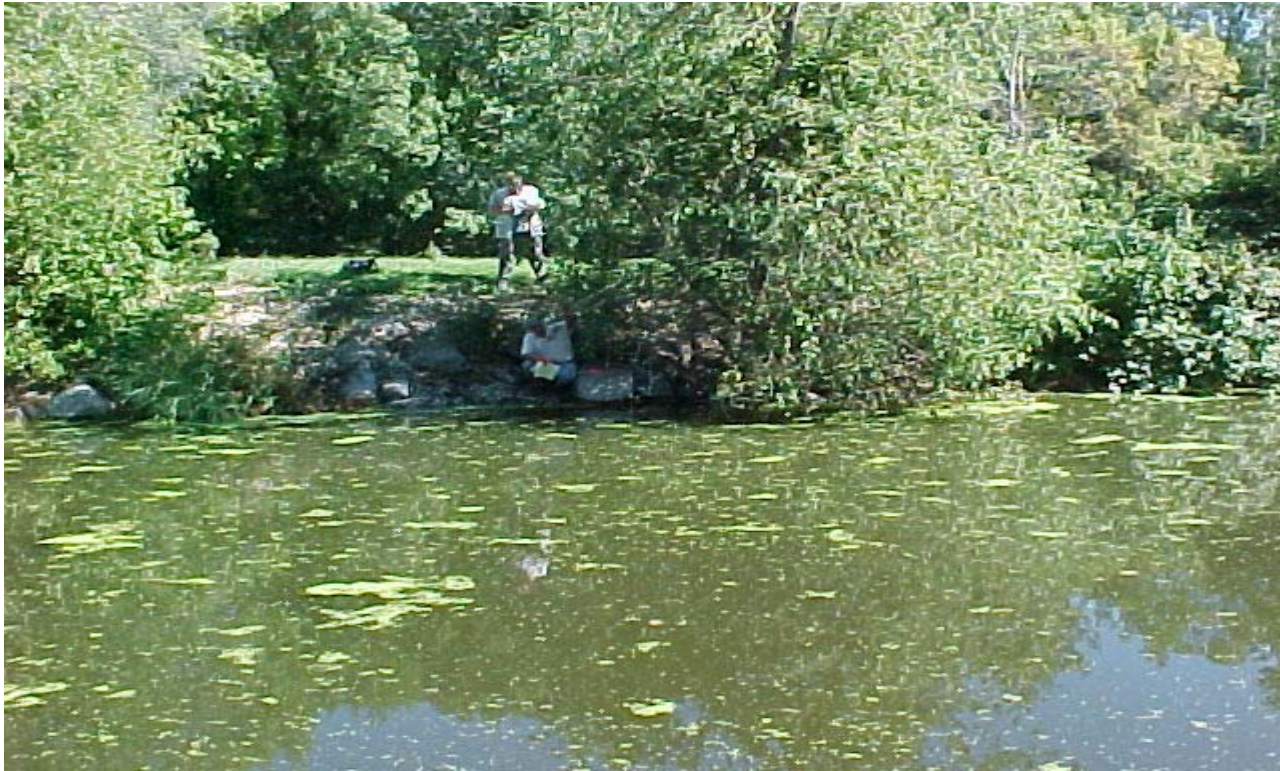
OHWL at Bingham's Bay (Oxbow) shoreline. OHWL elevation 778.32 msl.

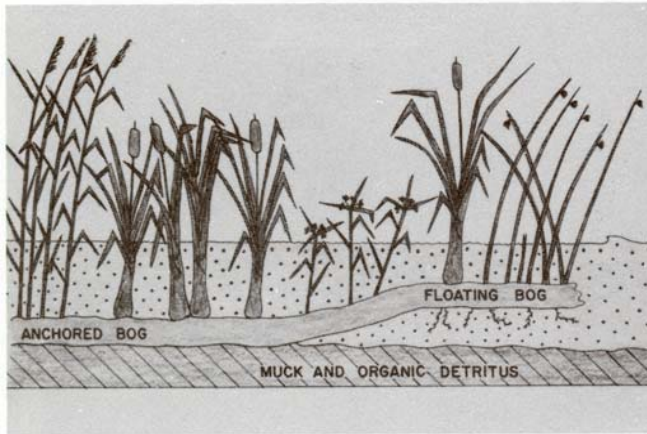
Floating bogs are created when (a) high and fluctuating water levels lift dense rhizomatous mats away from underlying substrates;

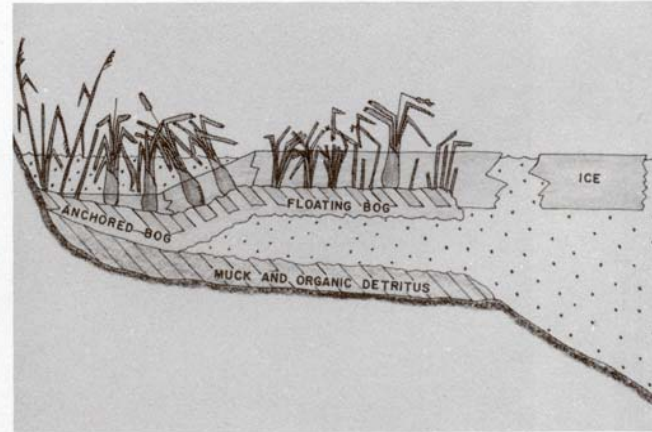
(b) rising water levels in spring prior to ice-out lift the ice layer formed within rhizomatous mats, tearing them away from bottom substrates;

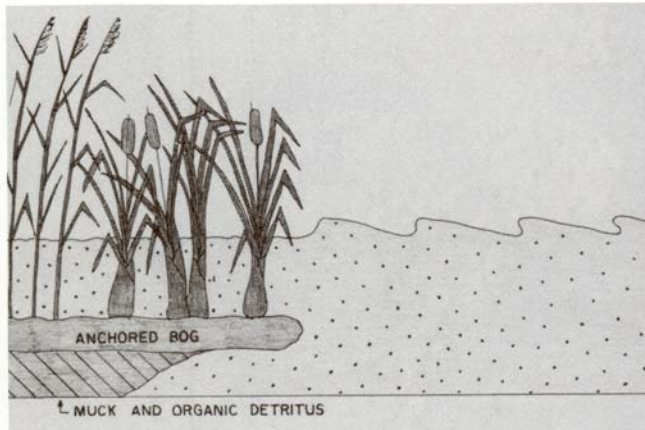
(c) substrates under rhizomatous mats are scoured away.

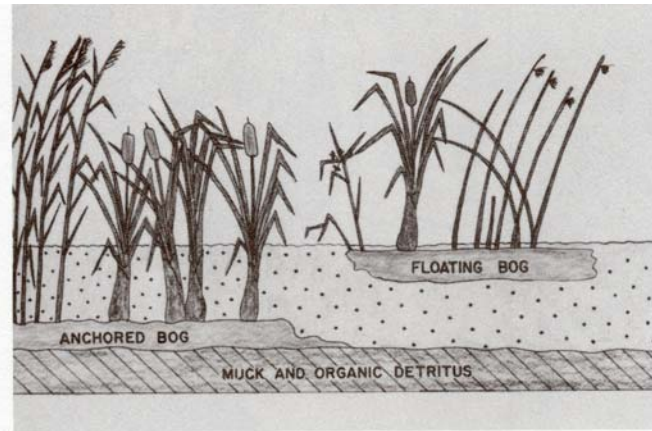
(d) Wave and ice action then break these bogs into small islands that float downstream (illustrations by Arlyn Linde and Tom Janisch).

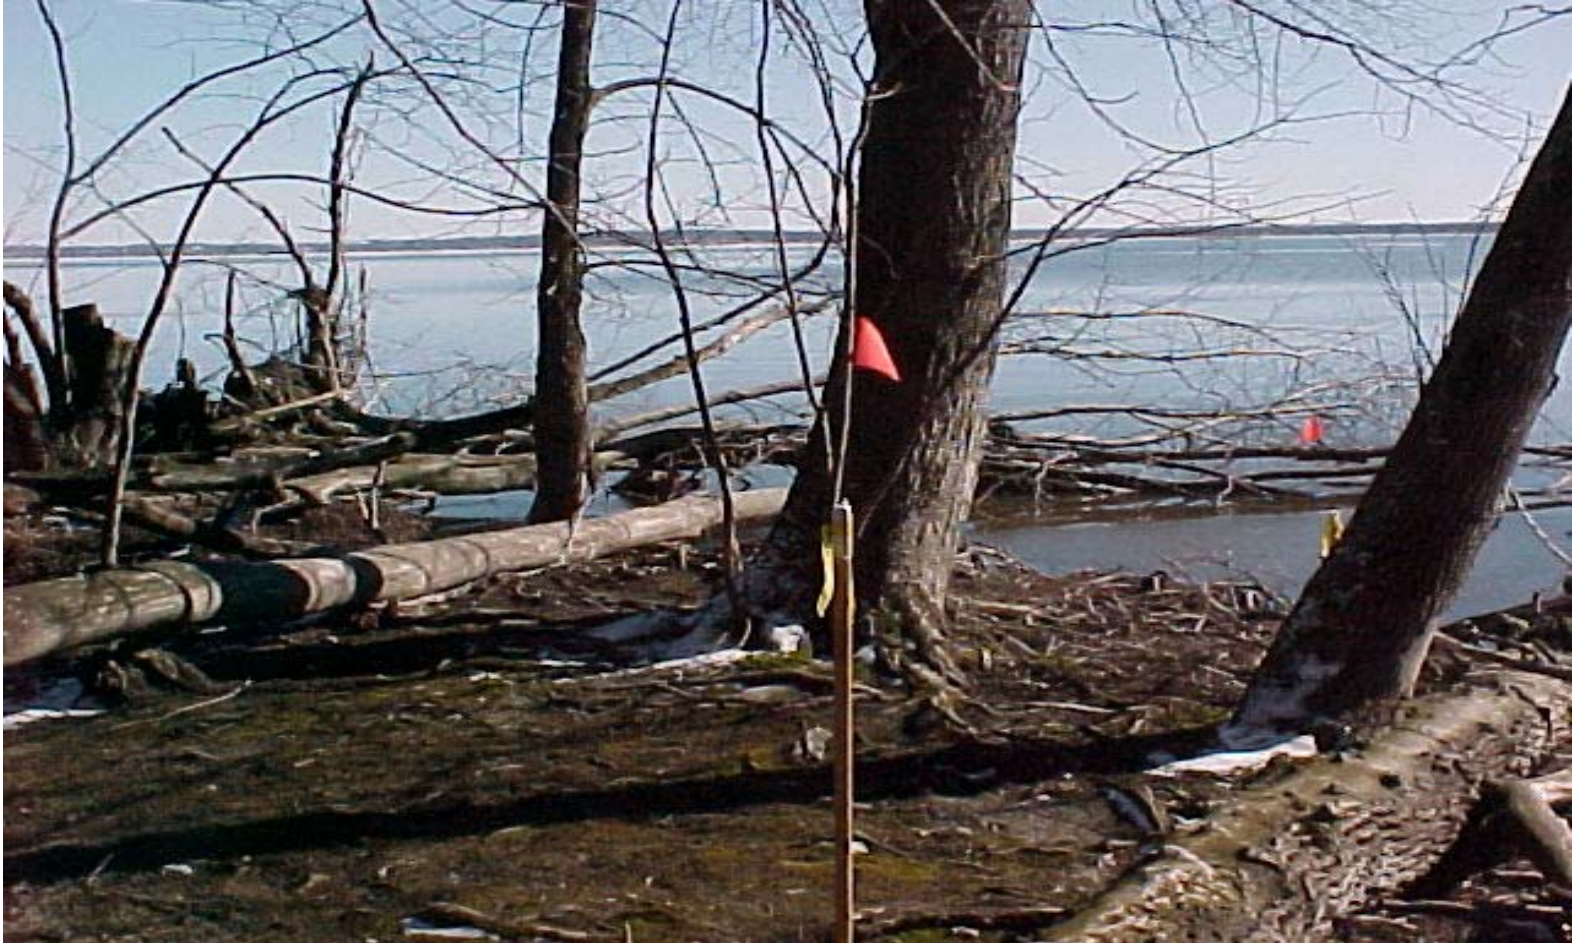
- Location: Carcajou Forested Floodplain Date: 2/22/02 WL: 776.48 msl
- Description: Photo taken from northwest of Quadrant A looking southeast. 25% moss layer coverage and sparse leaf litter. 8" dbh American elm tree healthy with small winter buds and some exposed roots that are scarred. 7" and 18" dbh double trunk silver maple with 4 suckers (.75", 1", 1" and 1.75").

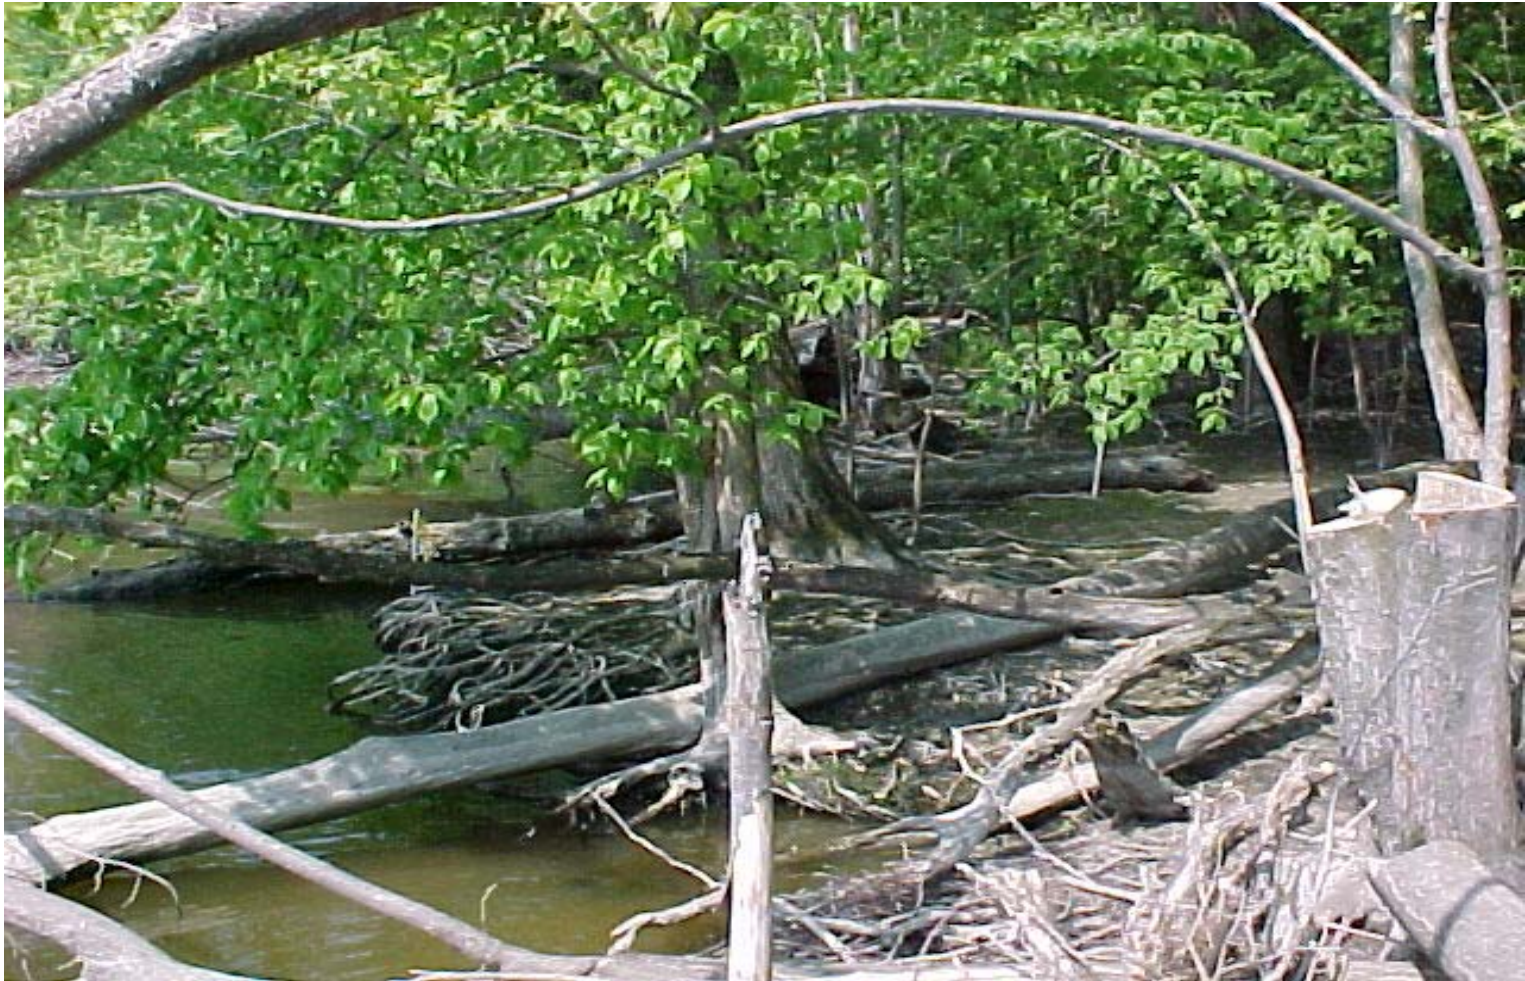
- Location: Carcajou Floodplain Forest Date: 5/28/02 WL: 776.81 msl
- Photo Description: Photo taken east of Quadrant A. Stake in SW corner of Quadrant A missing (replaced on 5/28/02). Evidence of erosional sediment loss in root systems along shore.

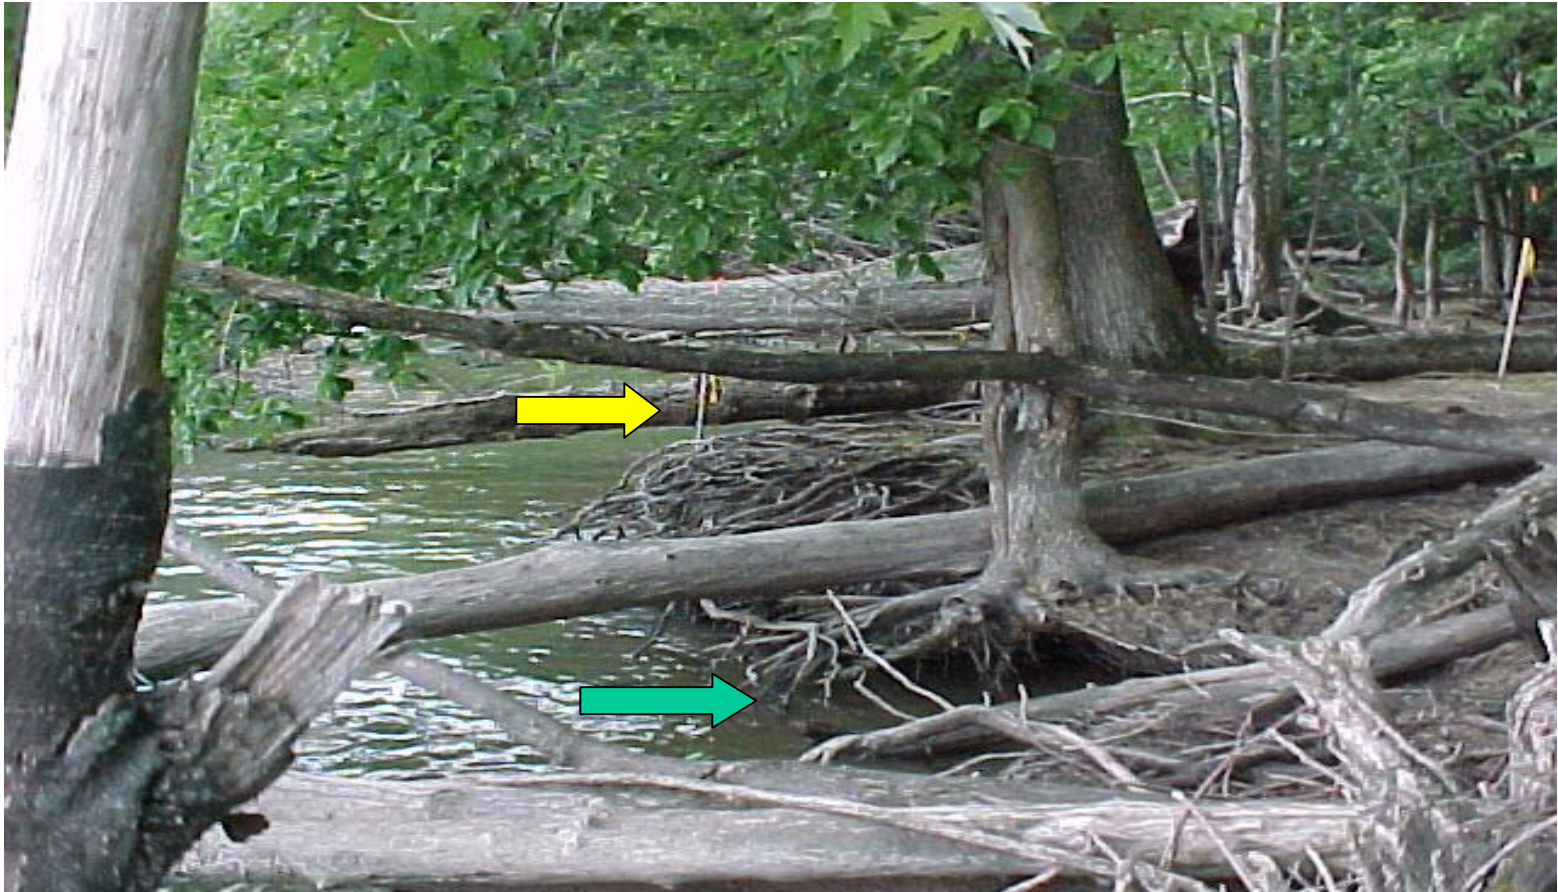
- Location: Carcajou Forested Floodplain Date: 7/9/02 WL: 776.13 msl
- Photo Description: Photo of Quadrant A, yellow arrow is SW corner of quadrant. Green arrow points to observed erosion under tree root systems. More than one foot of sediment loss since February, 2002.

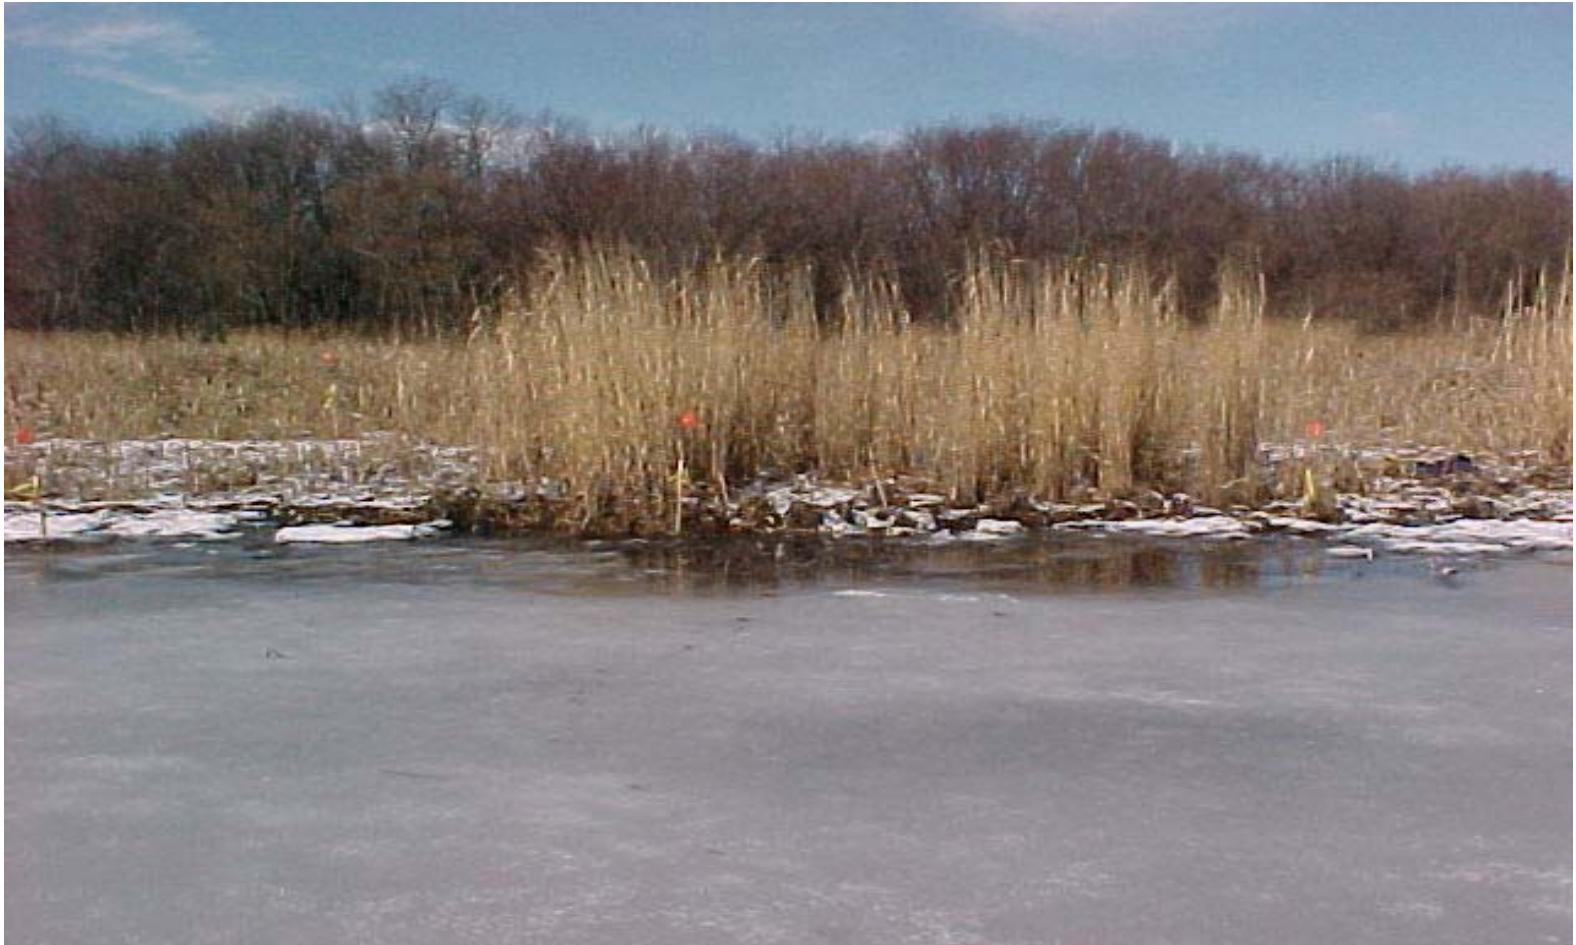
- Location: Carcajou Shallow Marsh Date: 2/22/02 WL: 776.48 msl
- Description: Photo of plot taken from north looking south. 0% tree cover 90% herb layer cover, soil description organic silt/muck,

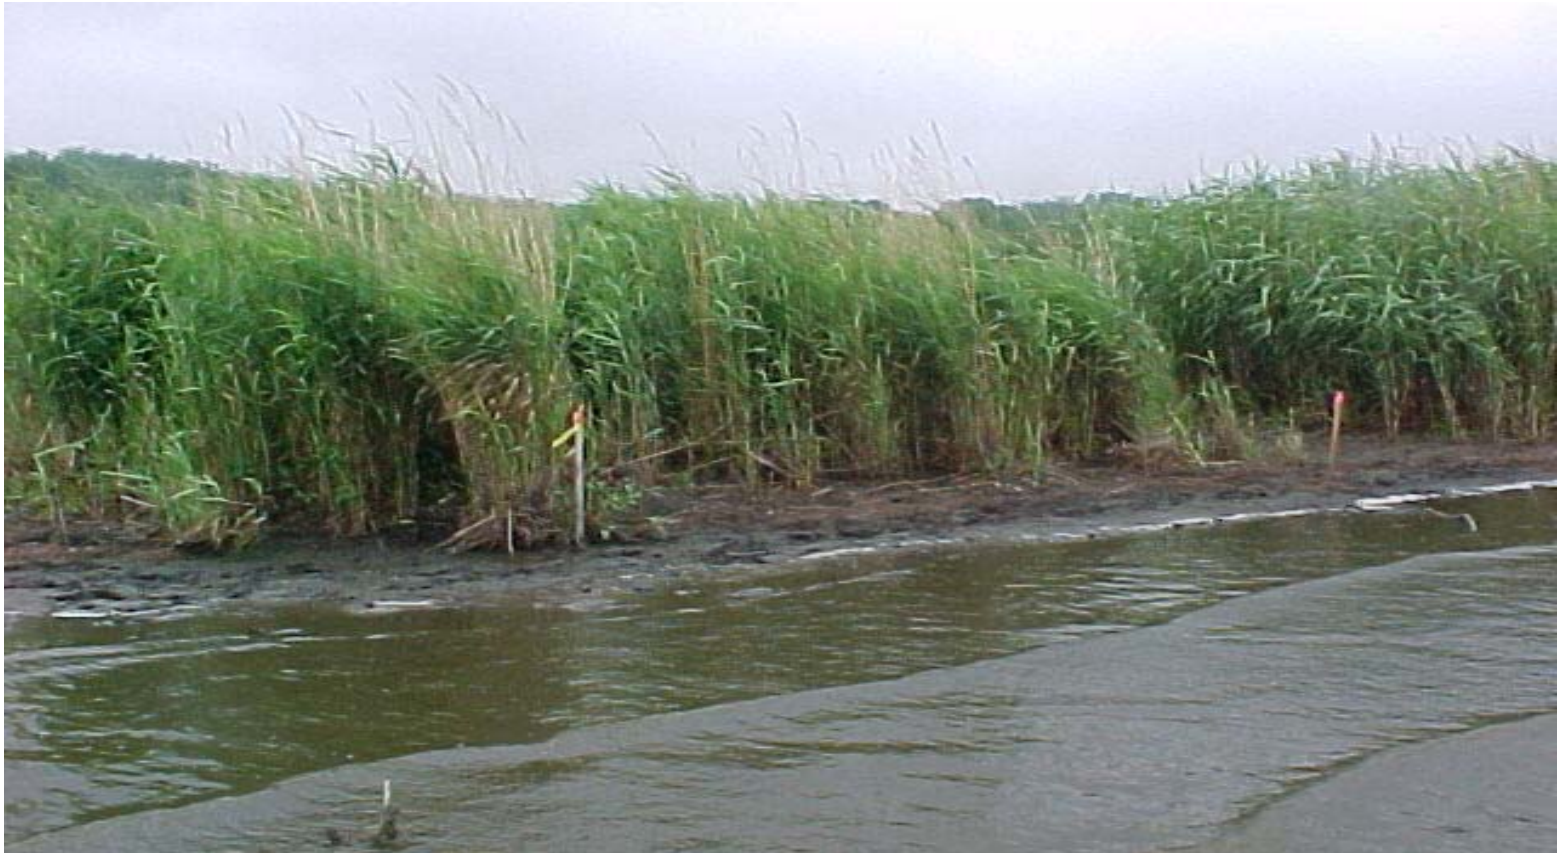
- Location: Carcajou Shallow Marsh Date: 7/9/02 WL: 776.14 msl
- Photo Description: Photo of Quadrant D. Evidence of predation on river bulrush and common reed along shore. 10% of this quadrant unvegetated. 70% common reed, 4% river bulrush, 5% water smartweed, 5% arrowhead. Some young river bulrush sprouted along edge of water.

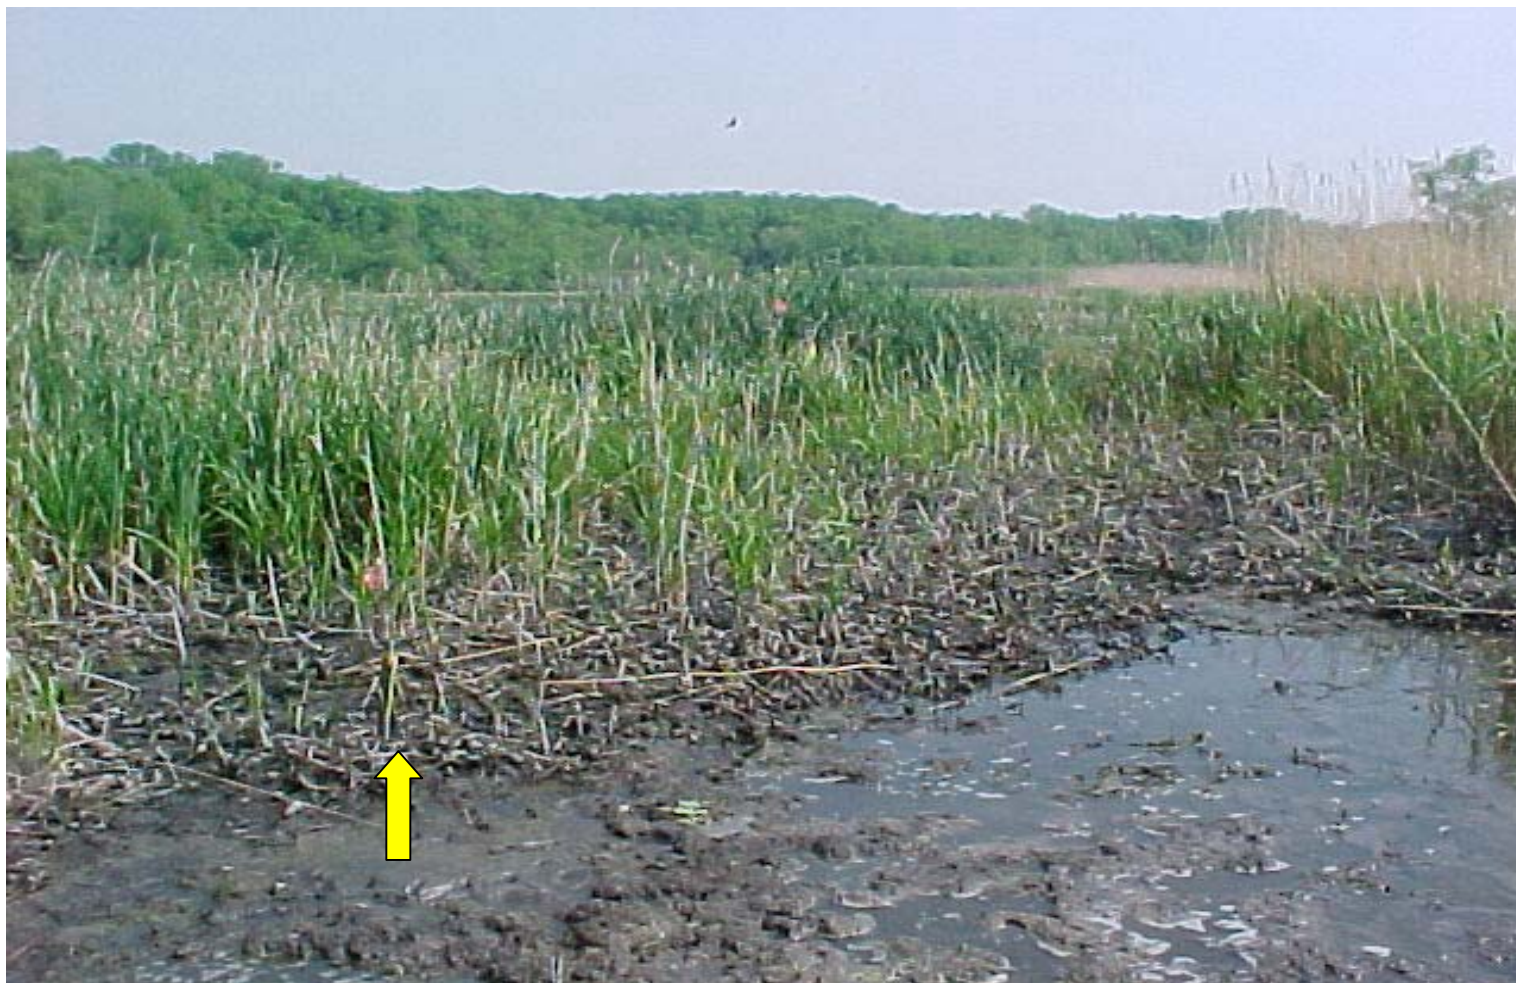
- Location: Carcajou Shallow Marsh Date: 5/28/02 WL: 776.81 msl
- Photo Description: Photo taken west of Quadrant B. Arrow indicates location of NW corner of Quadrant B. Significant vegetation and organic layer erosional loss. 15% live river bulrush, 35% dead river bulrush stalks, 50% un vegetated.

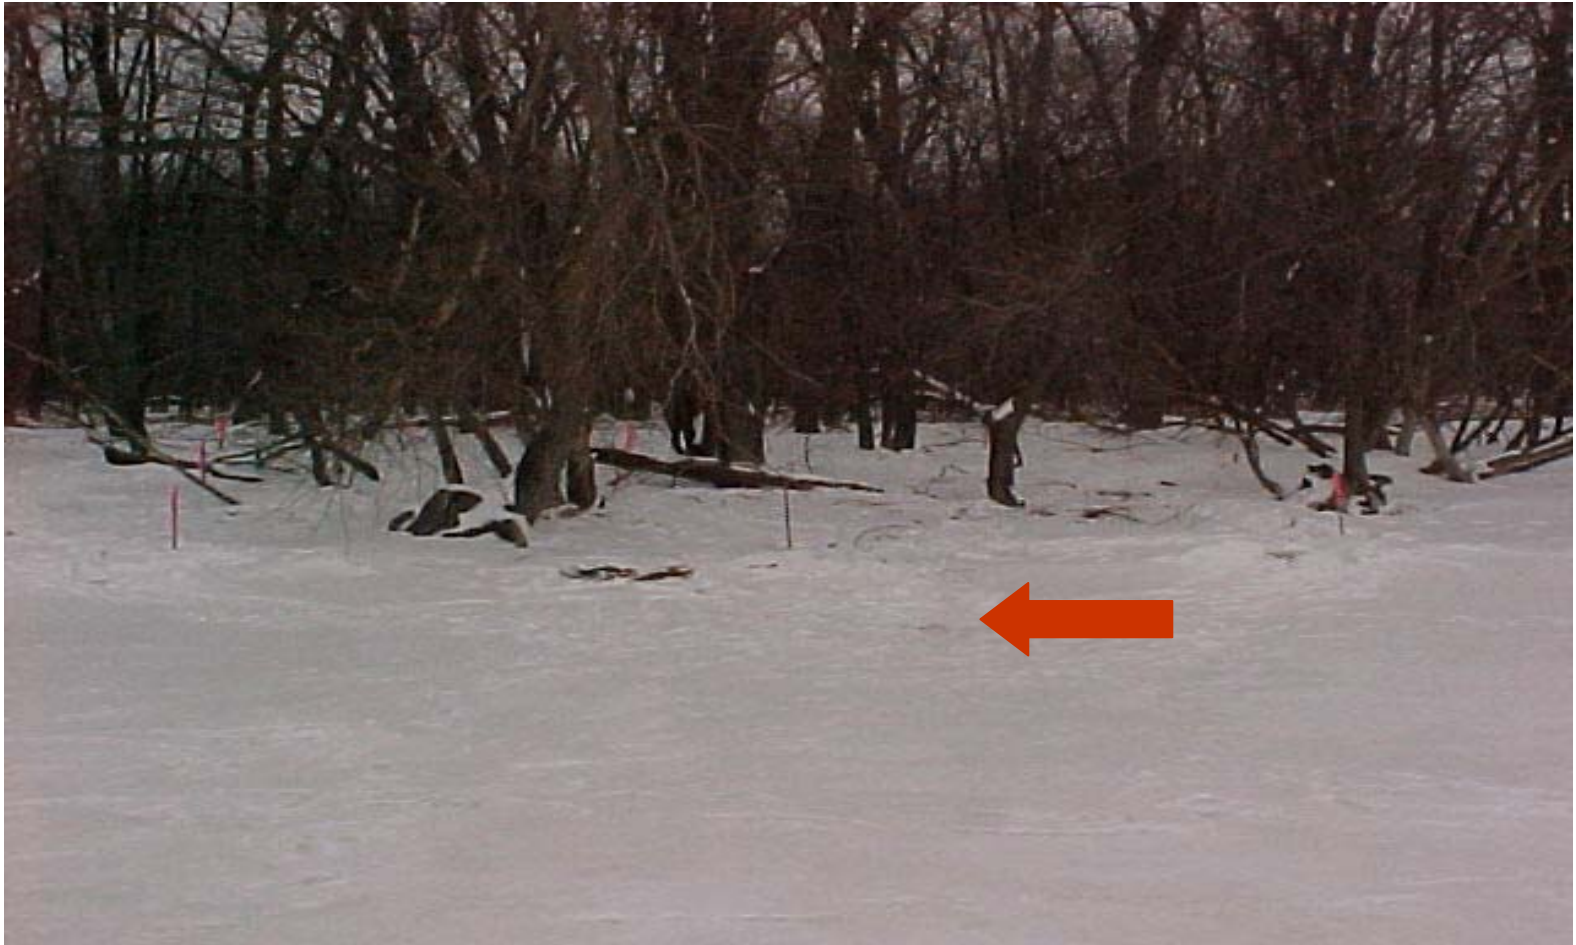
- Location: Gilberts Bay Forested Upland Date: 3/7/02 WL: 777.12 msl
- Description: Photo taken from west of the transect plot looking east showing the 30 foot width of the plot. Red arrow indicates hole augered into ice 15 feet lakeward of transect center.

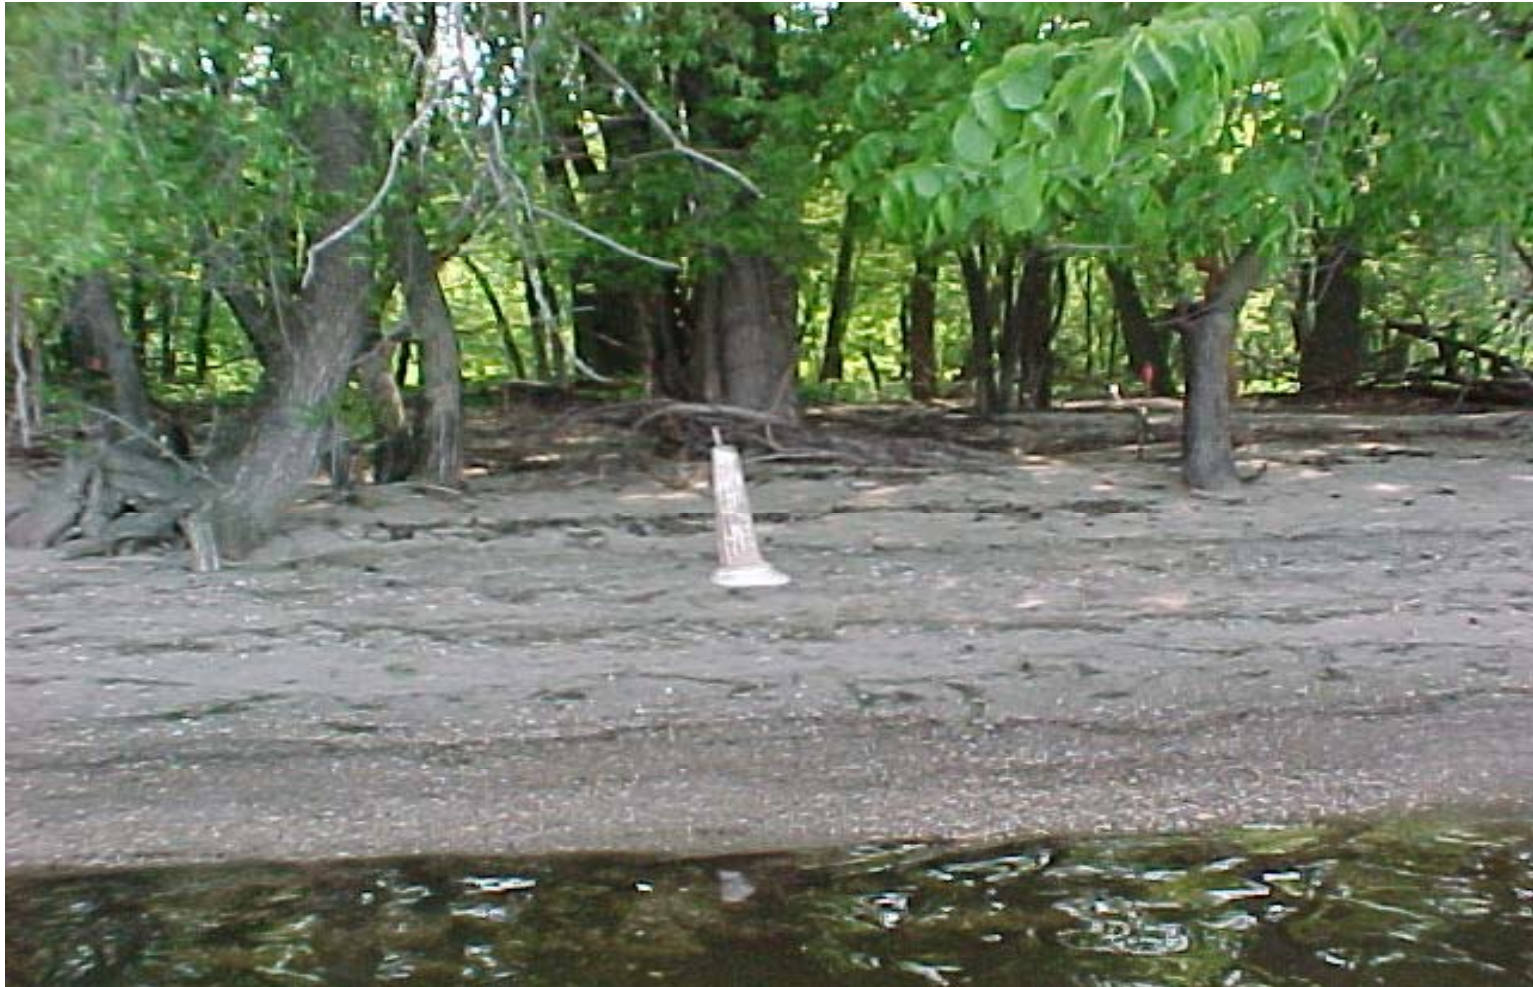
- Location: Gilberts Bay Forested Upland Date: 6/28/02 WL: 776/70 msl
- Photo Description: Photo taken west of midpoint of transect. Stake in center of photo is at O H W M . @ 18 inches of vertical drop from O H W M to water level.

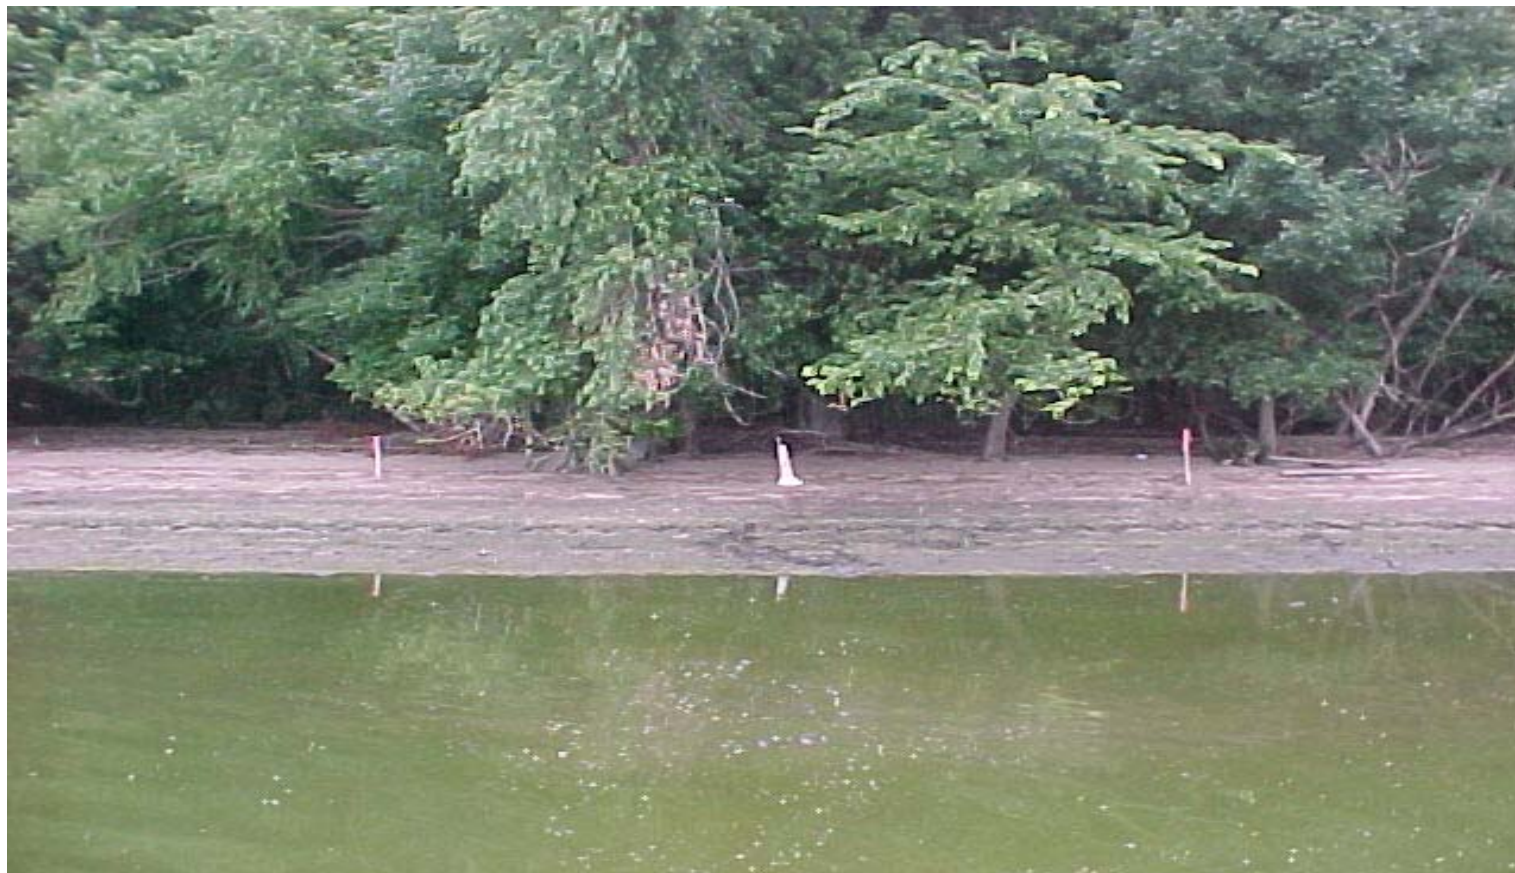
- Location: Vinne Ha Ha (Gilberts Bay) Date: 7/9/02 WL: 776.13 msl
- Photo Description: Photo of Vinne Ha Ha plot. Edge of water 20 feet from stakes (OHWM). Very little change in vegetation since Spring 2002. Two river bulrush plants (2-inch tall) growing on exposed sediments lakeward of stakes.
