Lake Koshkonong Lake and Wetland Survey

October 17, 2008

Hjort and Nichols observations at the following locations.

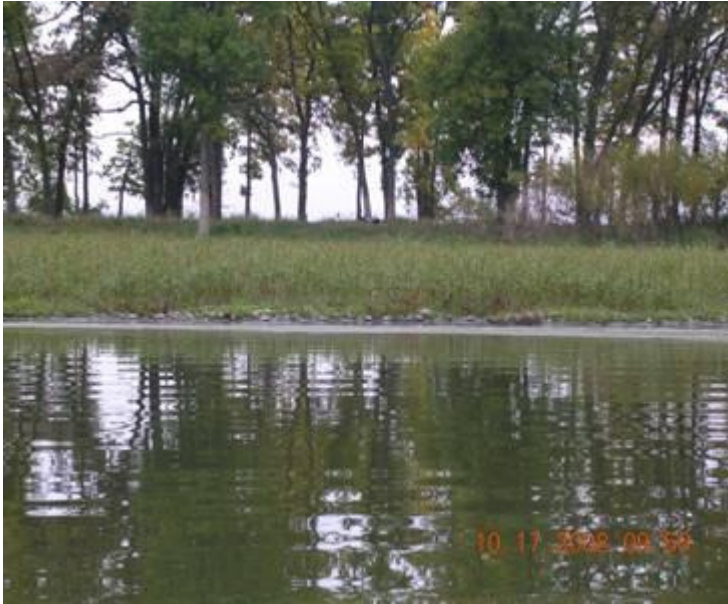
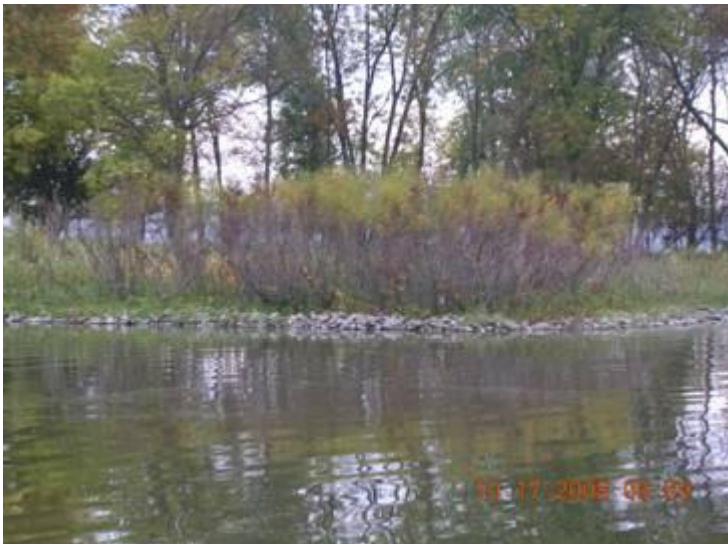
Haight's Bay Shallow Marsh (approximate location of Lake Study Plot)

The top photograph is of the approximate location of the Lake Study Plot and the bottom photograph is of the short point east of the Lake Study plot. The rock armor that was placed during the \$10K grants is still in place and working as a shoreline stabilization structure. Haight's

Bay normally contains a substantial area vegetated by sago pondweed but no submergent or emergent plants were observed outside of the armoring during the survey.

The Lake Study Plot was dominated by river bulrush and is vegetated out to the rock armor. The monotypic river bulrush community contrasts to other years studied and reflects extended flooding conditions that created an inundation amplitude and duration that selected for species that could survive high water conditions. Previous studies typically included numerous obligate and facultative wetland species in this area. The extended flooding essentially ‘drowned out’ the normal assemblage of species.

The absence of leaves on the lower portion of the sandbar willow in the second photograph shows the amplitude of floodwaters along the armored point. The willow survived the flood however the lower portions are likely permanently damaged.

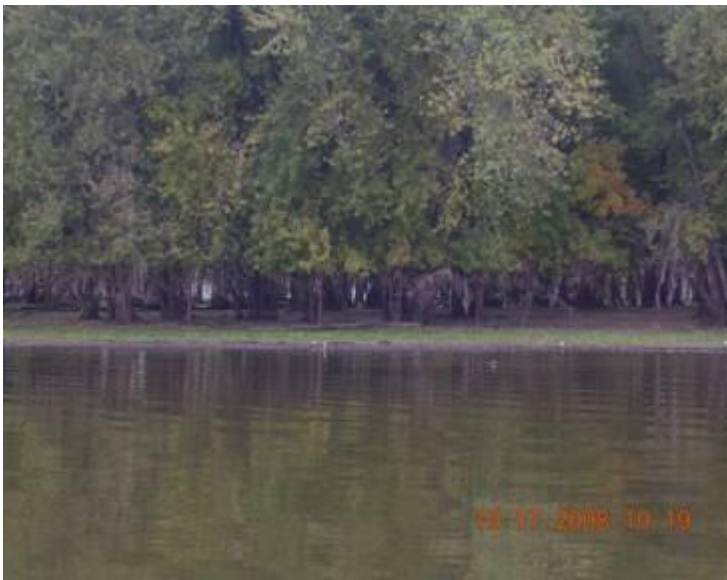
Vinne Ha Ha Floodplain Forest (approximate location of Lake Study Plot)

This Lake Study Plot looks similar to previous studies and the extended high water level is evident by the horizontal line of leaves and watermarks on the trees. It appears that additional sand and gravel was deposited along this shoreline similar to high water years of the recent past. It appeared that there was ponded surface water approximately 100 meters east of the shoreline. This area was previously an ephemeral pond. This lake area normally contains a substantial area vegetated by sago pondweed but no submergent or emergent plants were observed during the survey.

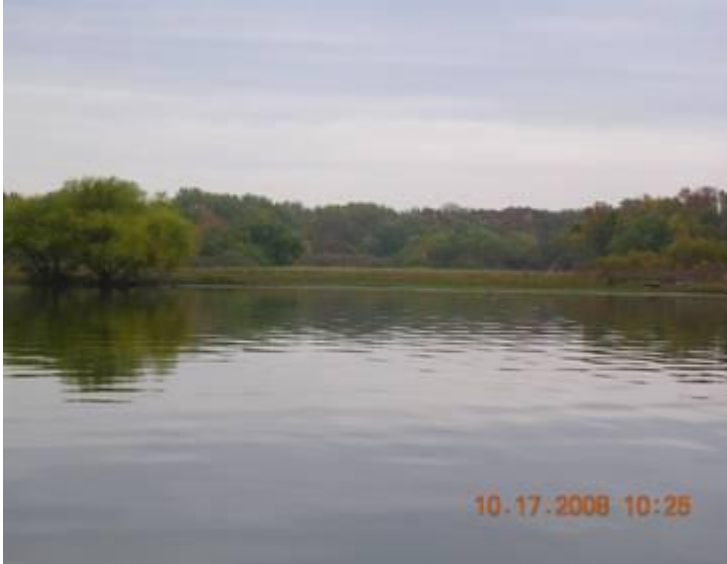
WDNR Public Land Shoreline

The lakeward or leading edge of the shallow marsh area does not appear to have been eroded by the high water. This lake area normally contains a substantial area vegetated by sago pondweed but no submergent or emergent plants were observed during the survey.

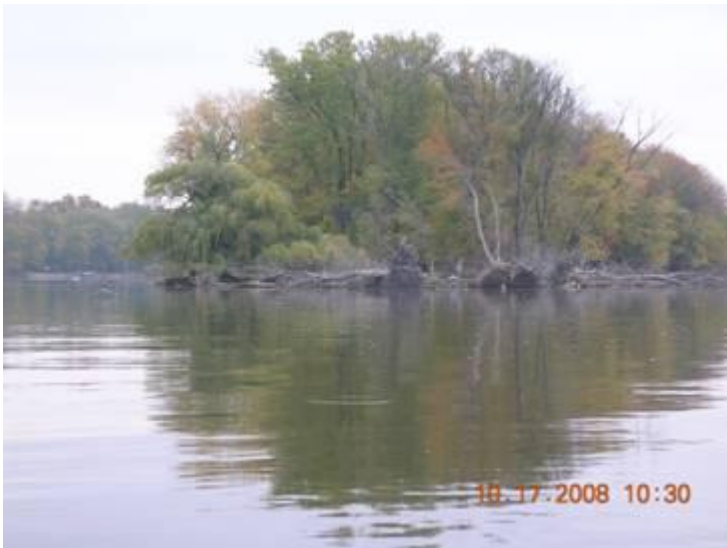
Blackhawk Island Southern River Mouth Floodplain Forest

Numerous tip-overs were observed and there was loss of some of the former leading edge trees on the point. The amount of acreage lost is uncertain but numerous tree stumps and large branches were noted.

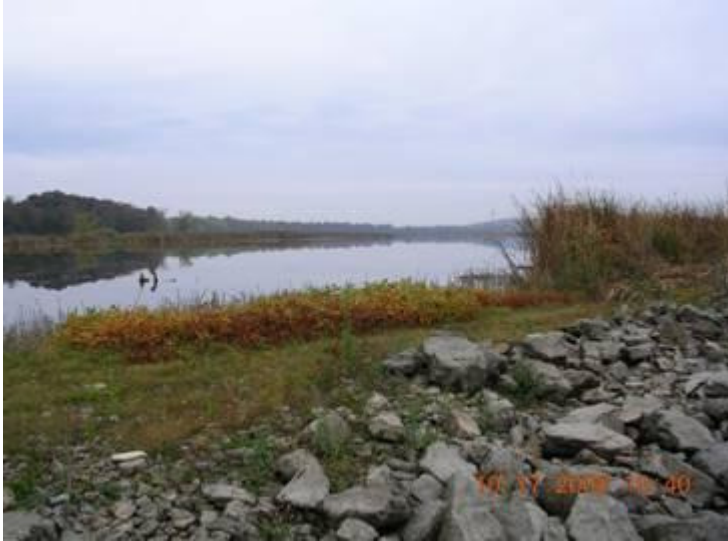
HAI Wetland

The shallow marsh appears to have lost a large amount of cattail and the open water area has increased significantly. Numerous cattail bogs settled on top of the rock armor after water levels receded.

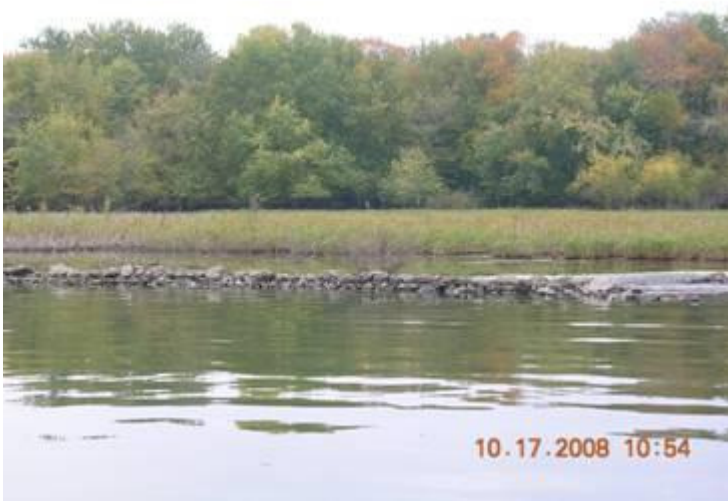
Carcajous Shallow Marsh (approximate location of Lake Study Plot)

The shallow marsh plant community was similar to Haight's Bay in density and limited species diversity. It appears that the lakeward or leading edge of the shallow marsh plant community has extended lakeward towards the rock armor and is comprised of river bulrush and cattail. The rock armor cut has silted in (right central portion of photograph) to the approximate elevation of the rock armor. Sandbar willow colonized portions of the rock armor.

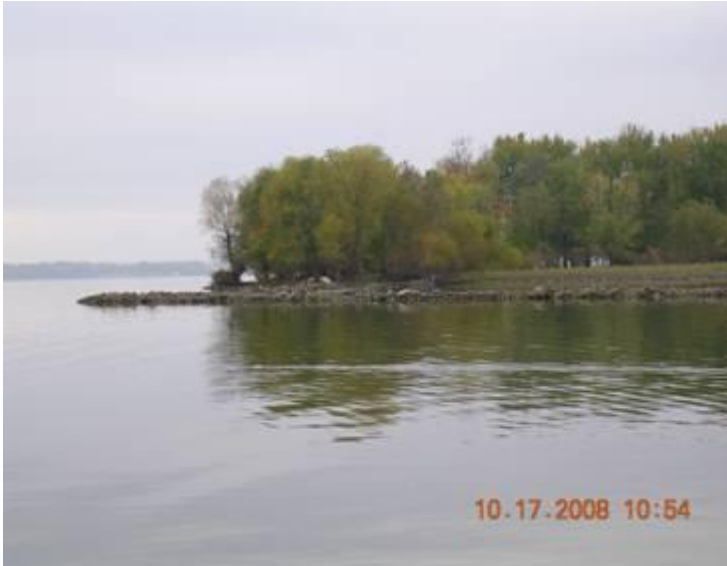
Photograph of rock armor extending west towards Carcajou Point. Rock armor appears to be maintaining position and effectiveness.

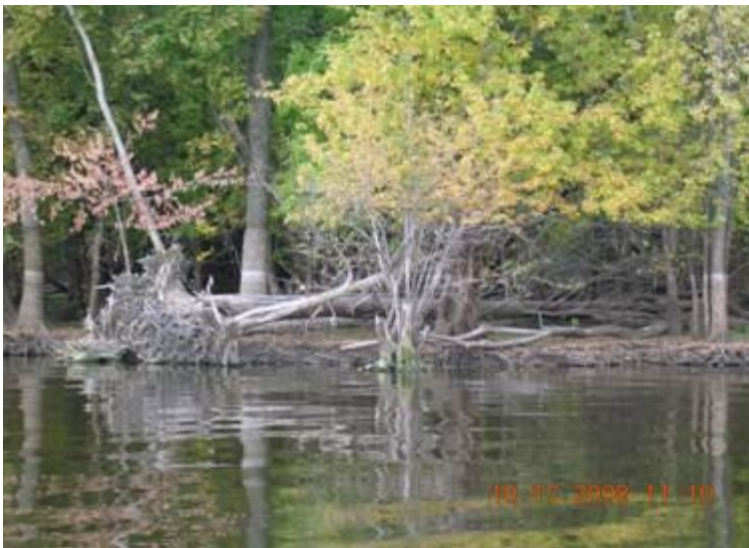
Carcajou Floodplain Forest (approximate location of Lake Study Plot)

The Lake Study Plot was not armored and showed evidence of continued erosional losses. Extreme high water mark (top of gray) and extended high water mark (white line) are easily observed on trees. Scattered sago pondweed was observed in this area of the lake.

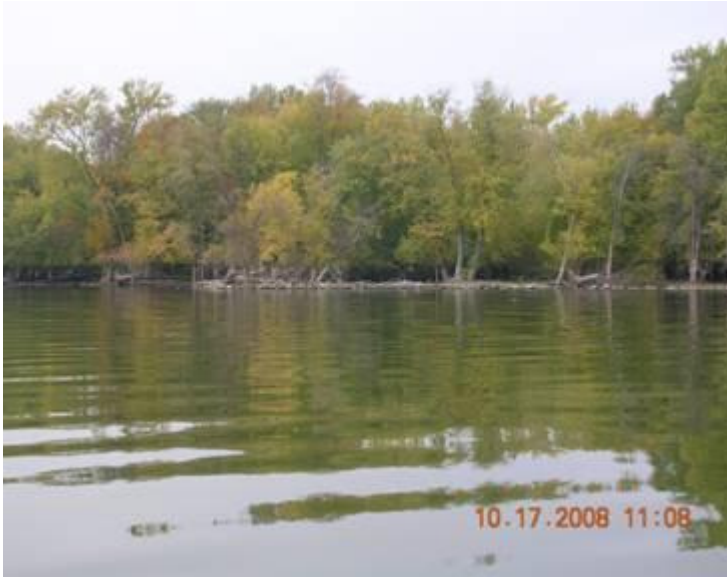
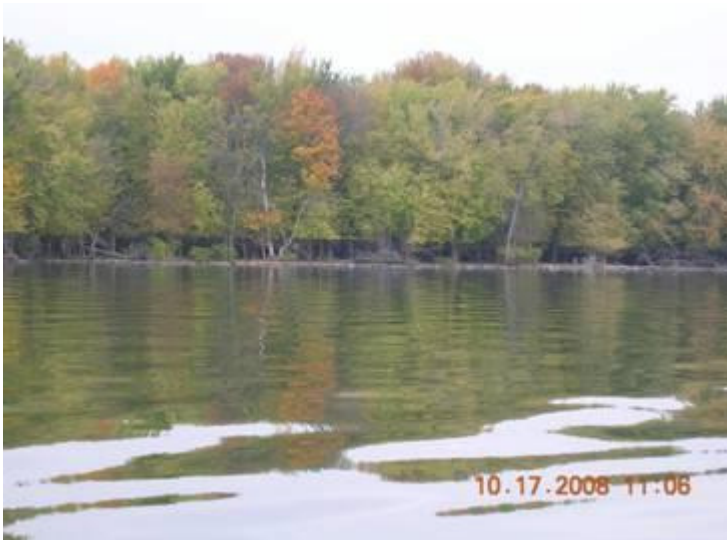
Rock armor along the western Carcajou shoreline appears to be effective for shoreline maintenance and reduction of tip-overs.

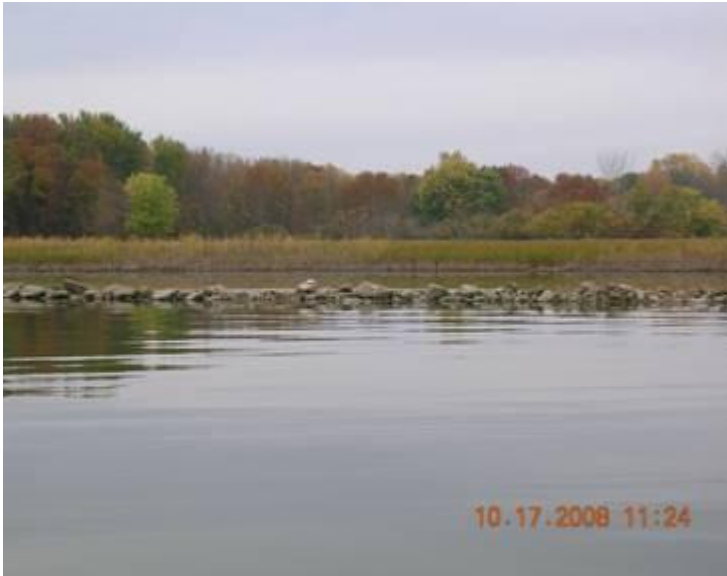
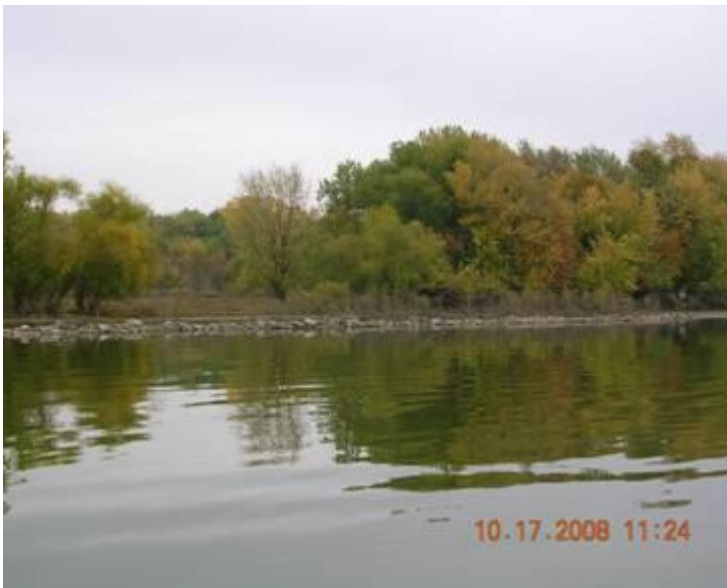
The Gilberts Bay wetland complex appears to be similar in appearance to other shallow marshes with less species diversity at the lake edge than in the past and with the rock armor being colonized by sandbar willow.
