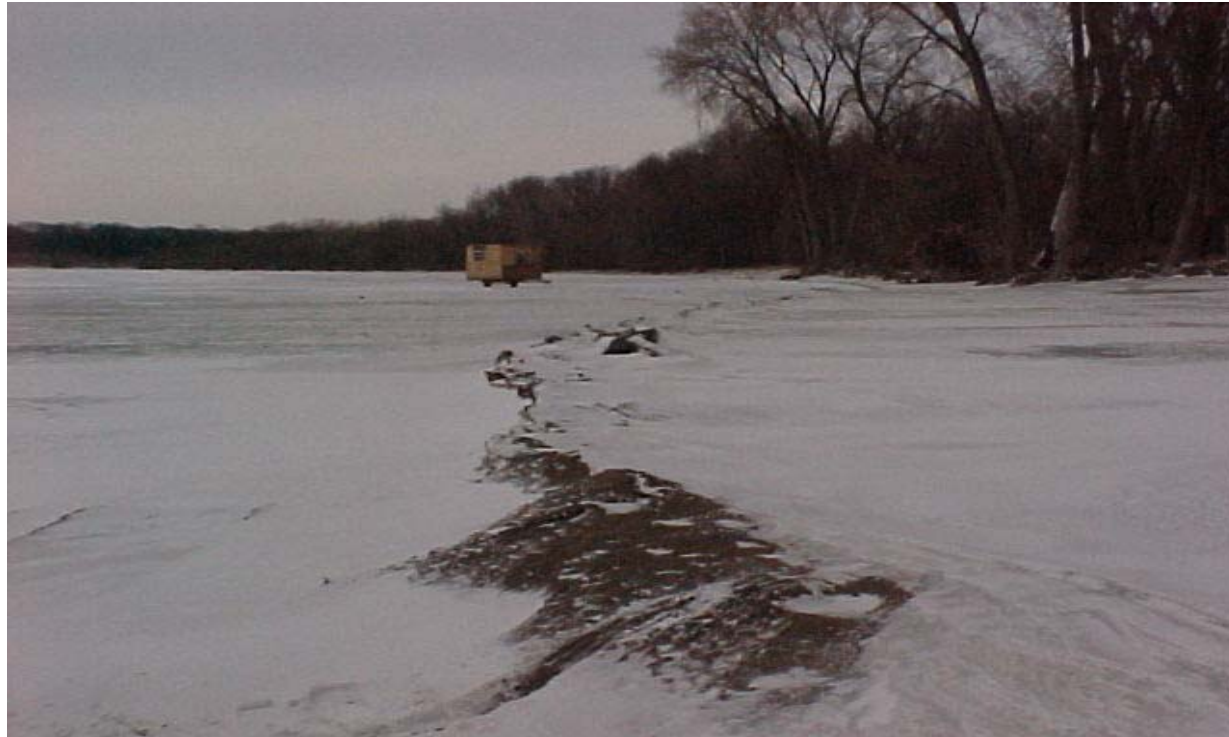
Location: North of Vinne Ha Ha Boat Landing

Photo of frozen sediment “heave”. This area is an area of lake bed that was desiccated during the winter drawdown and appears to have frozen and is acting like an ice sheet heaving close to the normal shoreline.

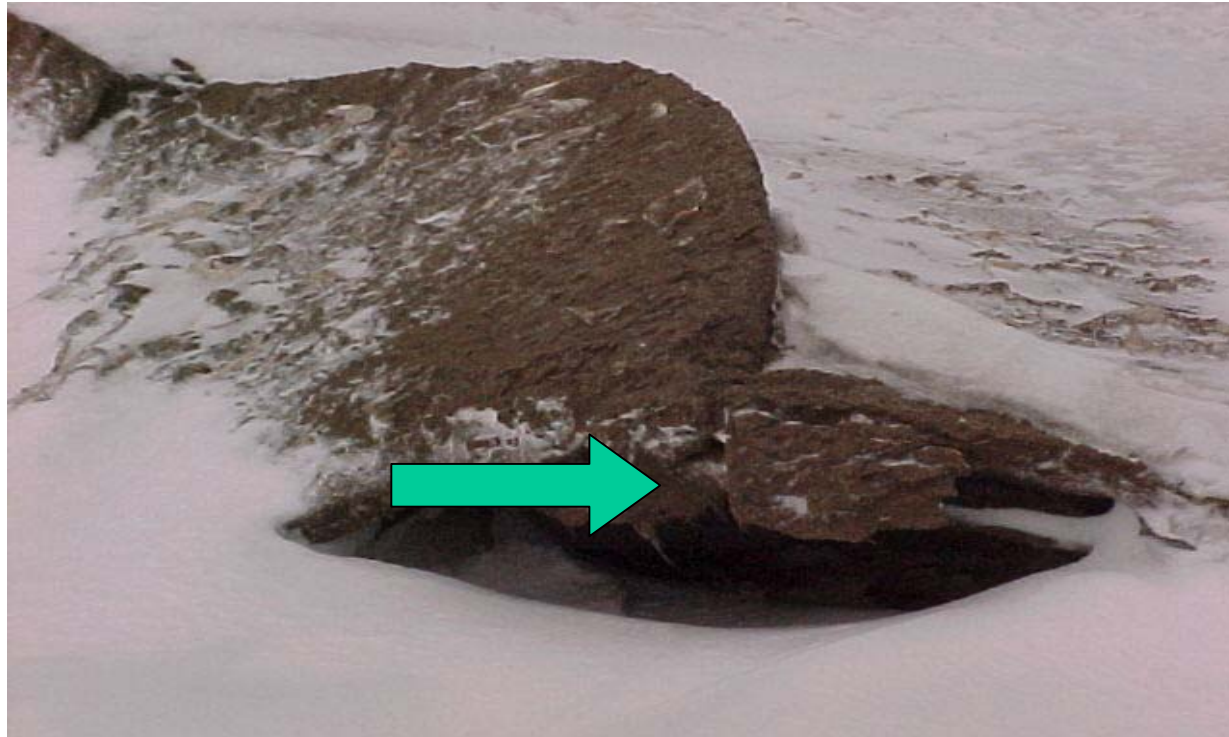
Location: North of Vinne Ha Ha Boat Landing

Photo of frozen sediment “heave”. This is a close-up of the frozen sediment layer heaving up. Width of frozen sediment about 4 inches thick.

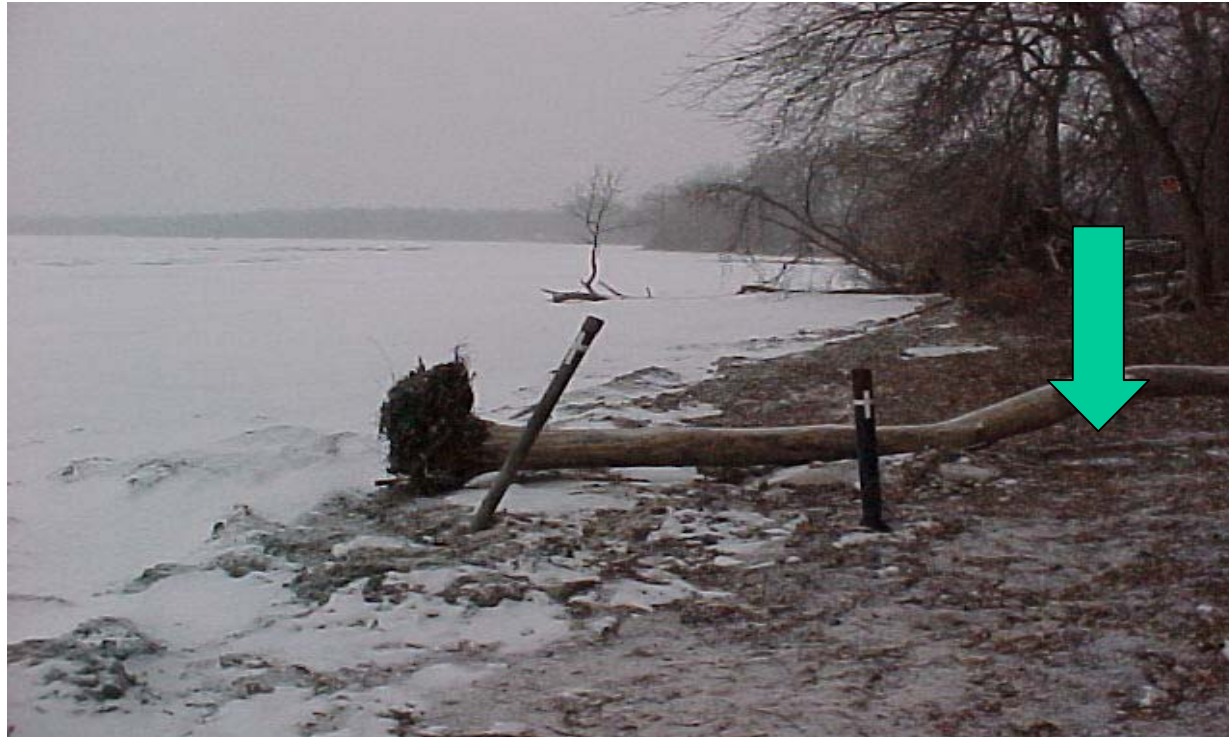
Location: West of Bingham Road Boat Landing

Photo of frozen sediment “heave” along exposed sediments below the normal water level elevation. Arrow depicts location of normal summer water level (@776.20 msl). Note heave action has moved the steel post in center of photo shoreward.

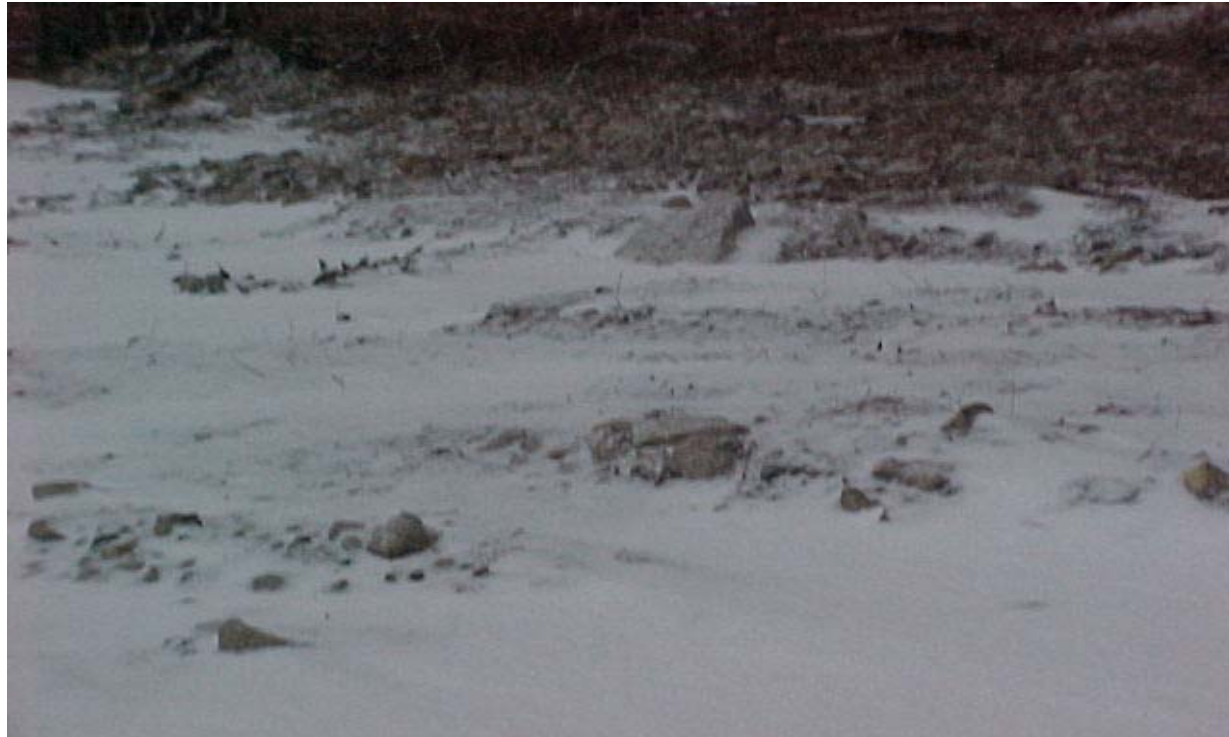
Location: West of Bingham Road Boat Landing
Photo of frozen sediment “heave”.
